# Gatton Shire Cultural Heritage Study

## Vol 2 Grantham Helidon

A report for  
Gatton Shire Council  
by  
Buchanan Architects

December 2000

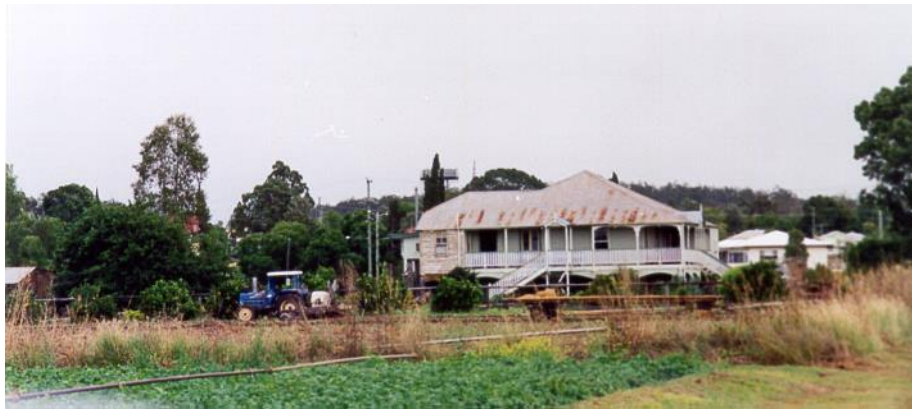
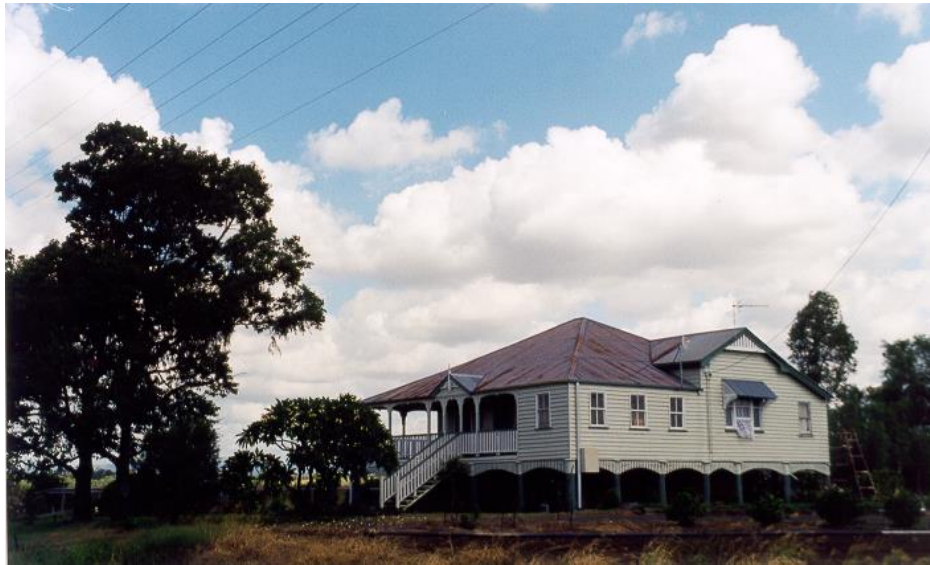
- Short ridge pyramid bungalow with 3 sides incorporated verandah and a north-west side gable.
- Weatherboard clad
- Half-hip roof to rear
- Prominent roadside position
- Open front verandah with two-rail timber slat balustrade
- Enclosed left-hand side verandah
- Timber stairs front and side, each with a gabled porch
- Colonial sash windows generally feature tripartite sash on gable elevation with skillion window hood
- High set on timber stumps, arched sub-floor timber valance

Important for its demonstration of early form and materials and for its demonstration of early building techniques.

The house has a prominent corner position and contributes aesthetically to the streetscape/rural landscape.

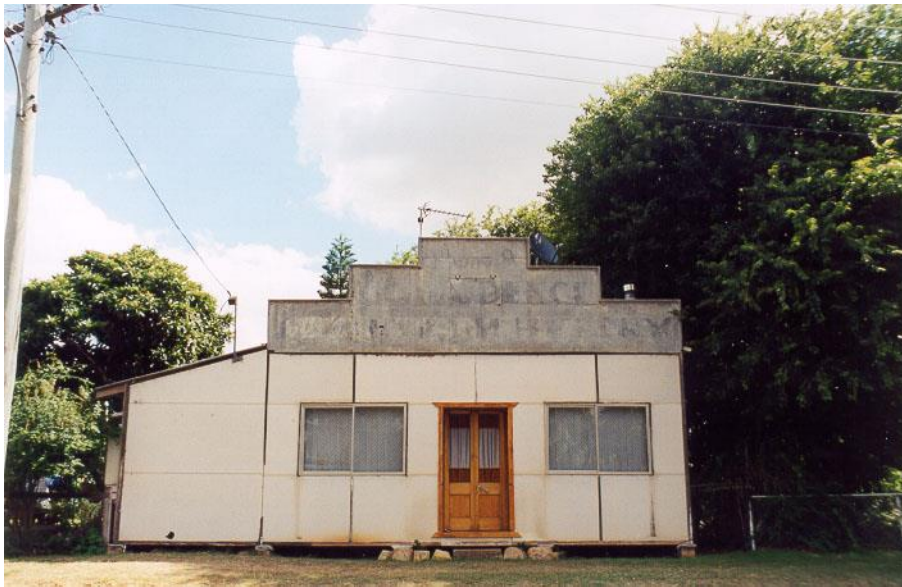
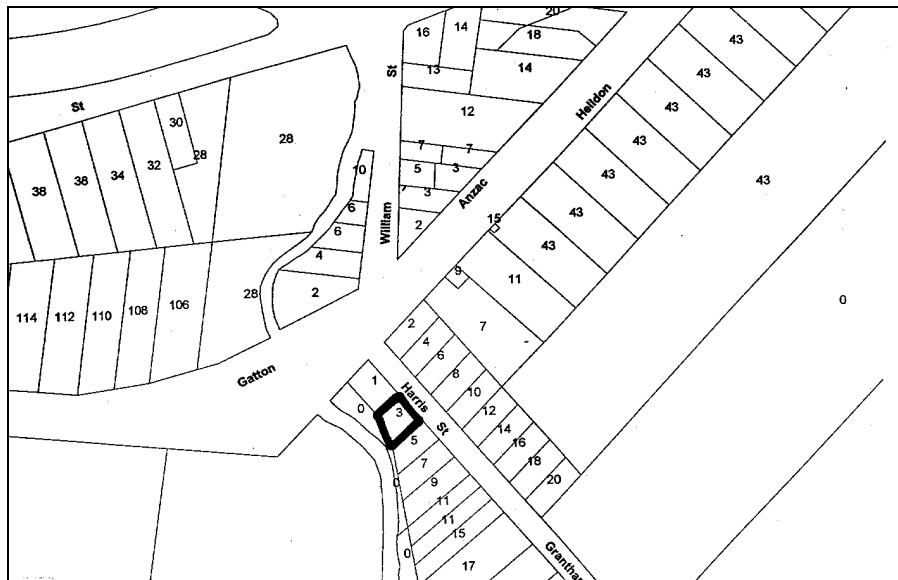
- Currently occupied as a residence.

- Gable ended pitched roof with side verandah and sheet metal parapet shop front to street.
- Front elevation fibro clad with aluminium framed windows and French door.
- Remainder of the building is weatherboard clad.
- Low-set on brick piers.

The building is recorded for the evidence it contains of the traditional form, detailing and materials of a small shop.

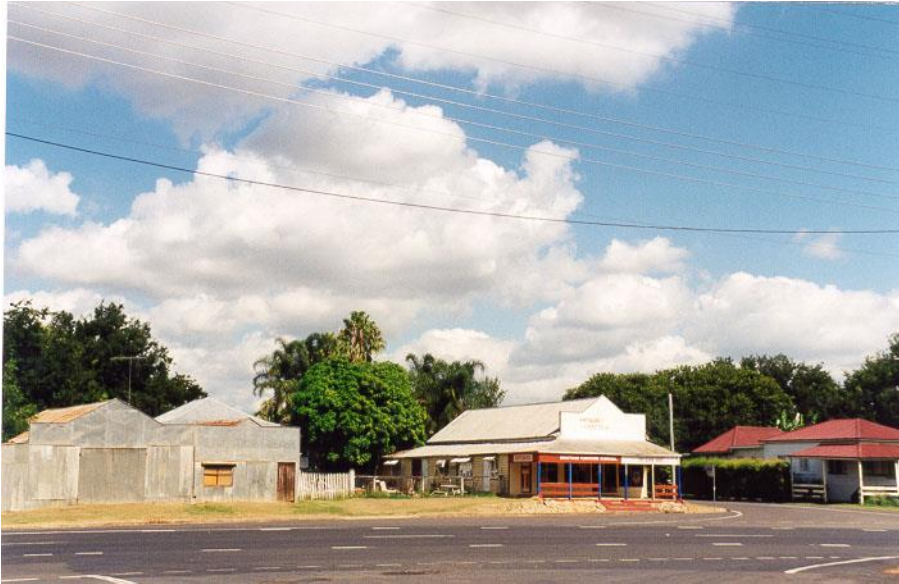
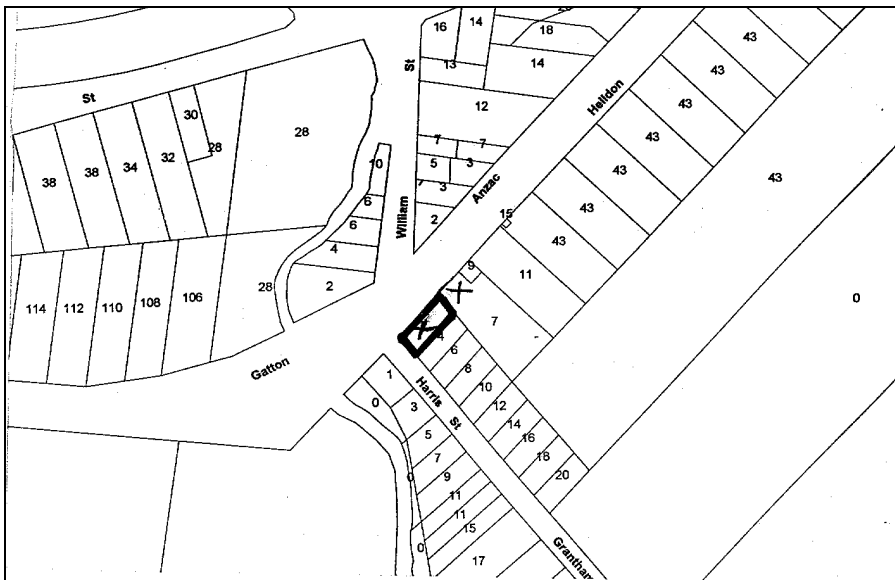
- Previously operated as a general store

- Gable ended pitched roof building with side and front verandah, the front used as a street awning.
- Fibro parapet to Gatton Helidon Road.
- Located on prominent corner in Grantham.
- Currently operating as an antique shop.

The building is important for the evidence it contains of the traditional form, detailing and materials of a small shop.

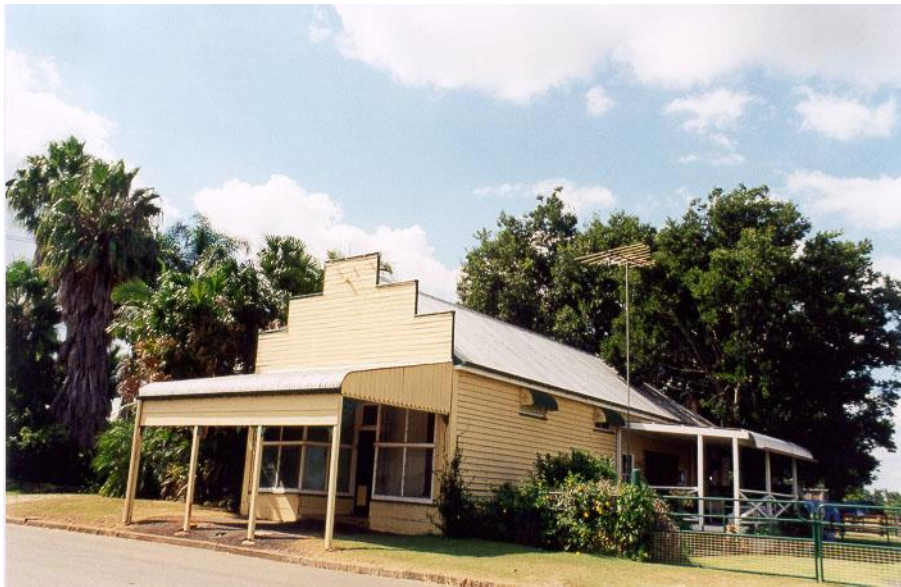
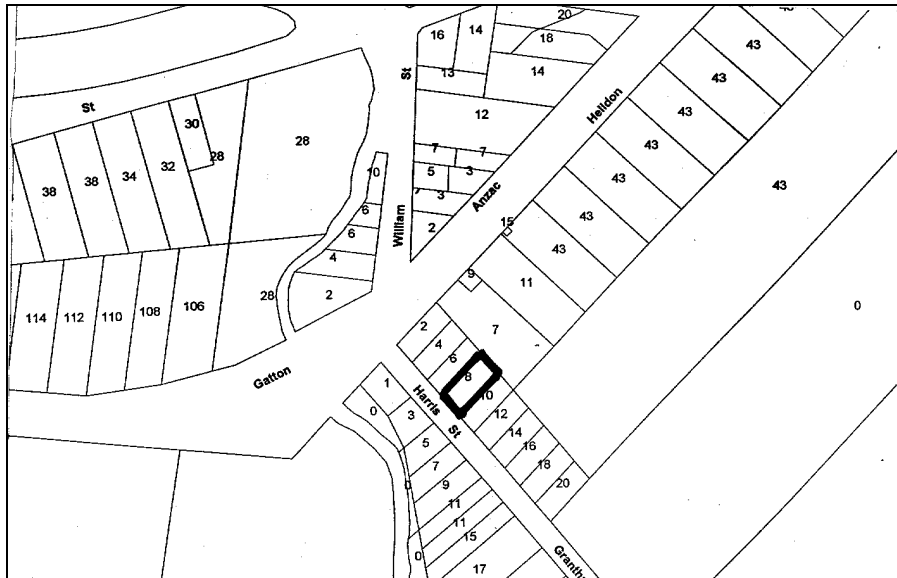
- Gable ended pitched roof with stepped weatherboard parapet facing street.
- Bullnose street awning with timber infill and posts.
- The side elevations are weatherboard clad and have 2 high venting windows with curved window hoods.
- The front elevation is mostly timber framed shop front windows with a recessed, angled central entry.
- French doors to the entry and fanlight over.
- Thought to be currently occupied as a residence.

The building is important for the evidence it contains of the traditional form, detailing and materials of a small shop and for its contribution to the streetscape.

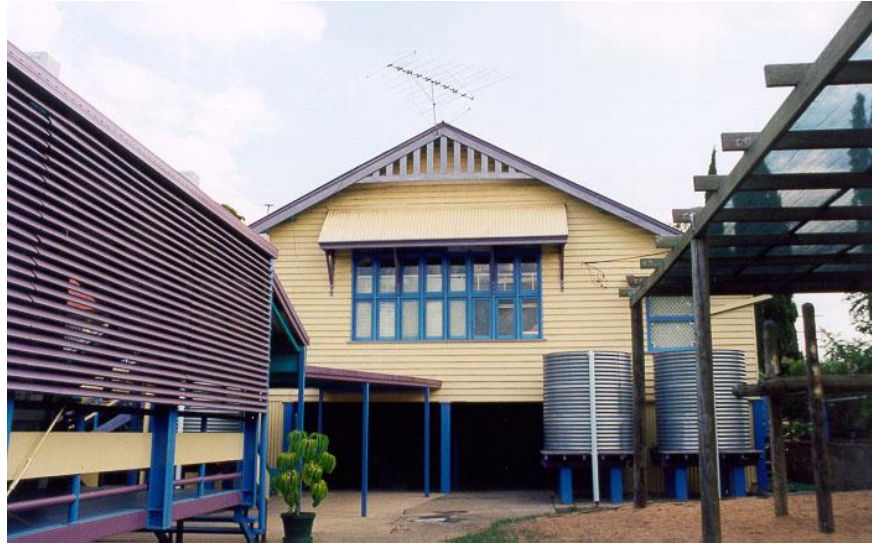
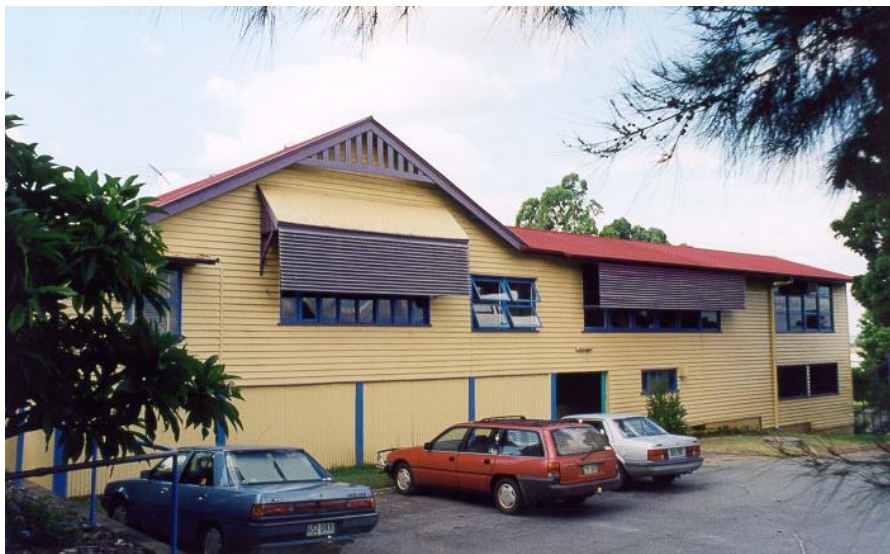
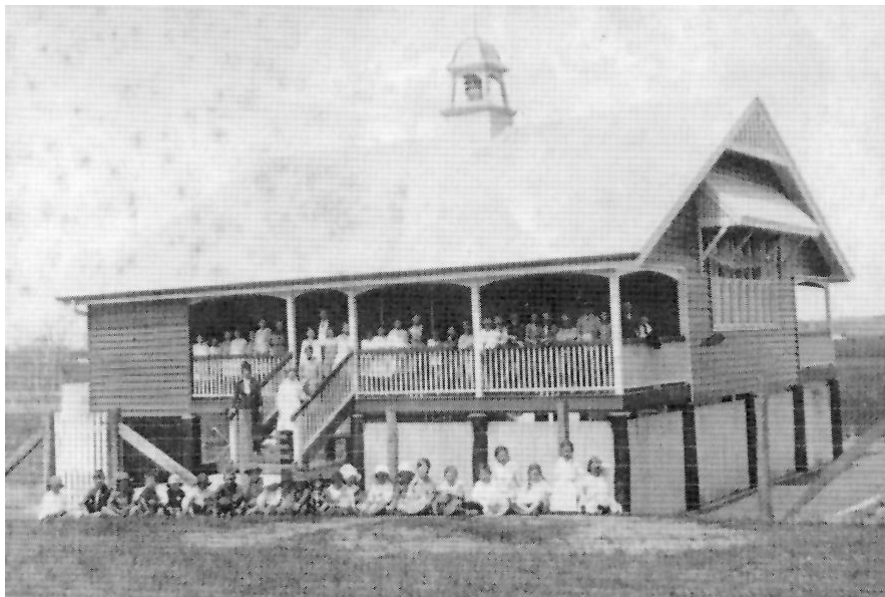
- Opened in 1905 (date noted on a plaque in the entry foyer)
- 1914 –1918 Honour Board in the entry foyer.
- The site was extended and a new school building was erected in 1916-17.

- Typical school building, gable ended with a pitched roof and slatted gable infill.
- Bank of timber framed windows under a large skillion awning on each gable end.
- Verandahs on each side have been enclosed with weatherboards.
- Ornate roof ventilator is no longer evident.
- Internally the ceilings are ornate pressed metal and in excellent condition.
- This main core is currently being used as the school office.
- Rear half hipped extension houses classrooms, c1950s.

*Photo taken shortly after opening*

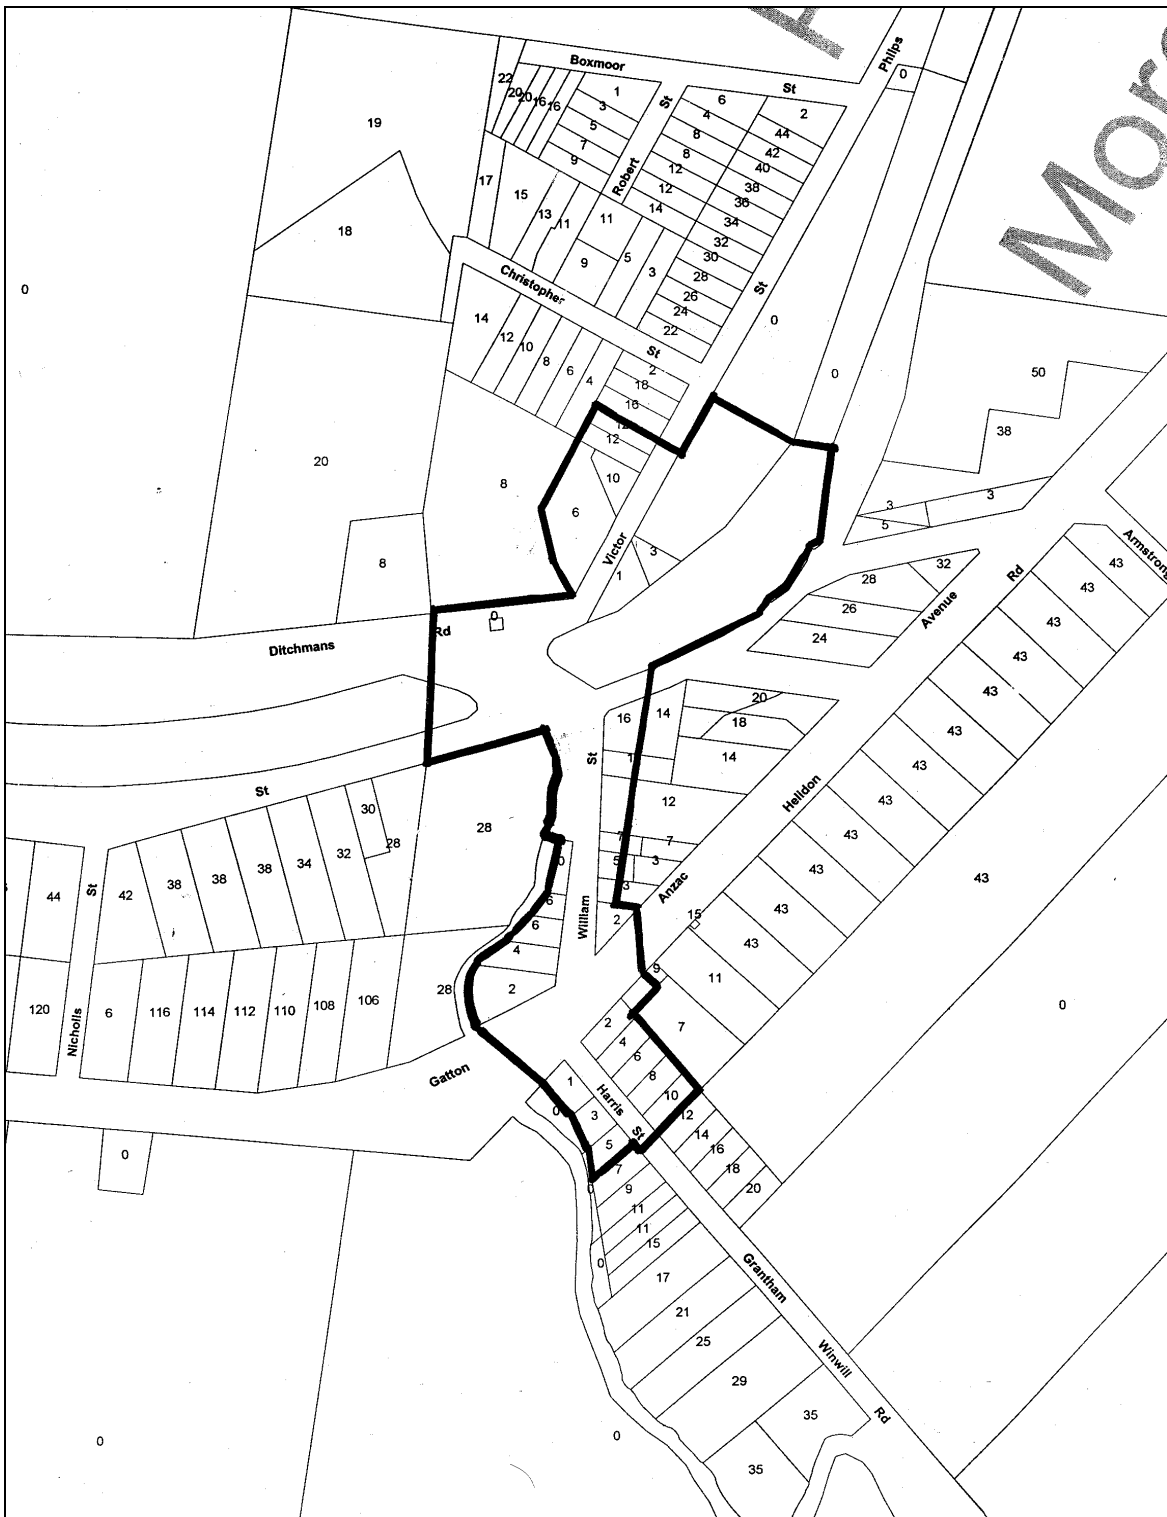
It will be important to try to retain the character of this area and prevent unsympathetic alterations and further erosion of its integrity. This does not mean that new buildings within this precinct should be replicas. New development and infill should respect the scale and materials of the historic buildings within the curtilage of the precinct.

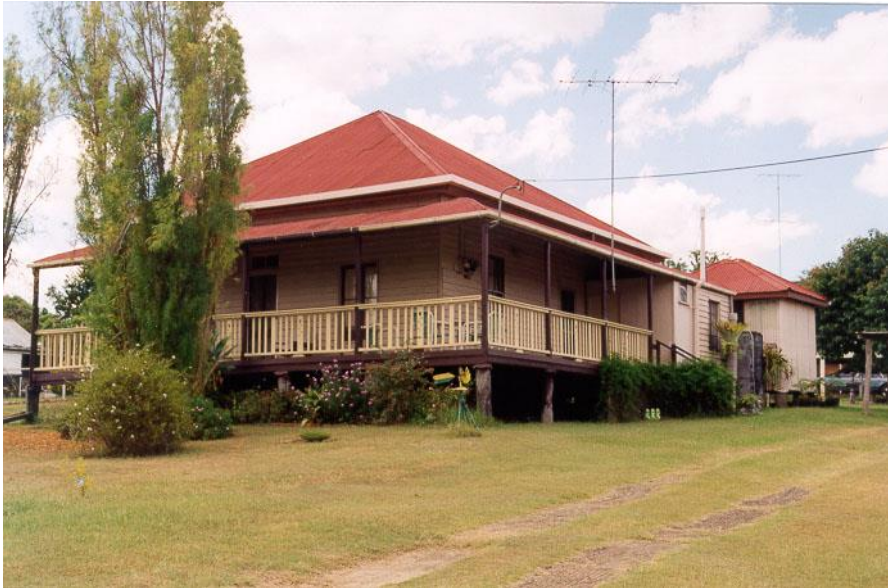
NAME	-
CATEGORY	House
LOCATION	20 Arthur St Helidon
RPD	2RP2591 and 3RP2591
LISTING BOUNDARY	Whole site
OTHER LISTINGS	-
SIGNIFICANCE LEVEL	Local

- c1890s style pyramid roof and stepped curved verandah dwelling.
- Separate kitchen wing and enclosed breezeway.
- Timber stumps
- Later weatherboard cladding possibly covering fan-lights over French doors.
- Later handrail.

Important for its demonstration of aesthetic characteristics and building techniques typical of the late 19<sup>th</sup>/early 20<sup>th</sup> century.

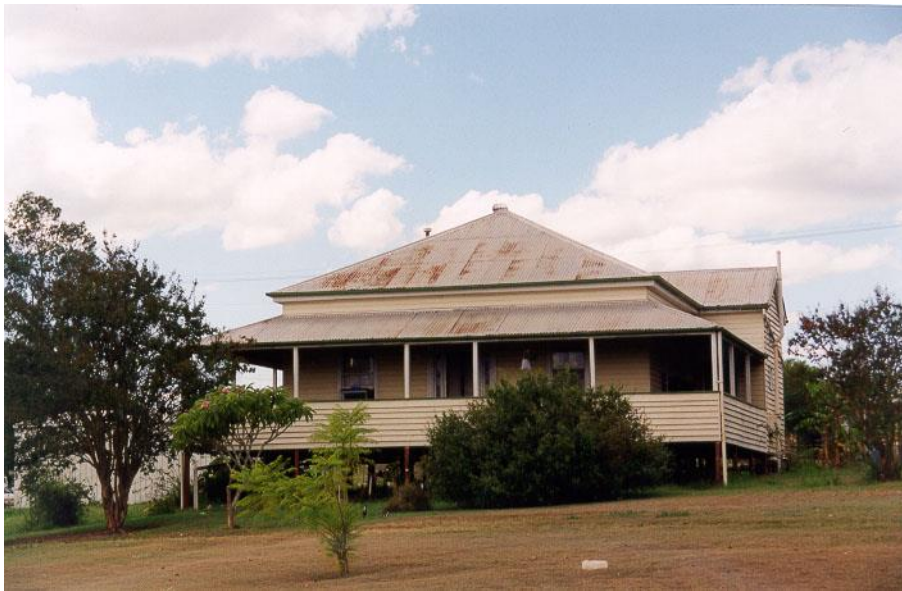
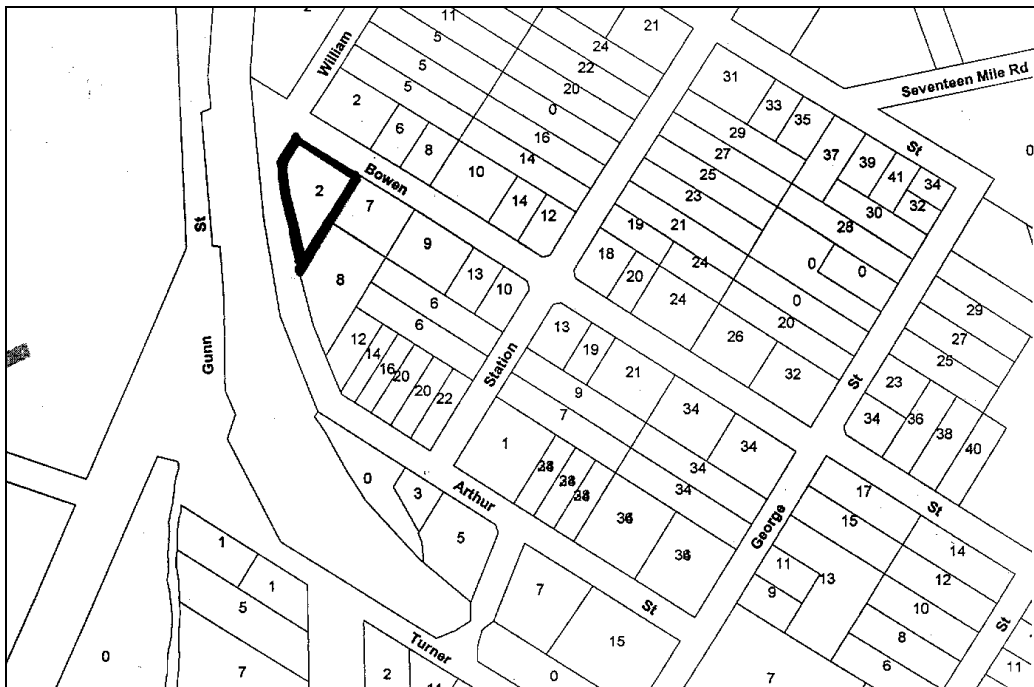
NAME	-
CATEGORY	House
LOCATION	2 Arthur St Helidon
RPD	101H1261
LISTING BOUNDARY	Whole site
OTHER LISTINGS	-
SIGNIFICANCE LEVEL	Local

- C1890s style pyramid roof and stepped verandah 3 sides.
- Front and rear gable.
- Weatherboard clad.
- Original windows and doors with coloured glass sidelights.
- Verandah balustrade replaced with weatherboard

Important for its demonstration of early form and materials and for its demonstration of early building techniques.

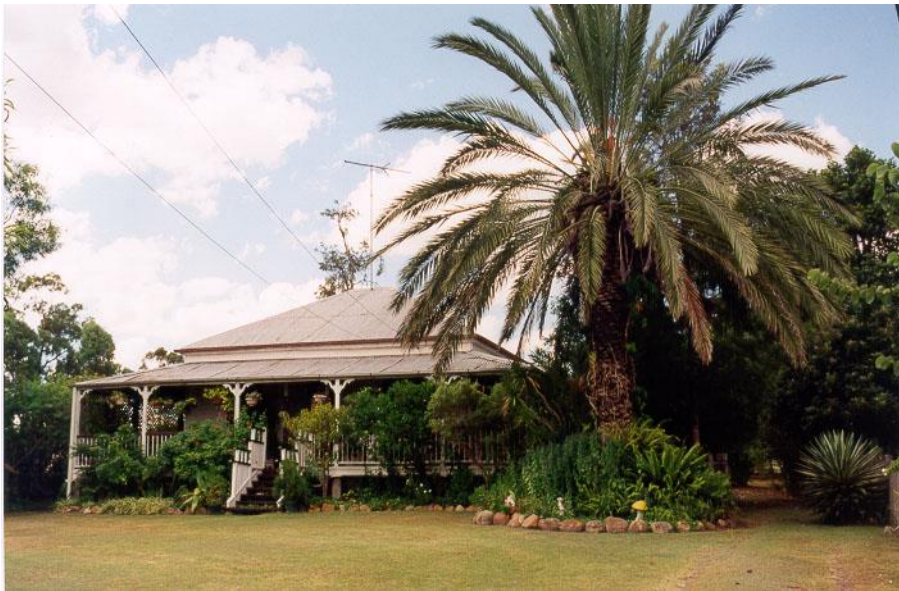
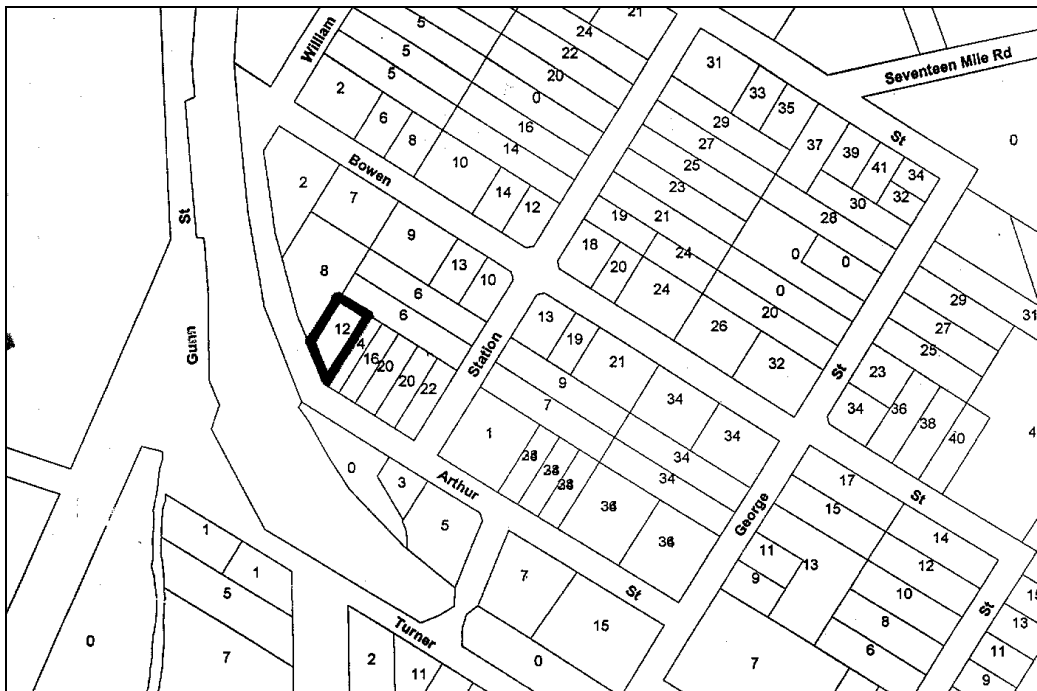
NAME	-
CATEGORY	House
LOCATION	12 Arthur St Helidon
RPD	1RP52940
LISTING BOUNDARY	Whole site
OTHER LISTINGS	-
SIGNIFICANCE LEVEL	Local

- C1890s style pyramid roof and stepped verandah 3 sides.
- Weatherboard clad.
- Original windows and doors with coloured glass sidelights.
- Two rail broomstick balustrade.
- Stop chamfered posts and ornate corner brackets.
- 1930s style entry stair and balustrade.
- Large Date Palm and mature trees in garden.

Important for its demonstration of early form and materials and for its demonstration of early building techniques.

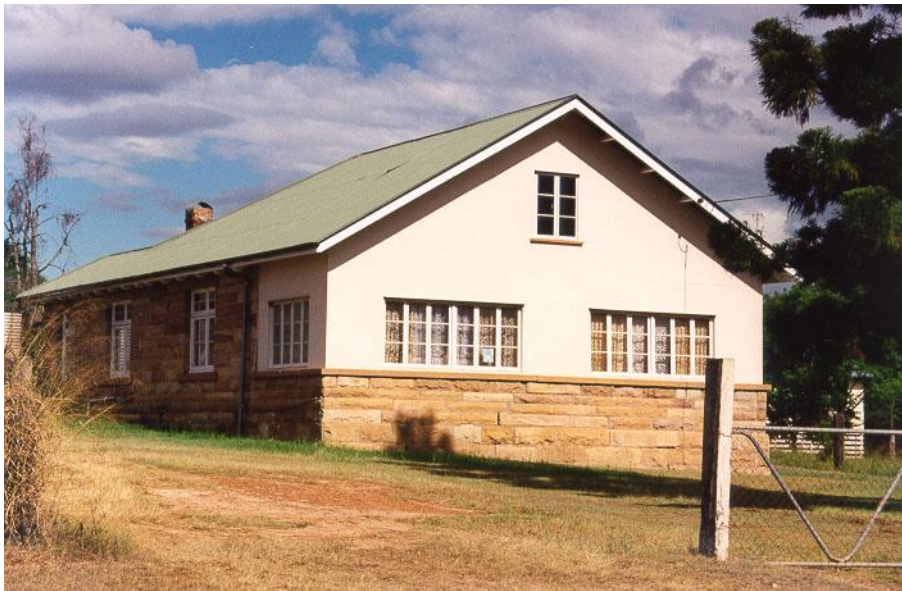
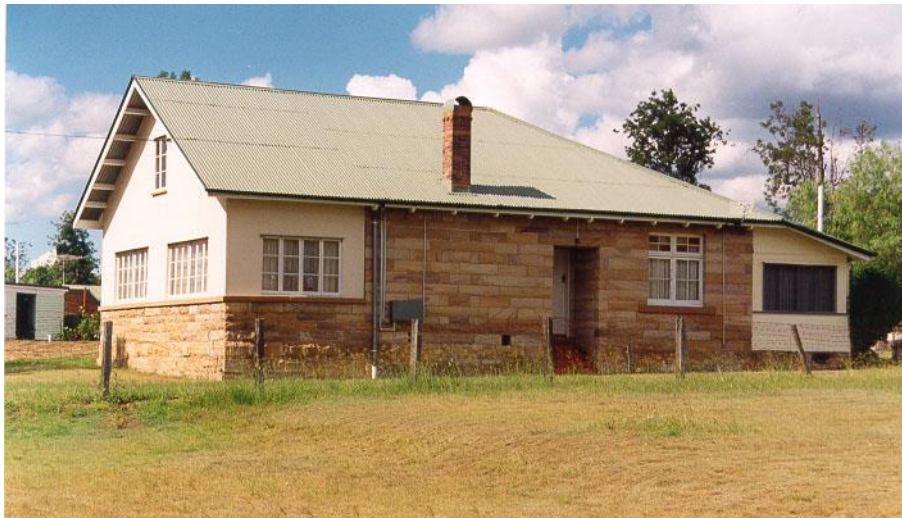
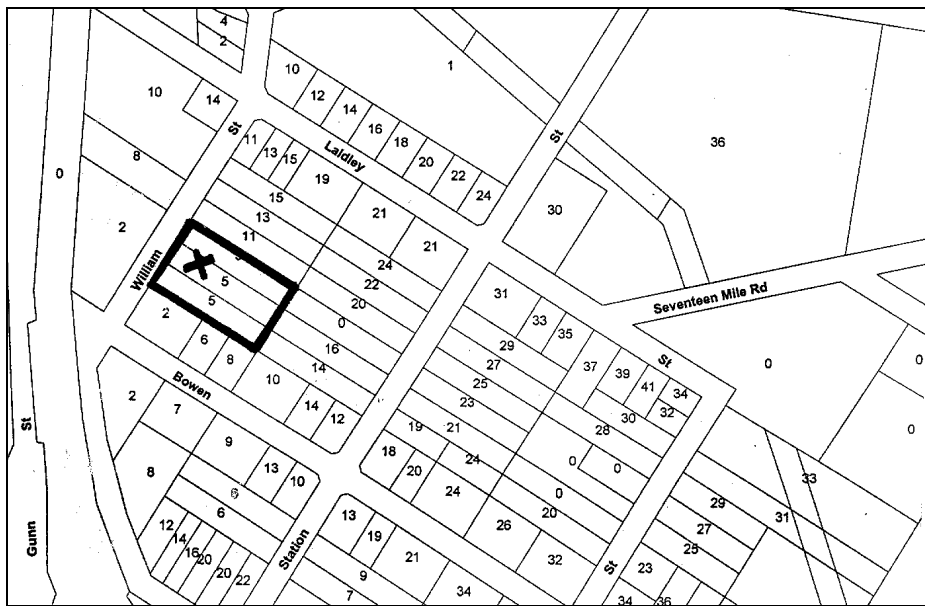
NAME	-
CATEGORY	House
LOCATION	5 William St Helidon
RPD	218H1261, 219H1261 and 220H1261
LISTING BOUNDARY	Whole site
OTHER LISTINGS	-
SIGNIFICANCE LEVEL	Local

- Front gable and rear hip roof
- Front gable fibro infill over the sandstone base
- windows and doors with coloured glass sidelights.
- Walls partly sandstone
- Brick Chimney.
- Rear skillion enclosed verandah on original sandstone plinth.

An interesting and rare example of a house built using local sandstone.

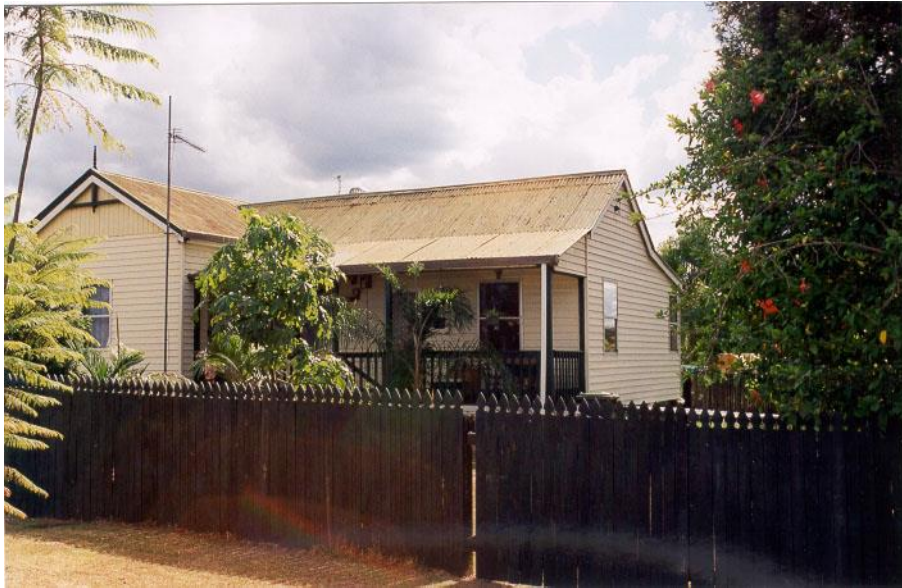
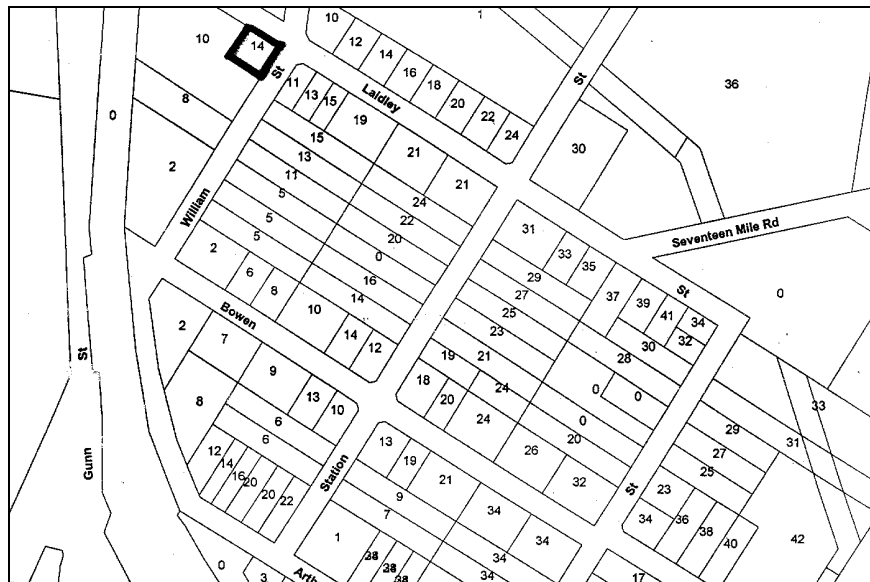
NAME	-
CATEGORY	House
LOCATION	14 William St Helidon
RPD	1RP148530
LISTING BOUNDARY	Whole site
OTHER LISTINGS	-
SIGNIFICANCE LEVEL	Local

- Colonial gable with front and rear skillion enclosed verandahs. A transverse gable extension added at a later date.
- Weatherboard clad.
- Aluminium framed windows.
- Recent entry stair and balustrade.

Important for its demonstration of early form and materials and for its demonstration of early building techniques.

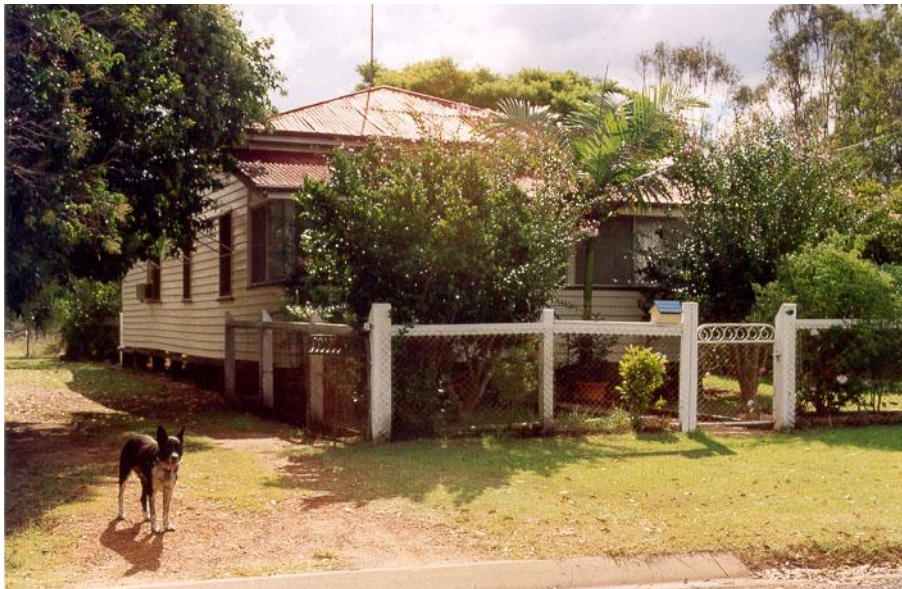
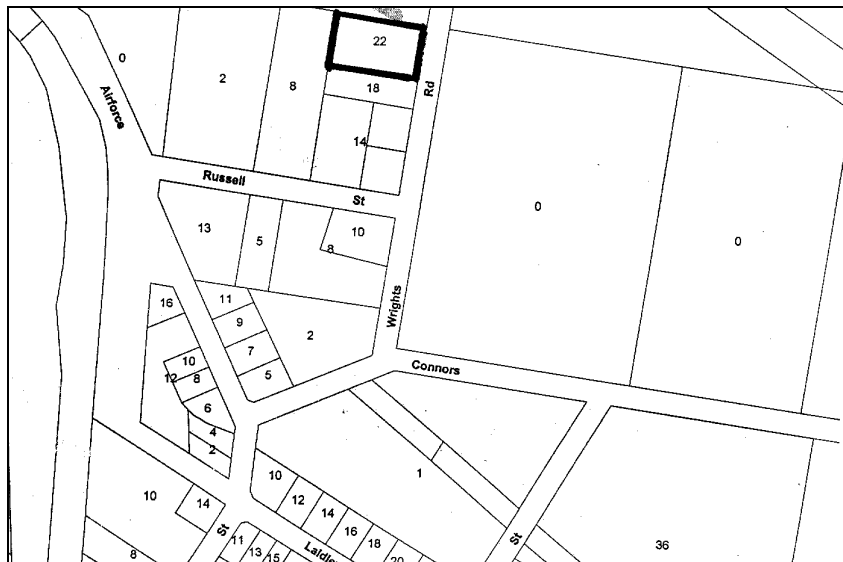
NAME	-
CATEGORY	House
LOCATION	22 Wrights Rd
RPD	2RP59783
LISTING BOUNDARY	Whole site
OTHER LISTINGS	-
SIGNIFICANCE LEVEL	Local

- C1890s style pyramid roof and stepped front verandah.
- Front verandah enclosed with weather board balustrade with aluminium windows above
- Weatherboard clad.
- Some windows and doors appear to be original.
- Post and chain wire fence.

Important for its demonstration of early form and materials and for its demonstration of early building techniques.

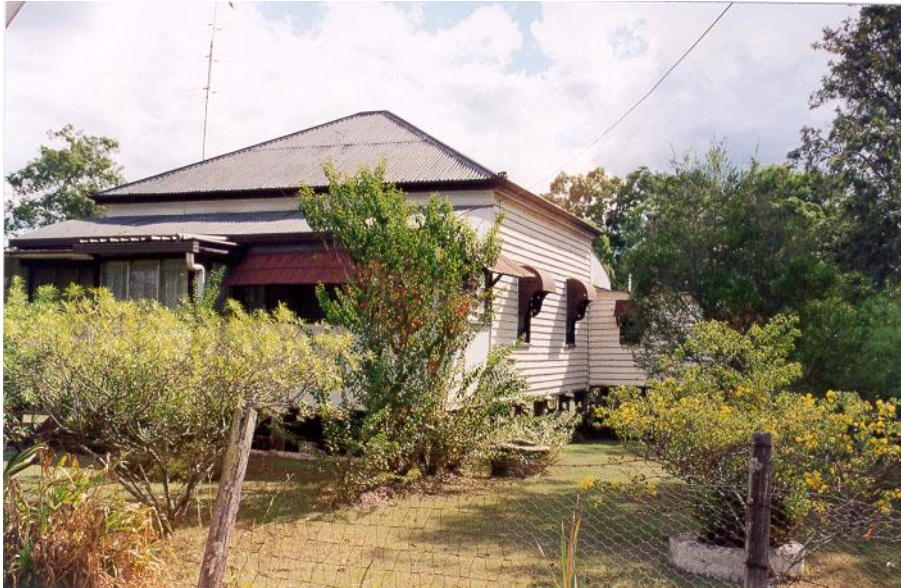
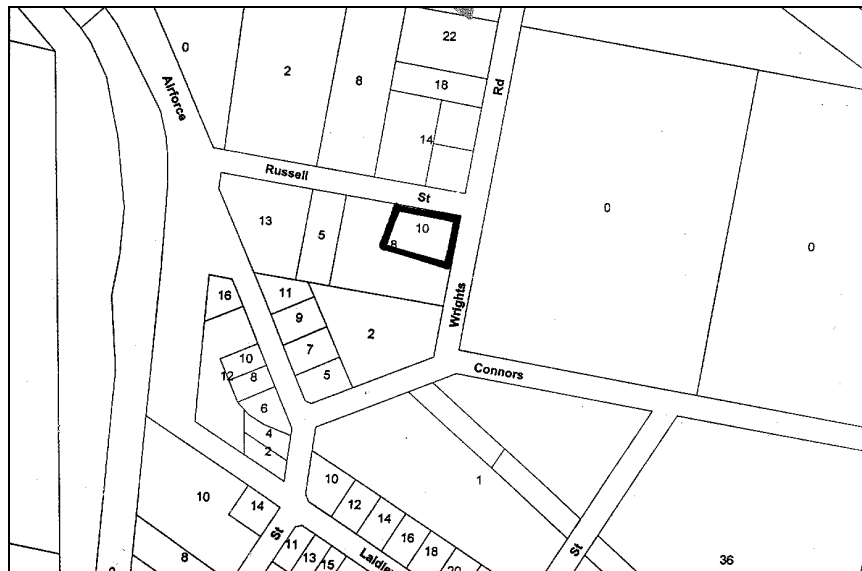
NAME	-
CATEGORY	House
LOCATION	10 Wrights Rd Helidon
RPD	1RP149759
LISTING BOUNDARY	Whole site
OTHER LISTINGS	-
SIGNIFICANCE LEVEL	Local

- C1890s style pyramid roof with acroterian gutter feature and stepped curved front and rear verandahs.
- Verandahs enclosed with fibro balustrade and glazed louvres, with various additions to the front verandah.
- Weatherboard clad.
- Original windows and metal sunhoods to main core.

Important for its demonstration of early form and materials and for its demonstration of early building techniques.

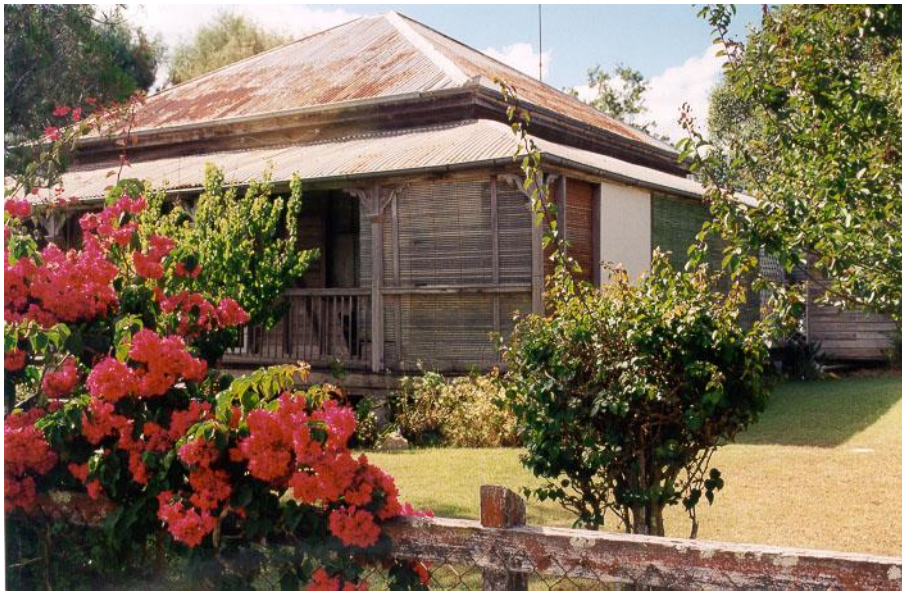
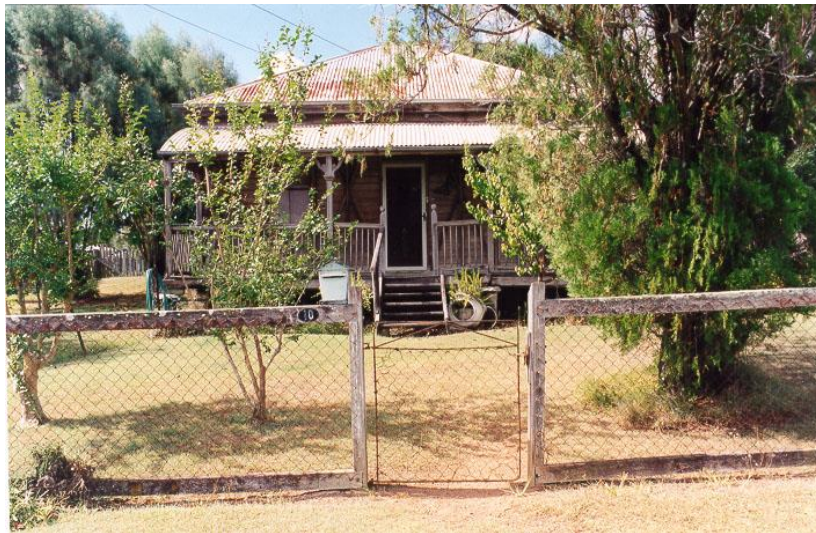
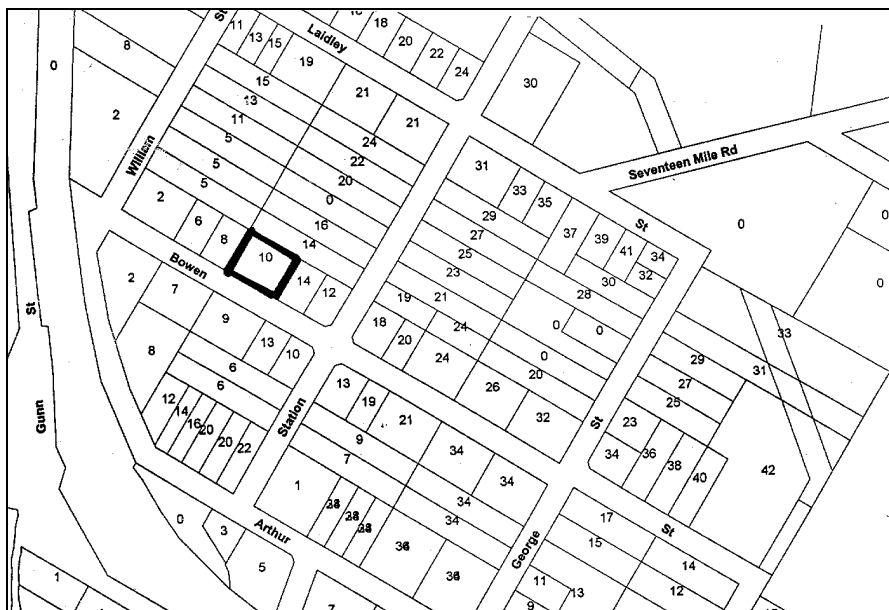
NAME	-
CATEGORY	House
LOCATION	10 Bowen St Helidon
RPD	203H1261
LISTING BOUNDARY	Whole site
OTHER LISTINGS	-
SIGNIFICANCE LEVEL	Local

- C1890s style pyramid roof with corner acroterian feature and stepped curved verandah 2 sides.
- Separate kitchen at rear.
- Single skin exposed stud and bracing and horizontal board lining.
- Original windows and doors.
- Two-rail broomstick balustrade with timber chain venetian blinds.
- Timber stumps
- Post, rail and chain wire fence.

Important for its demonstration of aesthetic characteristics and building techniques typical of the late 19<sup>th</sup>/early 20<sup>th</sup> century.

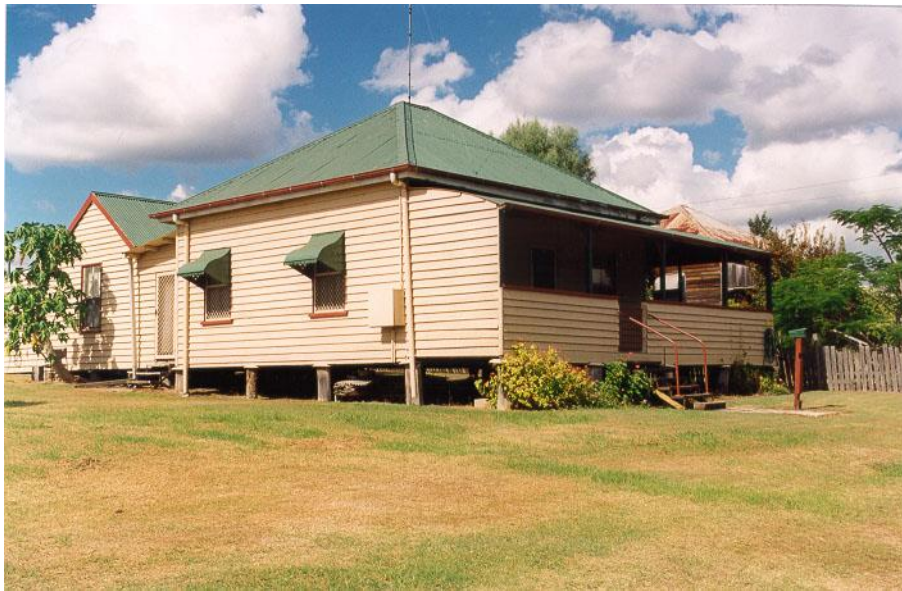
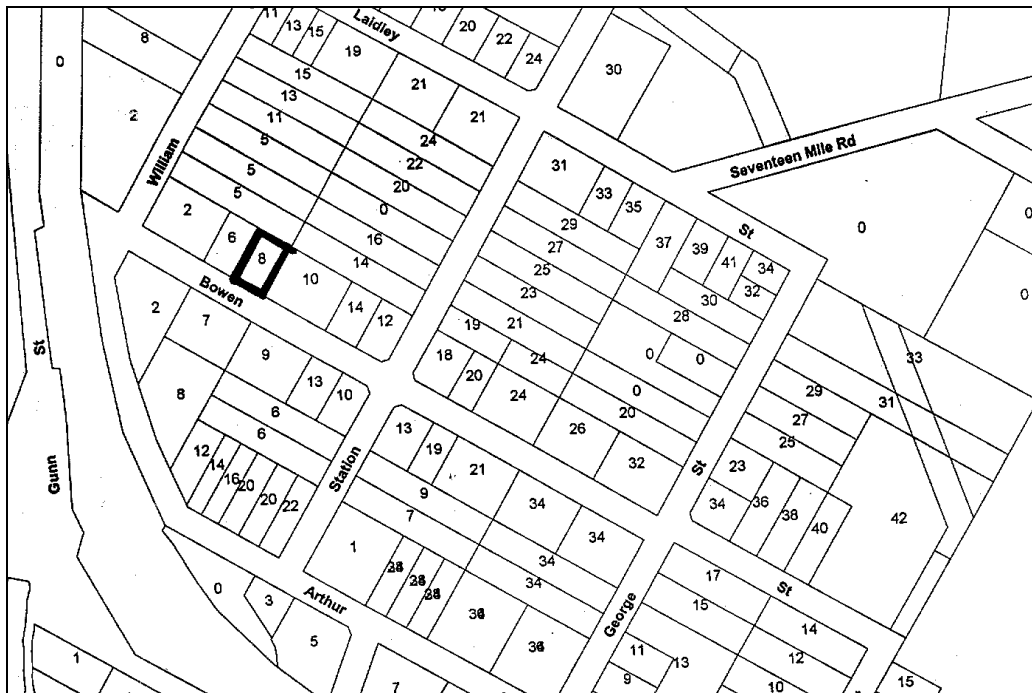
NAME	Emohruo
CATEGORY	House
LOCATION	8 Bowen St Helidon
RPD	1RP158389
LISTING BOUNDARY	Whole site
OTHER LISTINGS	-
SIGNIFICANCE LEVEL	Local

- C1890s style pyramid roof and stepped curved front and skillion rear verandah.
- Separate kitchen enclosed rear verandah breezeway
- Weatherboard clad.
- Original windows and doors.
- Weatherboard balustrade
- Original windows and metal sunhoods to main core.

Important for its demonstration of early form and materials and for its demonstration of early building techniques.

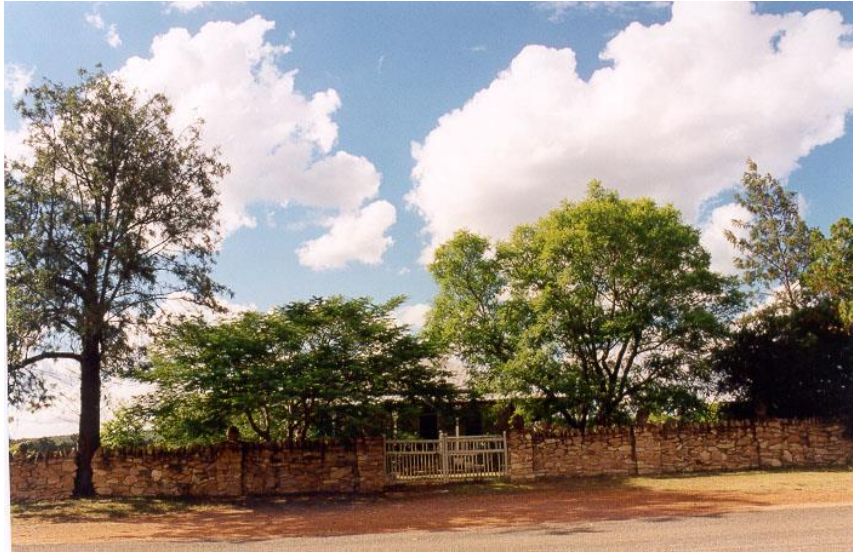
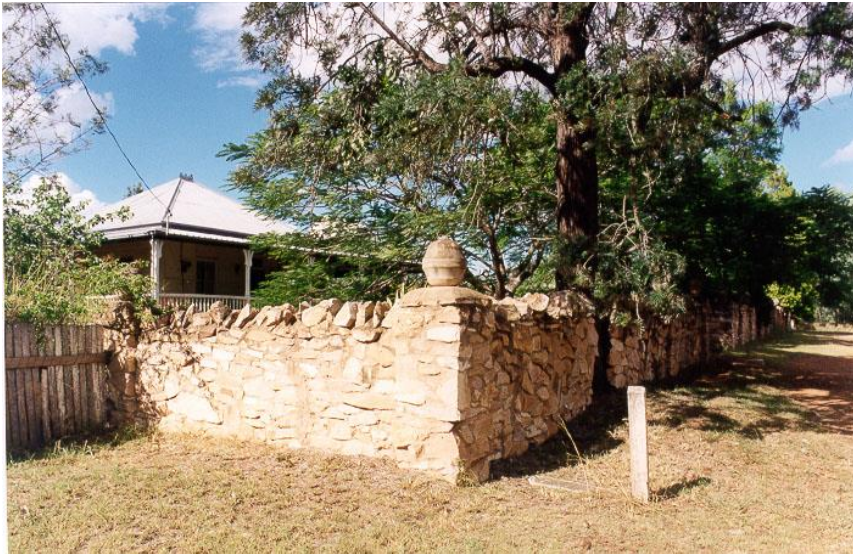
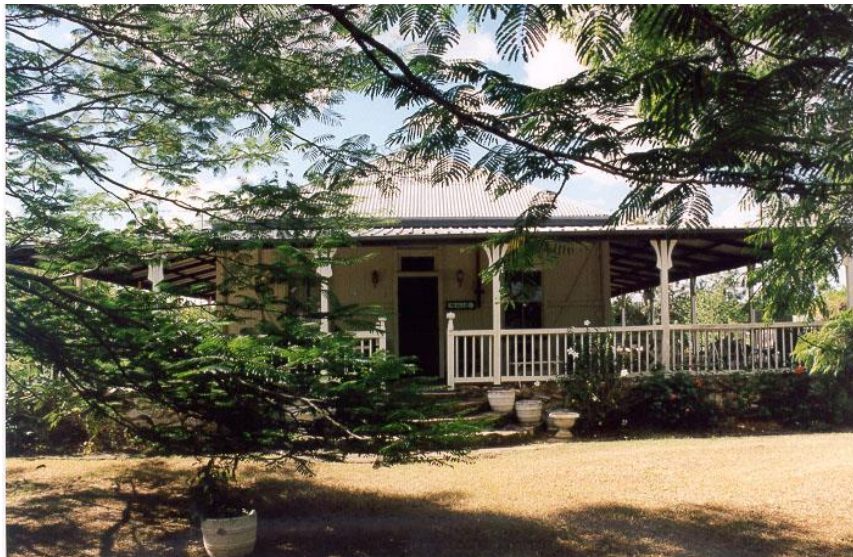
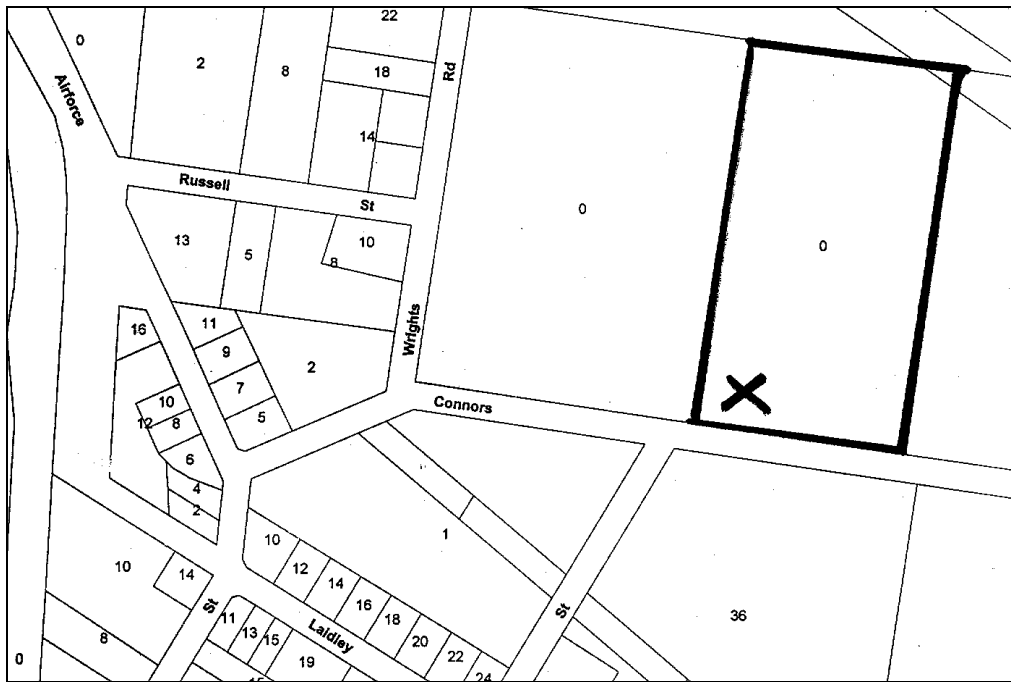
NAME	"Wingrove"
CATEGORY	House
LOCATION	Connors Rd Helidon
RPD	131CSH51
LISTING BOUNDARY	House and garden
OTHER LISTINGS	-
SIGNIFICANCE LEVEL	Local

- C1890s style pyramid roof and stepped verandah 3 sides.
- Single skin exposed stud and bracing and horizontal board lining.
- Original windows and doors.
- Two-rail broomstick balustrade.
- Stop chamfered posts and corner brackets
- Stone plinth to verandah.
- Sandstone rubble fence with urns on each pillar.

Important for its demonstration of aesthetic characteristics and building techniques typical of the late 19<sup>th</sup>/early 20<sup>th</sup> century

The fence is an interesting and rare example of the use of local sandstone.
