# Gatton Shire Cultural Heritage Study

## Vol 2 Grantham Helidon

A report for  
Gatton Shire Council  
by  
Buchanan Architects

December 2000

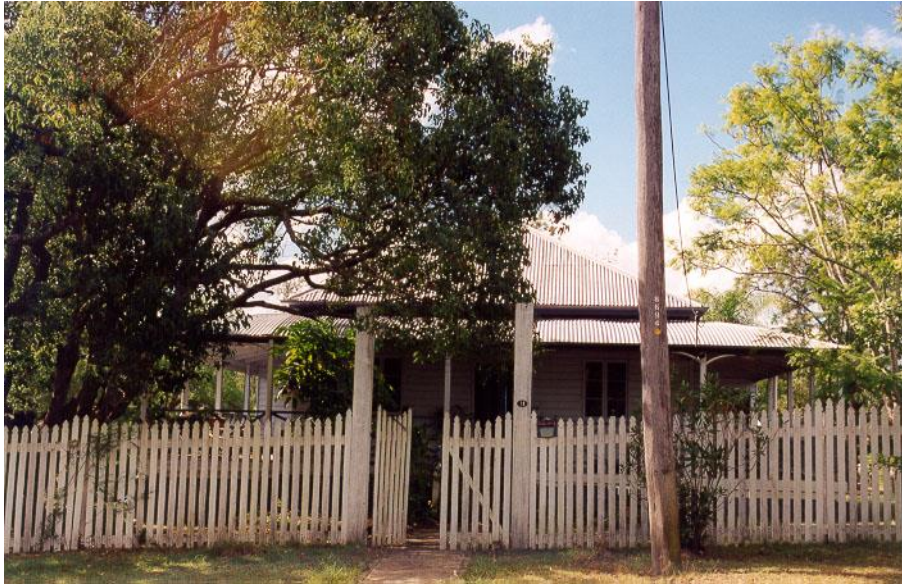
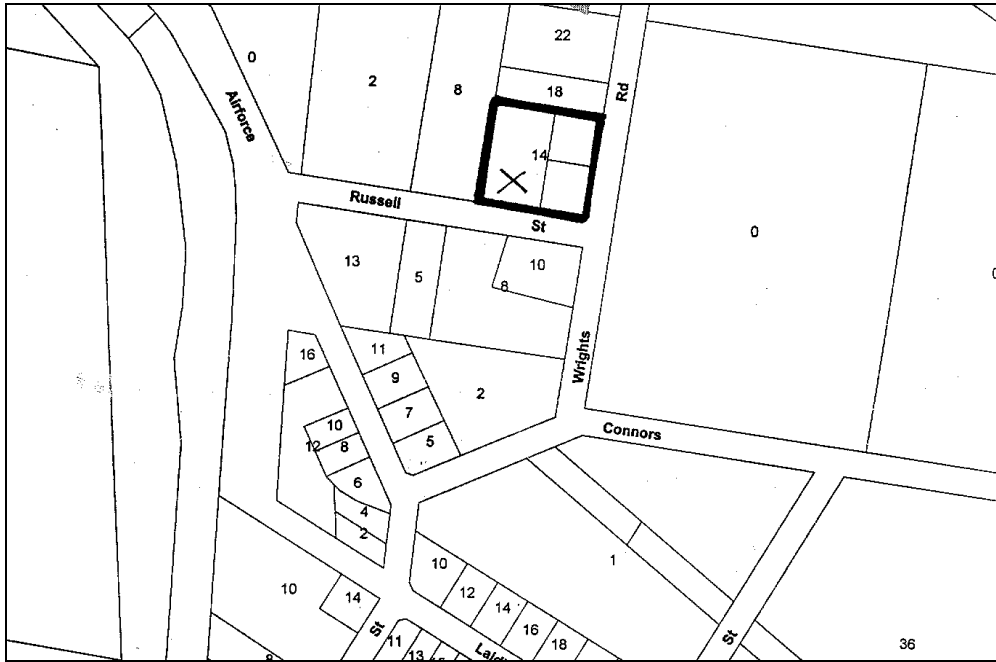
NAME	-
CATEGORY	House
LOCATION	14 Russell St Helidon
RPD	10SP112158 and 11SP112158 and 12SP112158
LISTING BOUNDARY	Whole site
OTHER LISTINGS	-
SIGNIFICANCE LEVEL	Local

- C1890s style pyramid roof and stepped curved verandah 3 sides.
- Chamferboard and weatherboard cladding.
- Original windows and doors.
- Two-rail broomstick balustrade.
- Stop chamfered posts and corner brackets
- Picket fence and double entry gate.

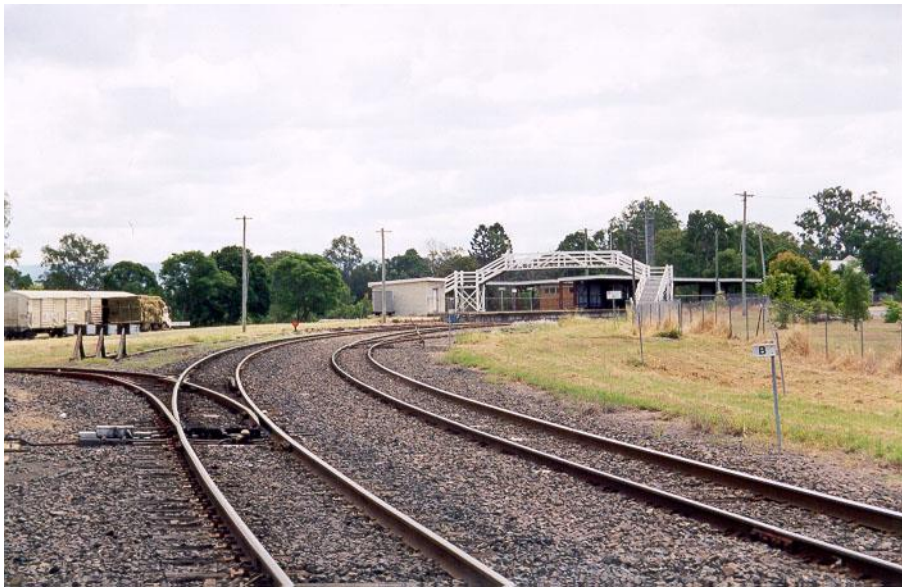
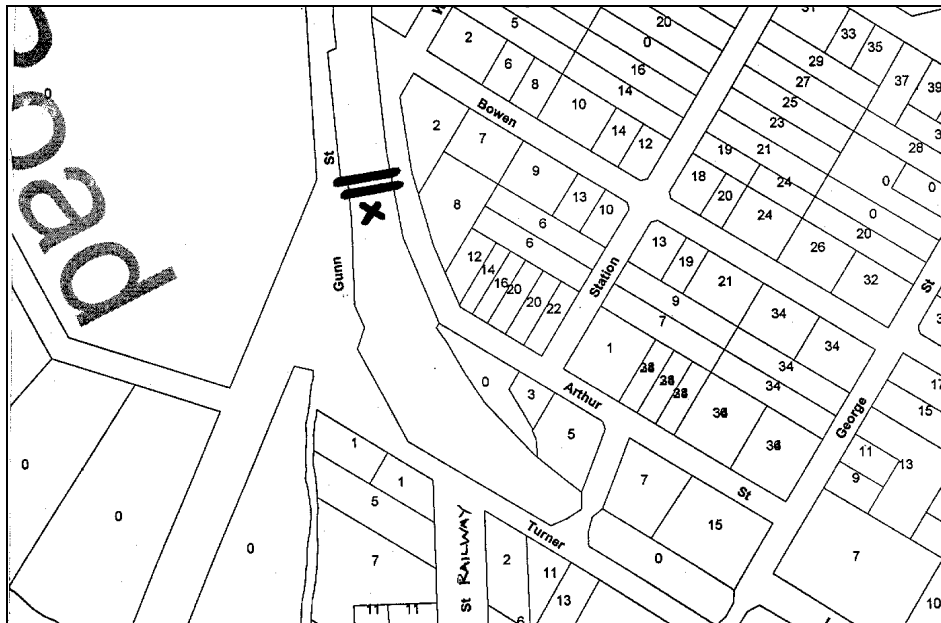
NAME	Timber Footbridge
CATEGORY	Railway structure
LOCATION	Across main railway line, Helidon
RPD	On 452CH5280
LISTING BOUNDARY	Site of footbridge
OTHER LISTINGS	-
SIGNIFICANCE LEVEL	Local

Timber framed and cross braced footbridge with half landings on both sides.

A good example of a timber railway overbridge, now becoming uncommon.

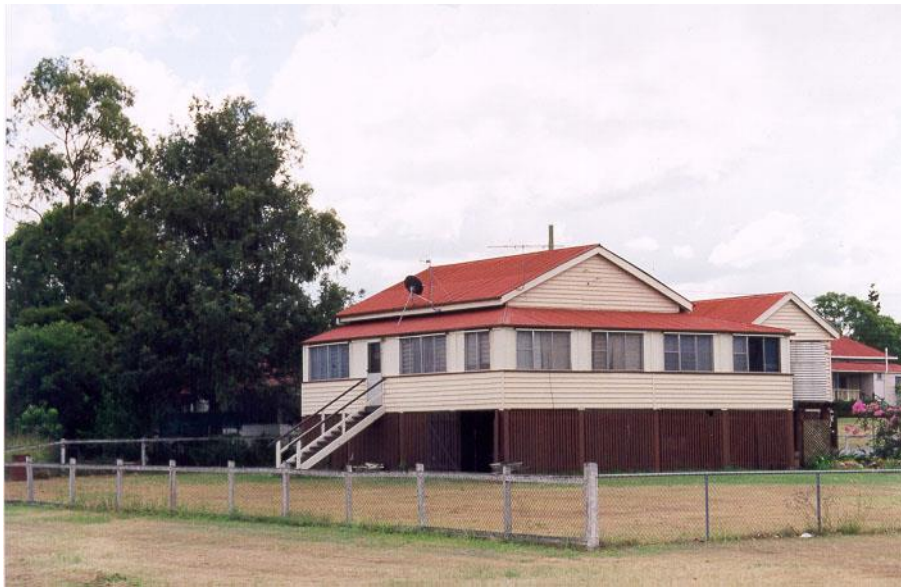
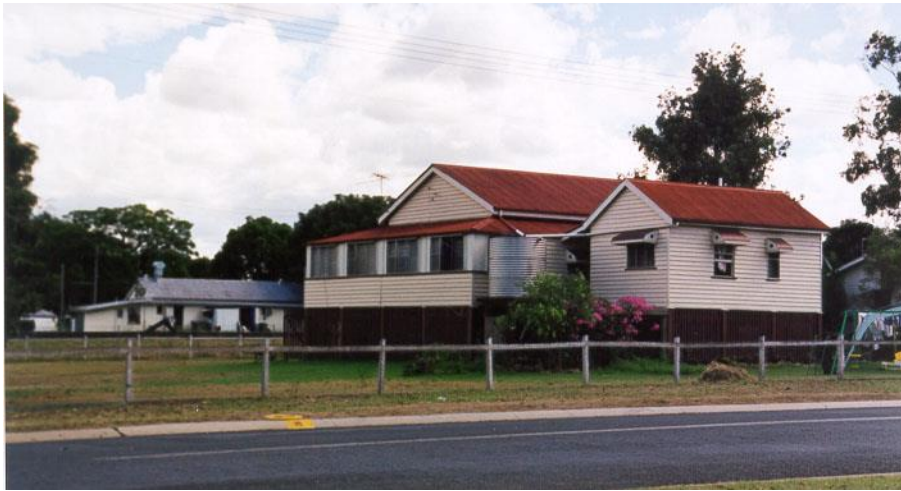
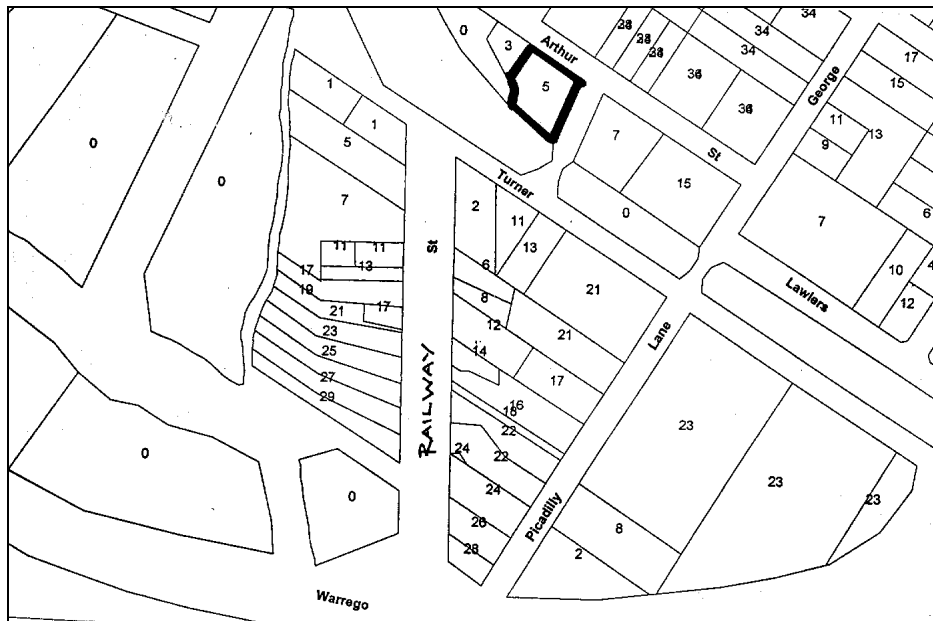
NAME	Station Master's Residence
CATEGORY	House - railway
LOCATION	5 Arthur St Helidon
RPD	5RP886802
LISTING BOUNDARY	Whole of site
OTHER LISTINGS	-
SIGNIFICANCE LEVEL	Local

- Gable-end core with stepped verandahs to 3 sides.
- Weatherboard clad and gable infill.
- Separate kitchen building accessed via breezeway.
- Original windows with bull-nose sunhoods.
- Weatherboard balustrade with louvred window infill above handrail.
- Post and rail fence.

Important for its demonstration of early form and materials and for its demonstration of early building techniques.

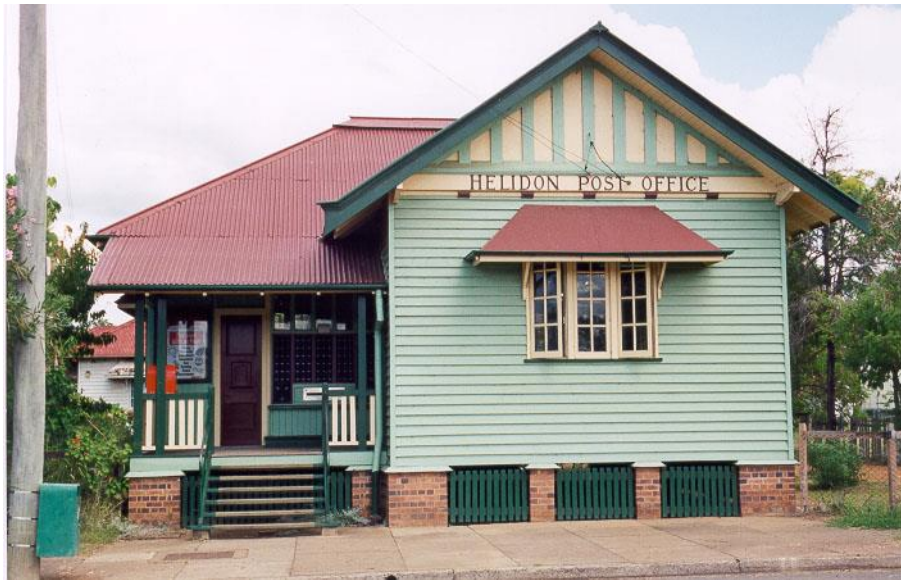
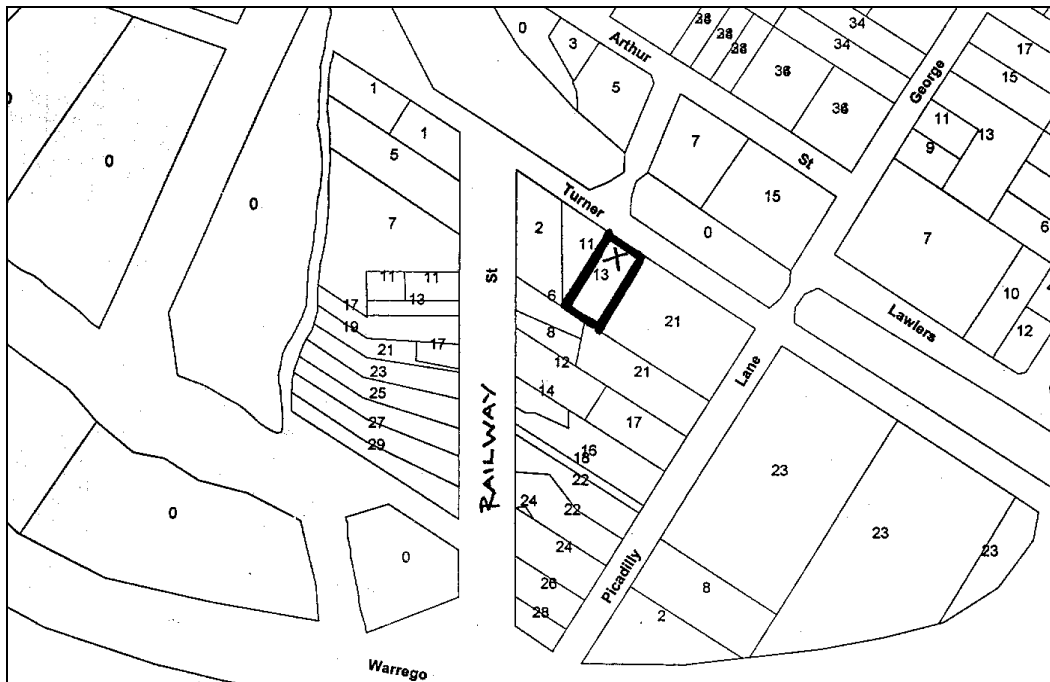
NAME	Helidon Post Office
CATEGORY	Government Building
LOCATION	13 Turner St Helidon
RPD	97H12610
LISTING BOUNDARY	Whole site
OTHER LISTINGS	-
SIGNIFICANCE LEVEL	Local.

**Said to have been** relocated from the right side of the Criterion Hotel to present site, probably before 1920.

- C1915 long ridge pyramid with asymmetrical street facing gable and front porch, rear skillion verandah.
- Gable infill of sheeting with wide cover moulds
- Weatherboard cladding.
- Original windows and doors.
- Hipped window hoods with the side hoods constructed with timber shingles, front replaced with mini orb iron.
- Low set with brick stumps and slatted infill between.
- Two-rail slat balustrade to small front porch.

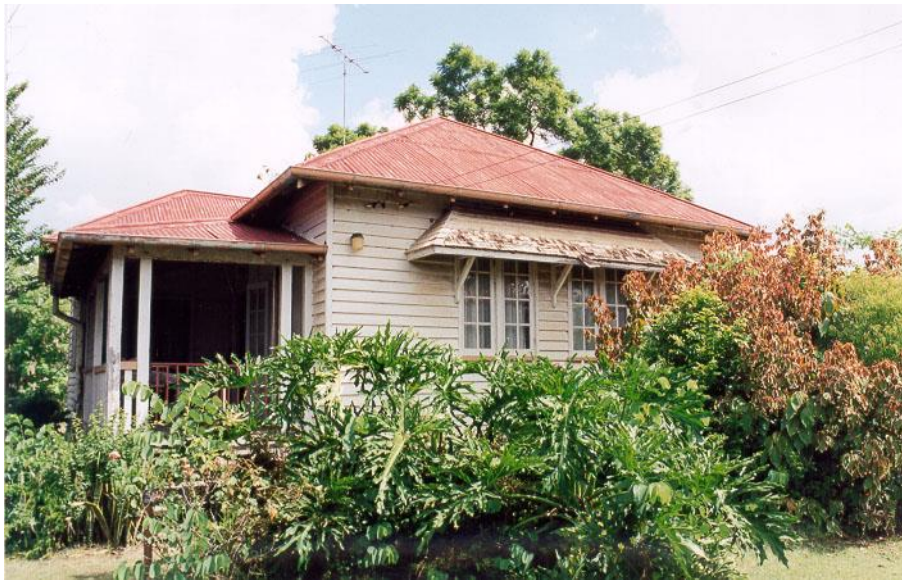
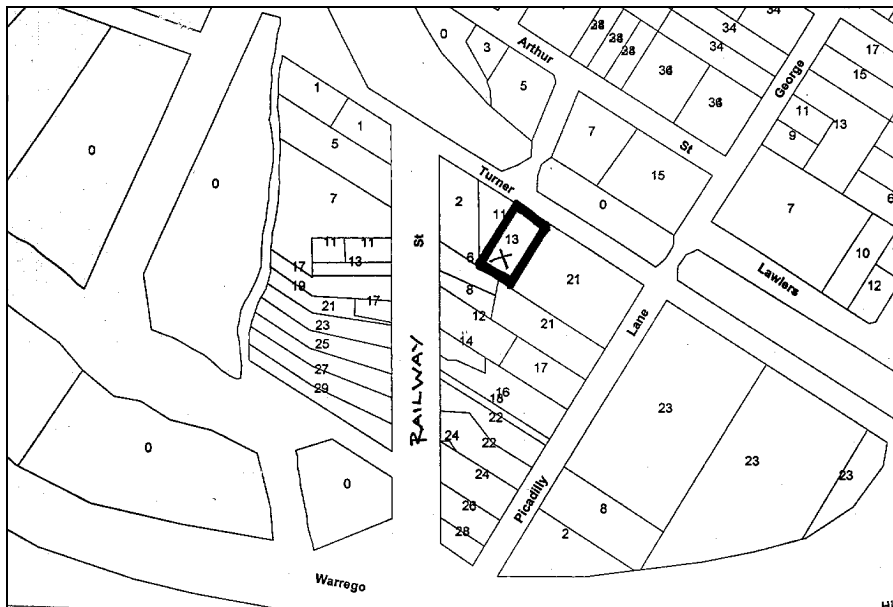
NAME	Post Master's Residence
CATEGORY	House
LOCATION	13 Turner St Helidon
RPD	97H12610
LISTING BOUNDARY	Whole site
OTHER LISTINGS	-
SIGNIFICANCE LEVEL	Local

- Probably c1910 long ridge hipped dwelling modified when Post Office was relocated. Modification comprised of the pyramid roofed front wing and hipped porch to the left side.
- Matching the Post Office, the front window hoods are constructed with timber shingles.
- Weatherboard cladding.
- Original windows and doors.
- Low set with timber stumps.
- Two-rail slat balustrade to small front porch.

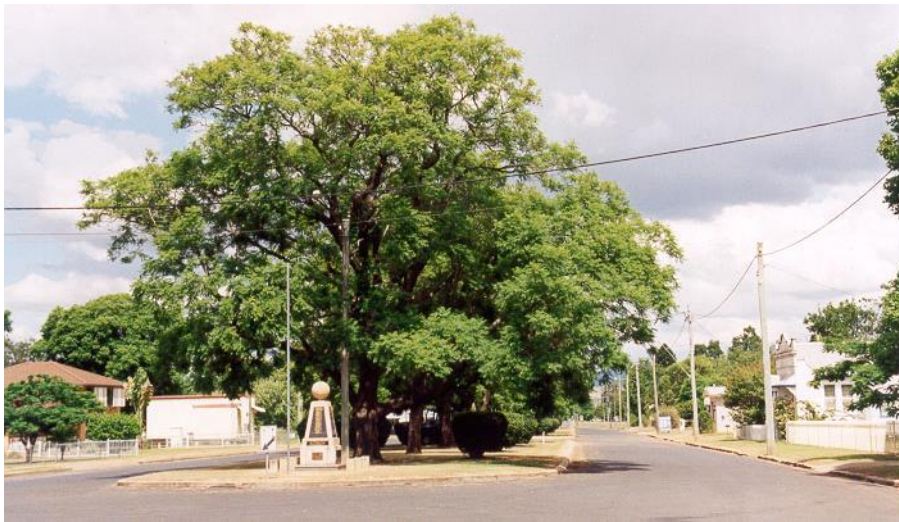
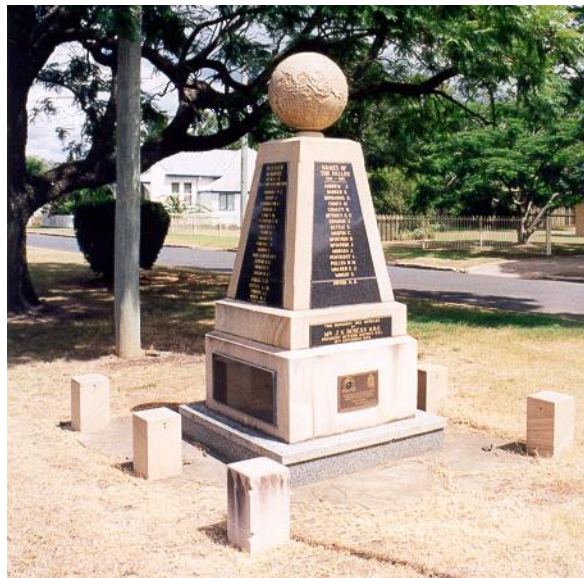
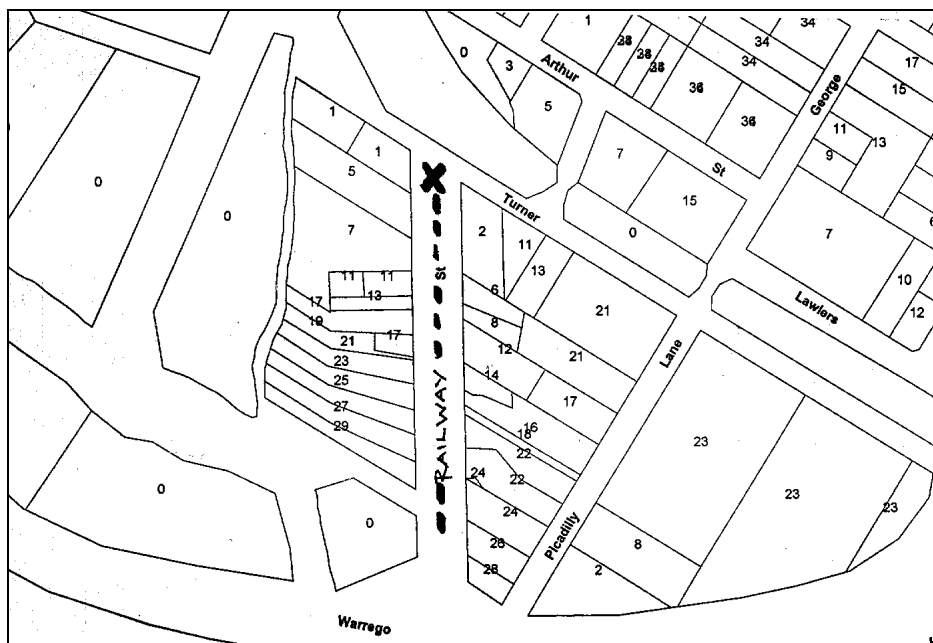
NAME	War memorial
CATEGORY	Monument and trees
LOCATION	In median strip, Railway Street
RPD	N/a
LISTING BOUNDARY	All of median strip
OTHER LISTINGS	-
SIGNIFICANCE LEVEL	State

- Titled "Names of the fallen" and unveiled 14<sup>th</sup> September, 1978.
- Sandstone blocks on granite plinth.
- Spherical etched sandstone world map balanced on top.
- Engraved brass plaques on each side.
- Six low sandstone blocks mark the edge of the base.

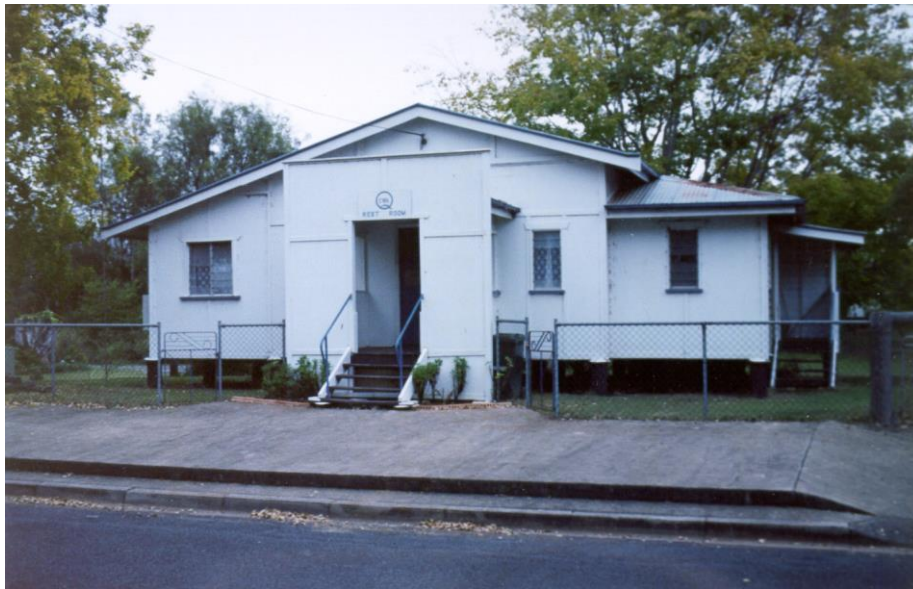
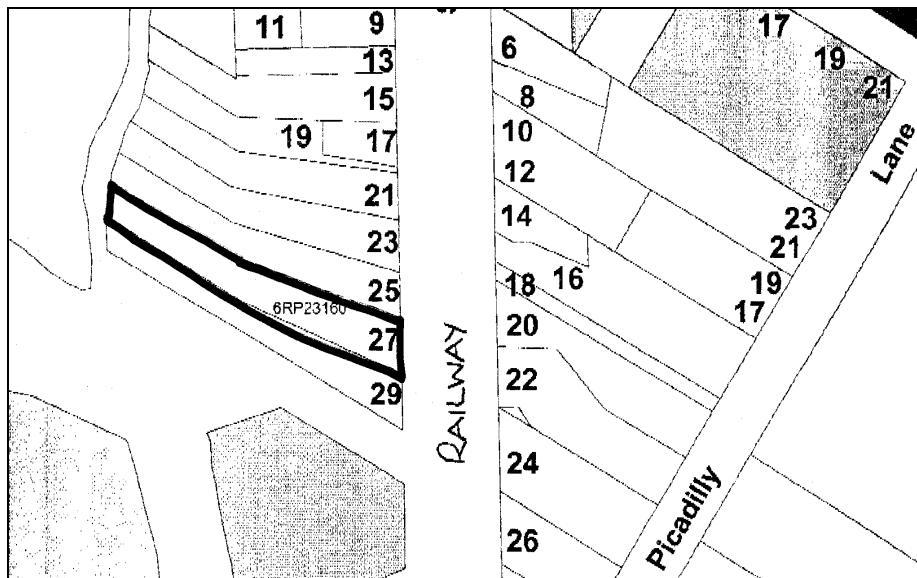
NAME	QCWA
CATEGORY	Public building
LOCATION	27 Railway St Helidon
RPD	L6RP23160
LISTING BOUNDARY	Whole site
OTHER LISTINGS	-
SIGNIFICANCE LEVEL	Recorded

Description: Domestic scale lowset building sheeted with fibro cement, simple parapeted front entry

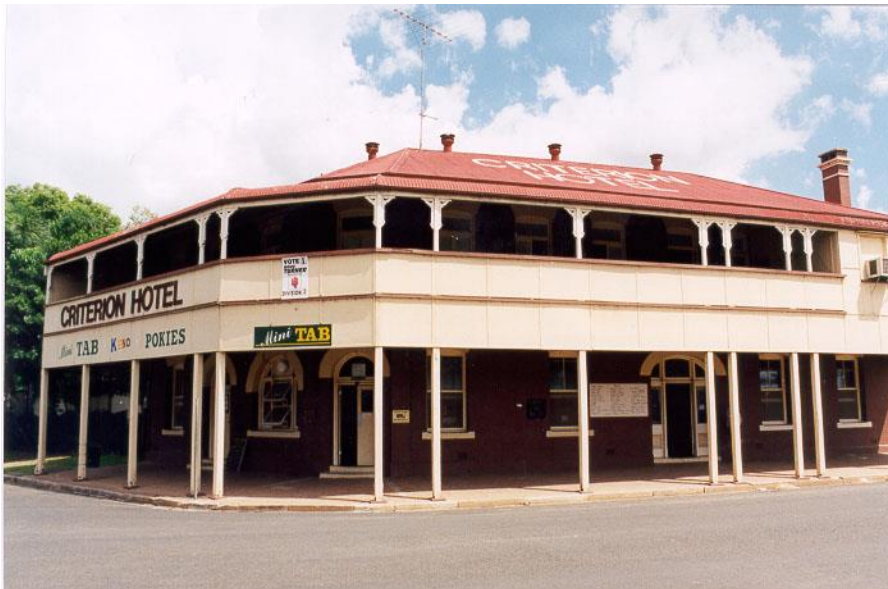
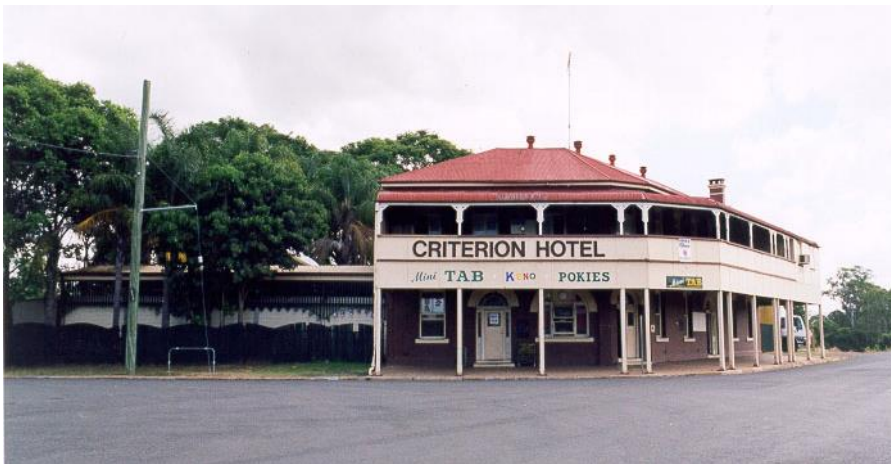
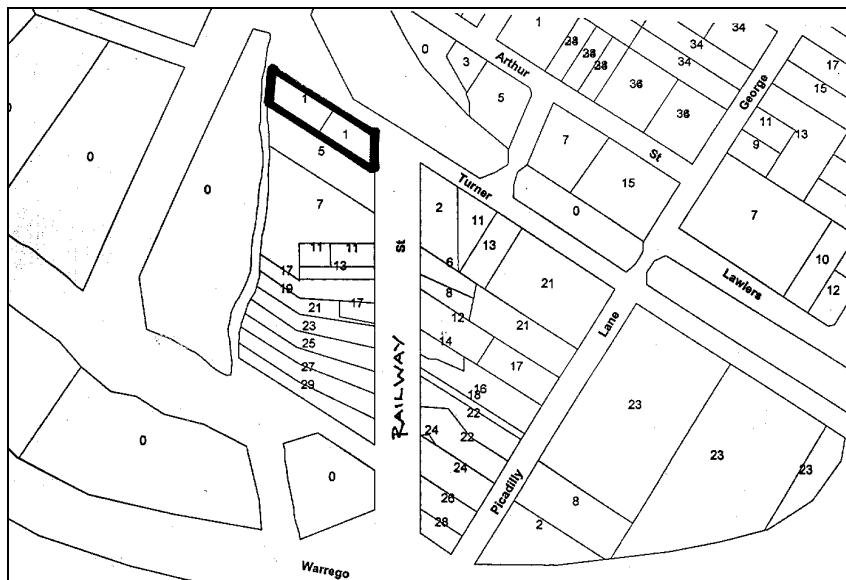
NAME	Criterion Hotel
CATEGORY	Hotel
LOCATION	Cnr Turner St and Railway St, Helidon
RPD	1RP53098 and 2RP53098
LISTING BOUNDARY	Whole site
OTHER LISTINGS	-
SIGNIFICANCE LEVEL	Local

- Two storey Federation, hipped roof with stepped bull-nose verandahs. The plan follows the alignment and wraps around the corner into Railway Street.
- The main core is painted brick construction.
- Verandahs are timber with the original posts and corner brackets remaining on the upper level only.
- Fibro valance and balustrade has replace the original, probably timber.
- Original triple course arched windows and doors to feature window and doors with segmental arches to less prominent windows.
- A chimney and roof vents.

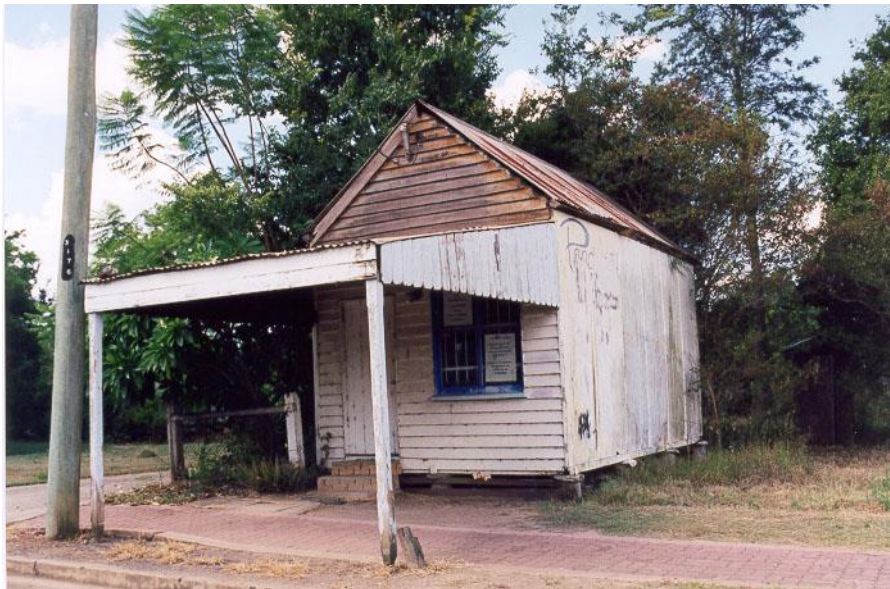
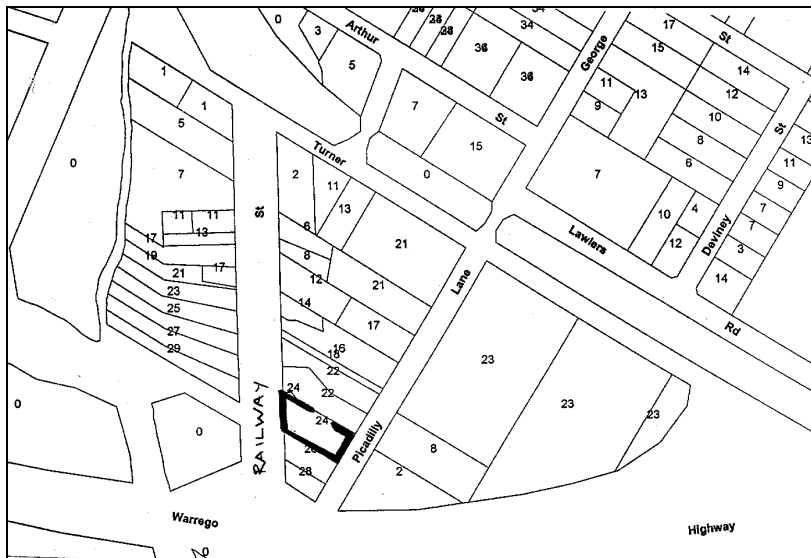
NAME	-
CATEGORY	Commercial building (shop)
LOCATION	24 Railway St Helidon
RPD	7RP23156
LISTING BOUNDARY	Whole of site
OTHER LISTINGS	-
SIGNIFICANCE LEVEL	Local

- Weatherboard clad gable ended shop with street facing gable.
- Street awning supported on timber posts infill detail intact.
- Dilapidated condition.

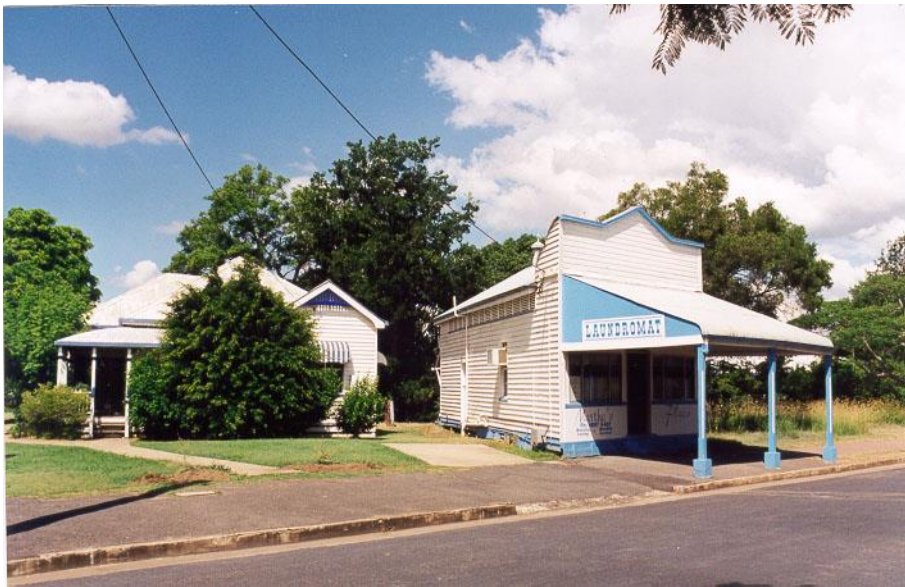
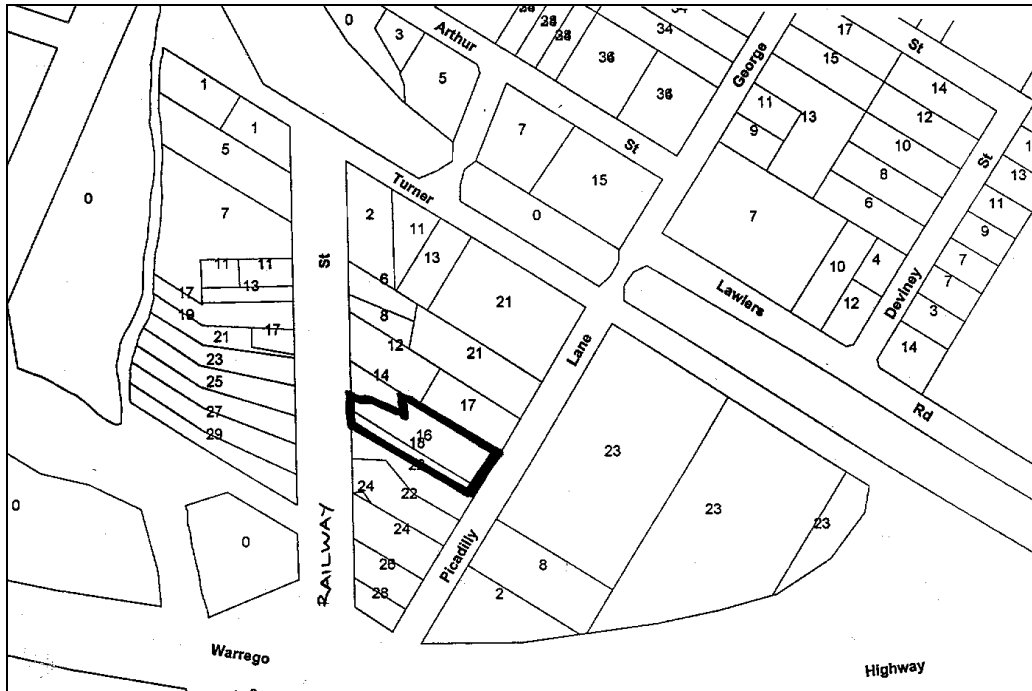
- Weatherboard clad gable ended shop with street parapet.
- Steeply pitched bull-nose front street awning supported on timber posts.
- Fixed timber vents along both sides for ventilation.

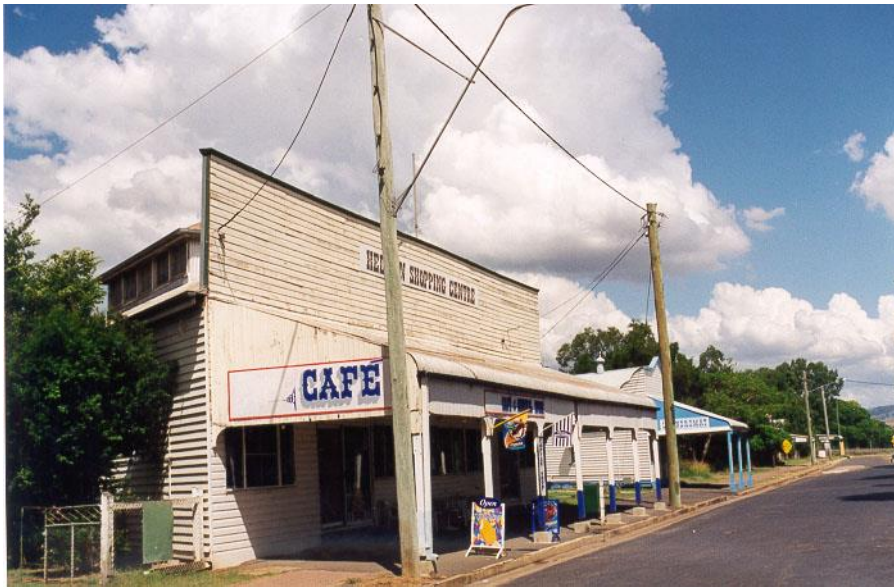
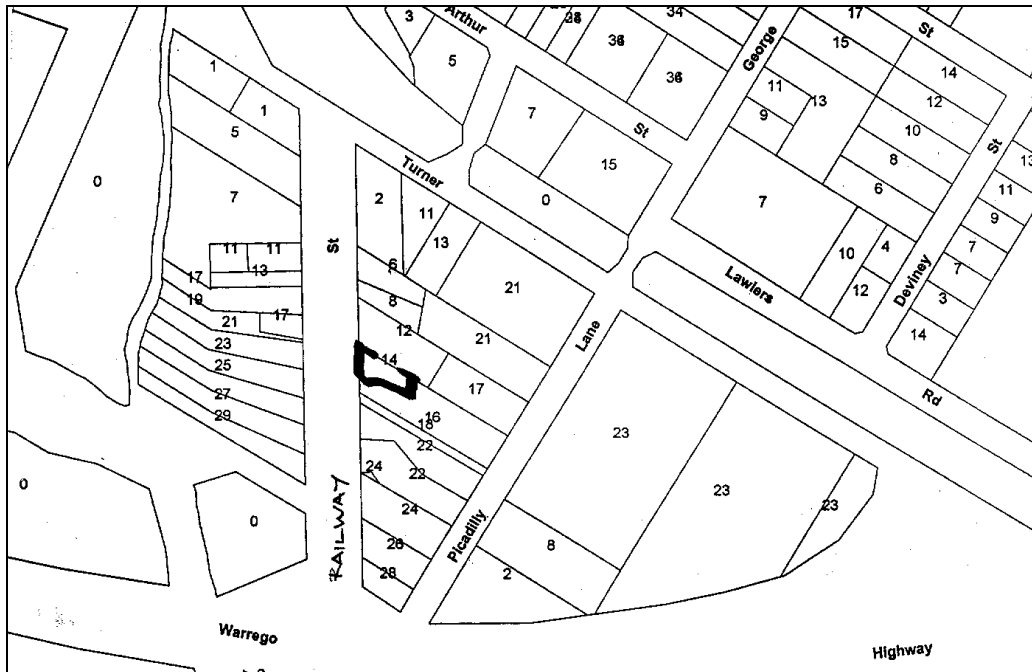
- Pitched roof with large multi-paned window lantern light on top and weatherboard parapet to street elevation.
- Steeply pitched bull-nose front street awning supported on stop chamfered posts and iron valance. Similar to Laundromat
- Interior restored and clear finished ceiling highlights the good condition of the lantern light.
- Chamfer boards and aluminium windows and sliding doors to street entry.

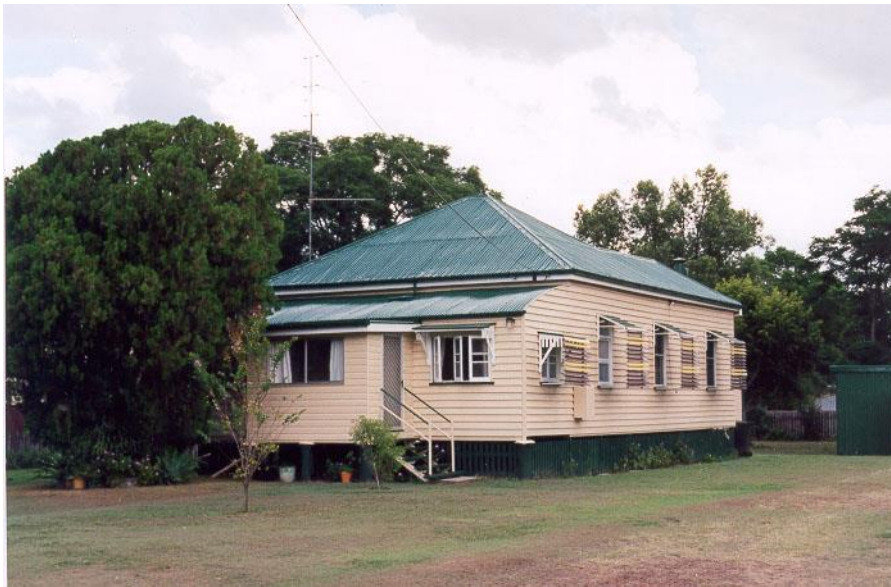
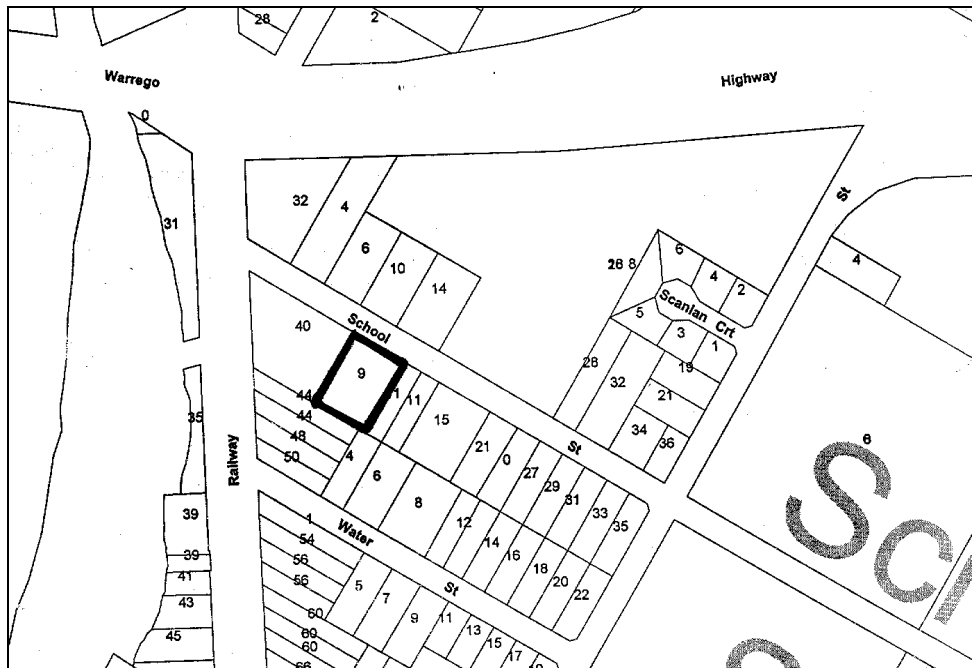
- C1890s pyramid roof with right rear hip and stepped curved front verandah.
- Weatherboard clad.
- Few original windows and doors.
- Weatherboard enclosed front verandah with 1950s casement windows.

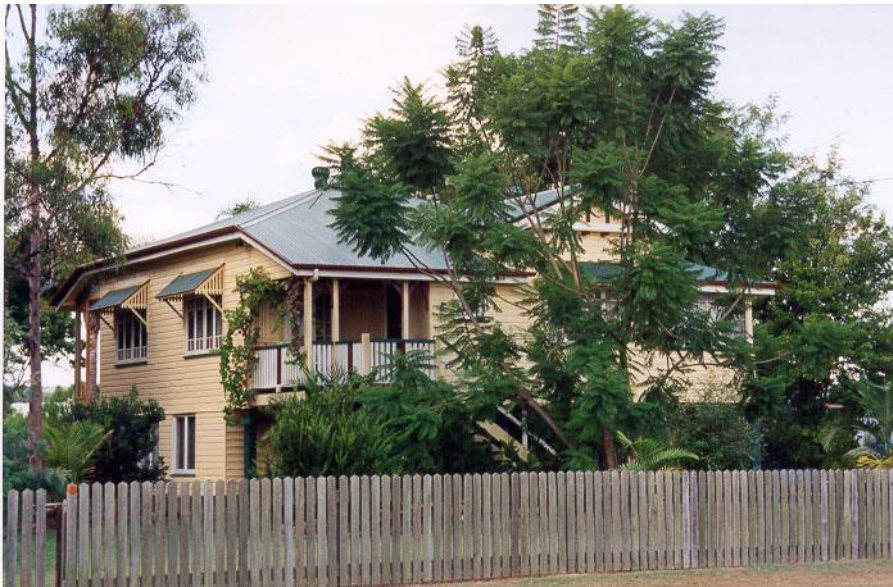
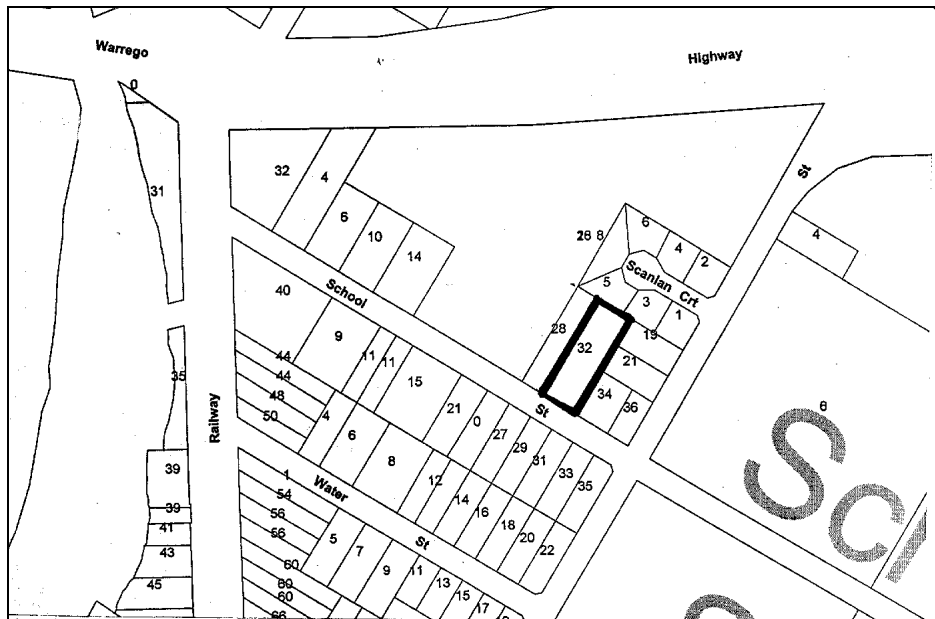
- Asymmetrical bungalow with slightly off centre boxed and jettied gable and pyramid main roof.
- Slat balustrade on entrance verandah.
- Lobby window to vestibule entry off verandah.
- Weatherboard balustrade and refurbished aluminium sliding windows over to enclose sleep-out area on right of gable.
- Mini orb iron and timber slatted hood over bank of four casement windows on front and side elevations
- Refurbished and enclosed under.

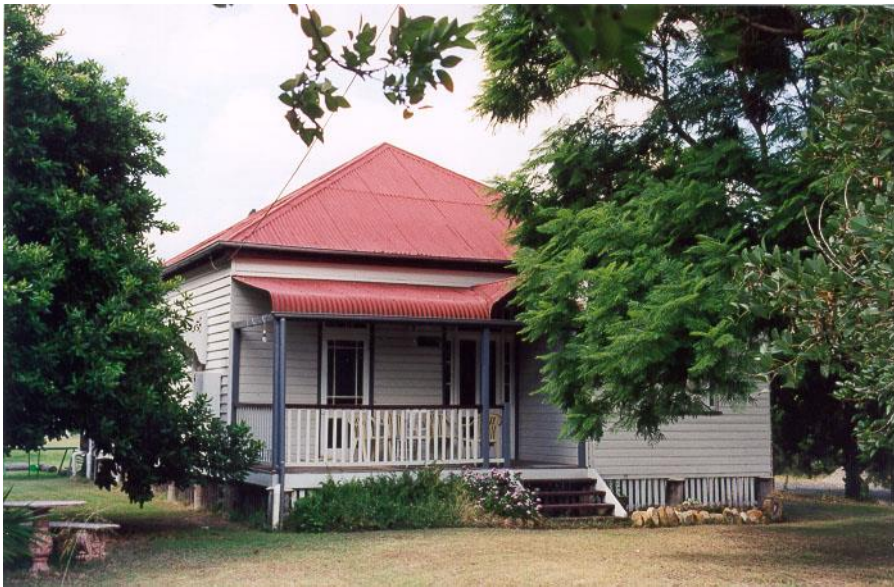
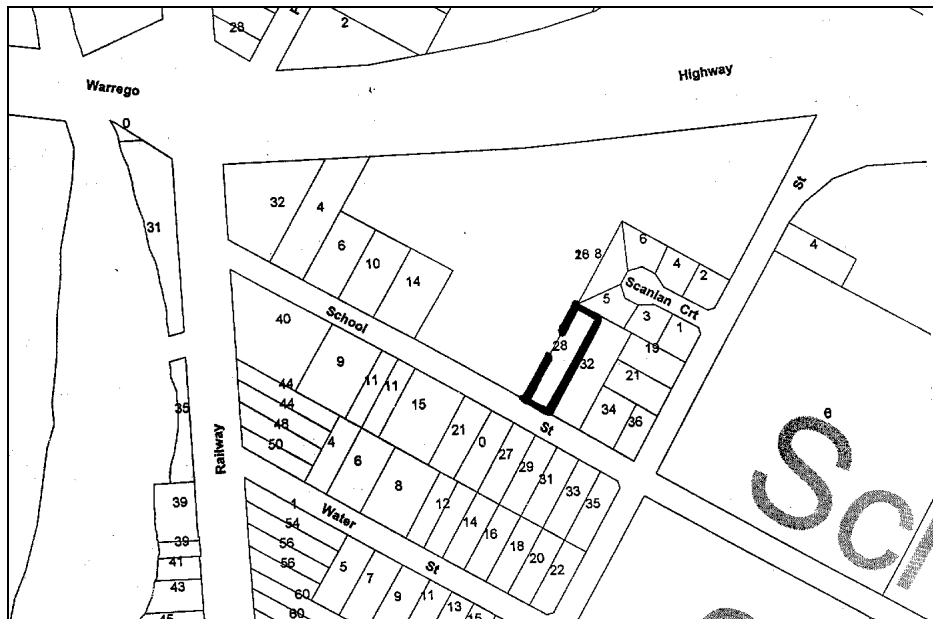
- C1890s style pyramid roof and asymmetrical gable.
- Stepped bullnose front verandah with pediment over entry stair and skillion rear verandah.
- Weatherboard clad.
- Original windows and doors with coloured glass sidelights.
- Two-rail slat balustrade.
- Original windows and curved metal sunhoods to main core.
- Low-set on timber stumps, batten infill.

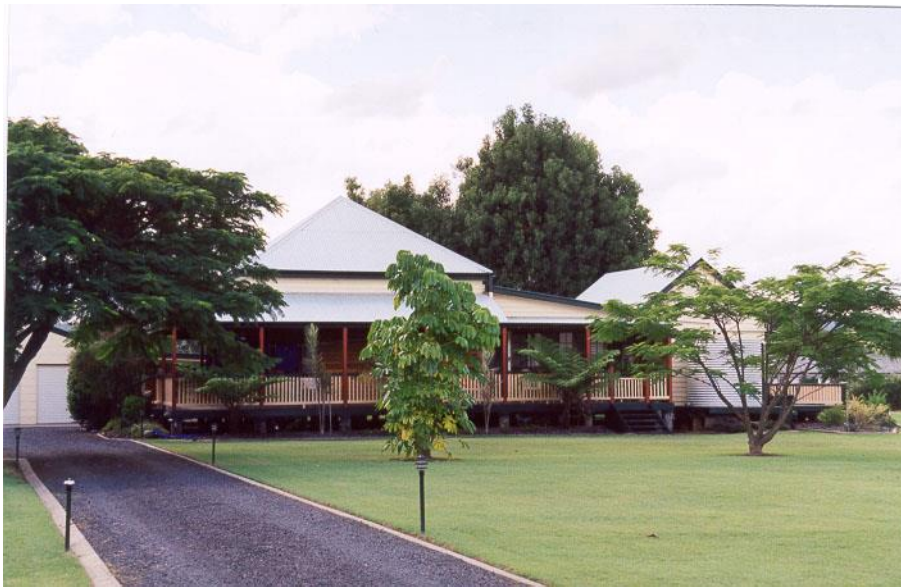
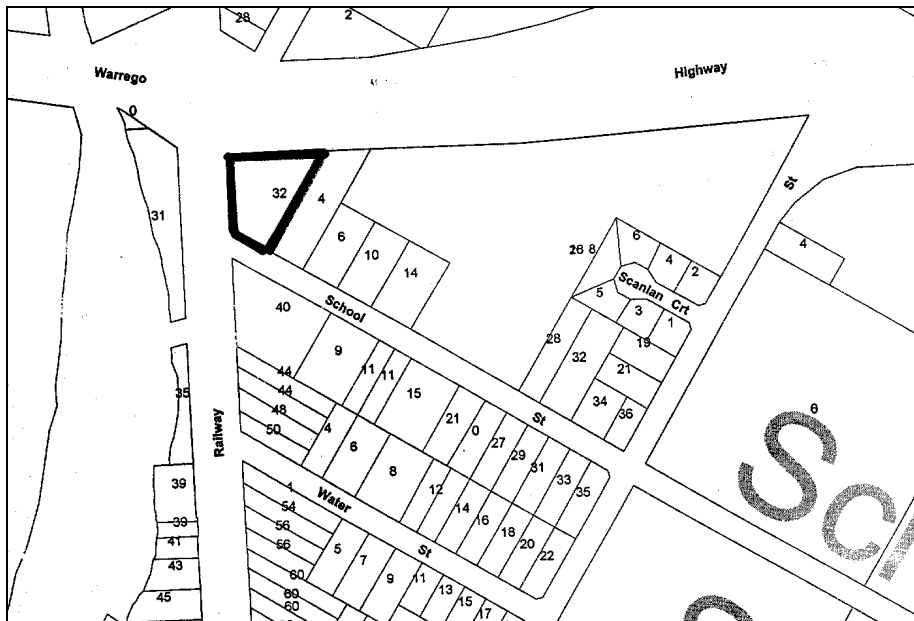
- C1890s style pyramid roof and stepped curved front and side verandahs as well as skillion rear verandah.
- Separate kitchen enclosed rear verandah breezeway
- Weatherboard clad generally, clear finished chamfer boards to verandah area.
- Original windows and doors.
- Two-rail slatted balustrade.

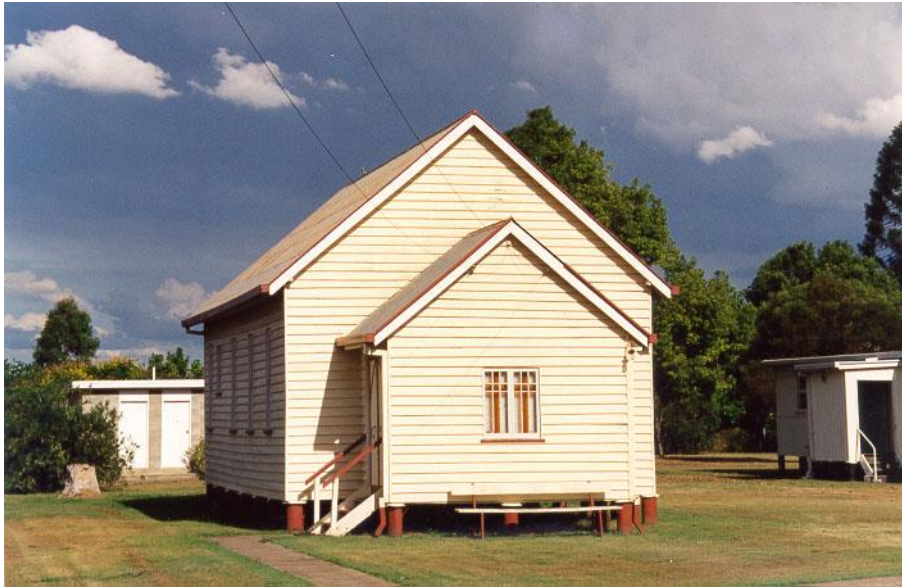
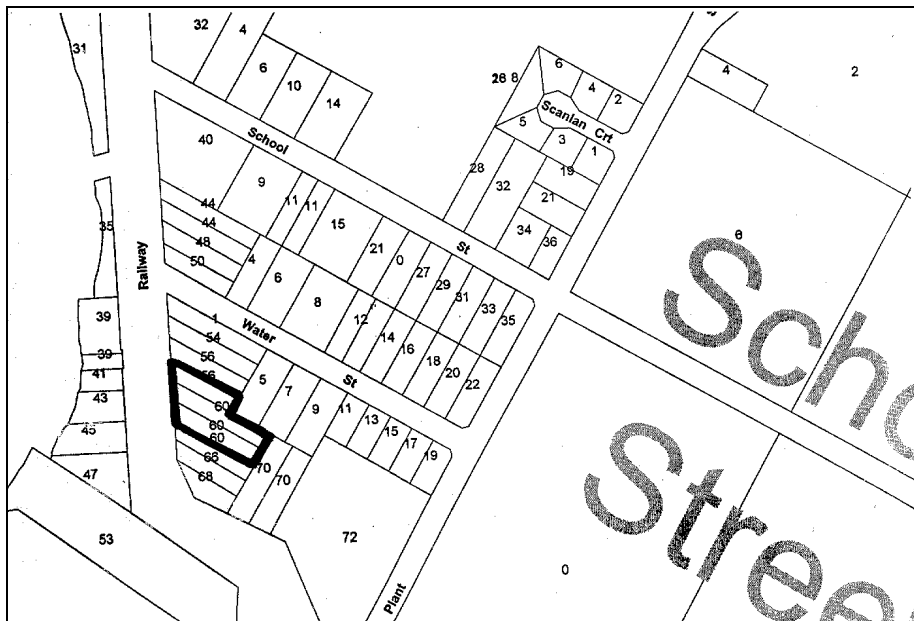
- Rectangular plan with pitched roof and gable ends.
- Centred front entry gable.
- Weatherboard clad
- Casement windows with coloured glass in the form of a Latin cross
- Lancet shaped windows to side elevations
- Timber stumps

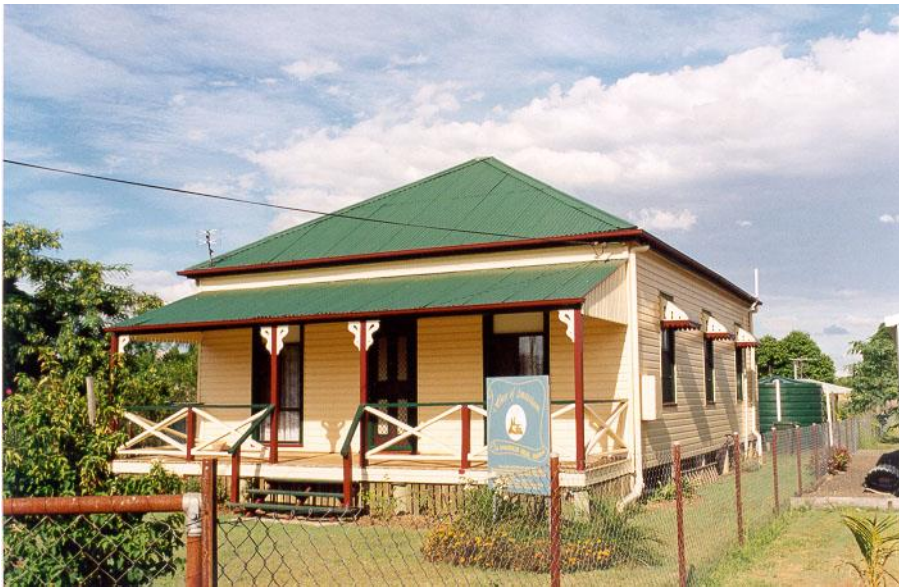
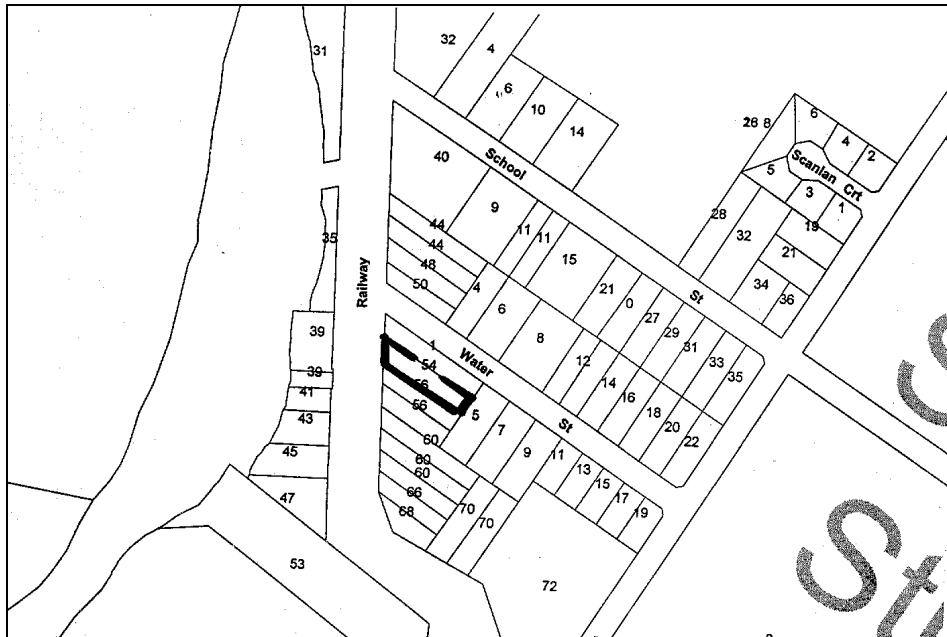
- Victorian pyramid roof and stepped front verandah.
- Few original doors and windows
- Replacement balustrade.
- Chamfer board clad.
- Bullnose iron window hoods.

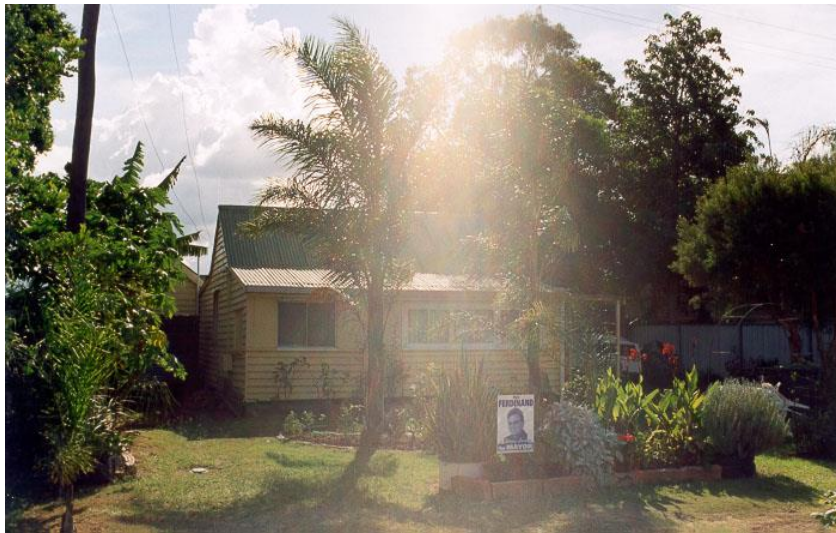
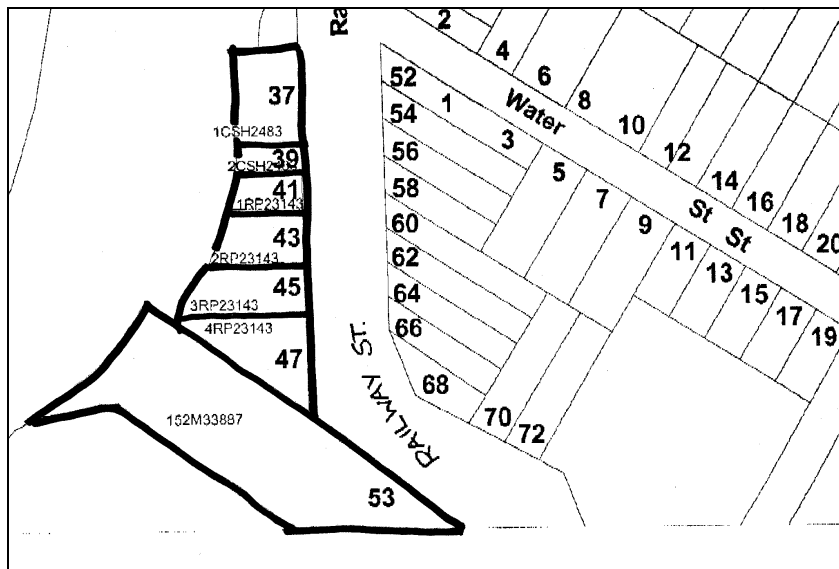
No 41

- Core thought to be C1880.
- Steeply pitched roof with gable ends.
- Incorporated front and rear verandahs, enclosed
- Weatherboard clad
- Much altered with aluminium windows
- Recent right side pergola structure
