# Gatton Shire Cultural Heritage Study

## Vol 2 Grantham Helidon

A report for  
Gatton Shire Council  
by  
Buchanan Architects

December 2000

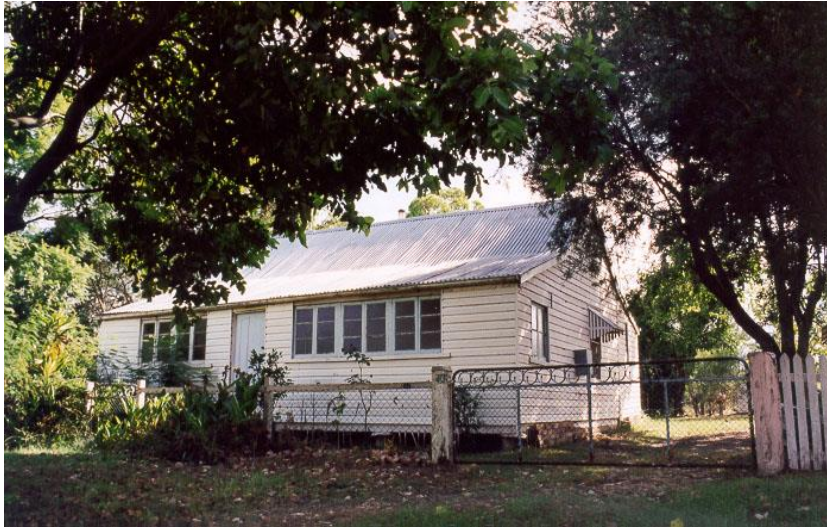
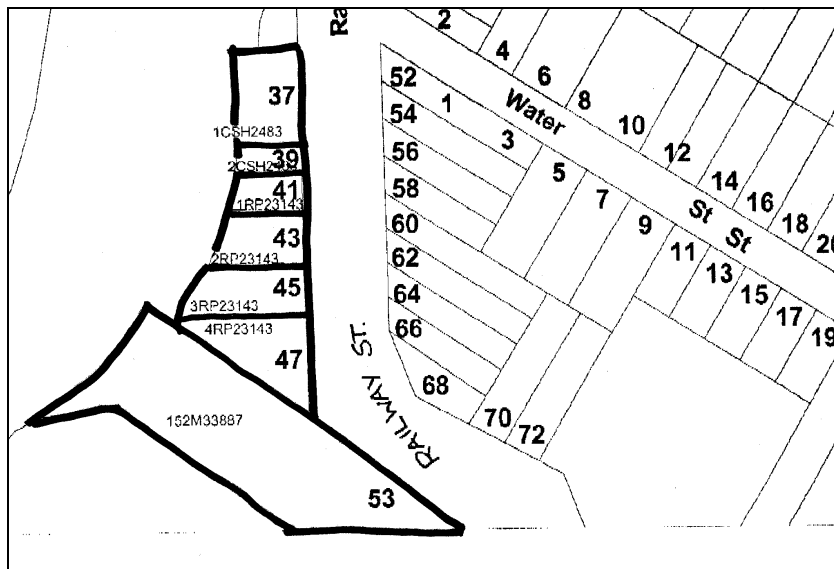
No 43

- Core thought to be C1880.
- Pitched roof with gable ends.
- Incorporated front and rear verandahs, enclosed possibly 1930s with casement windows
- Weatherboard clad
- Original sash windows and an iron window hood on each side remains.

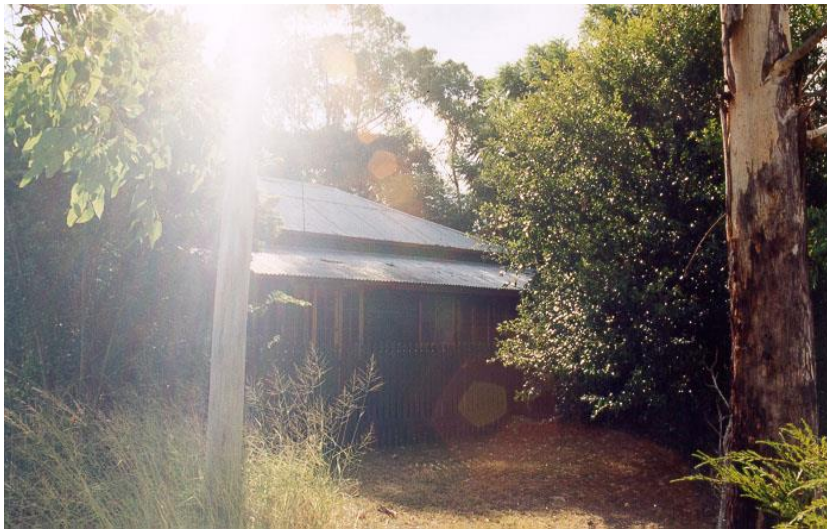
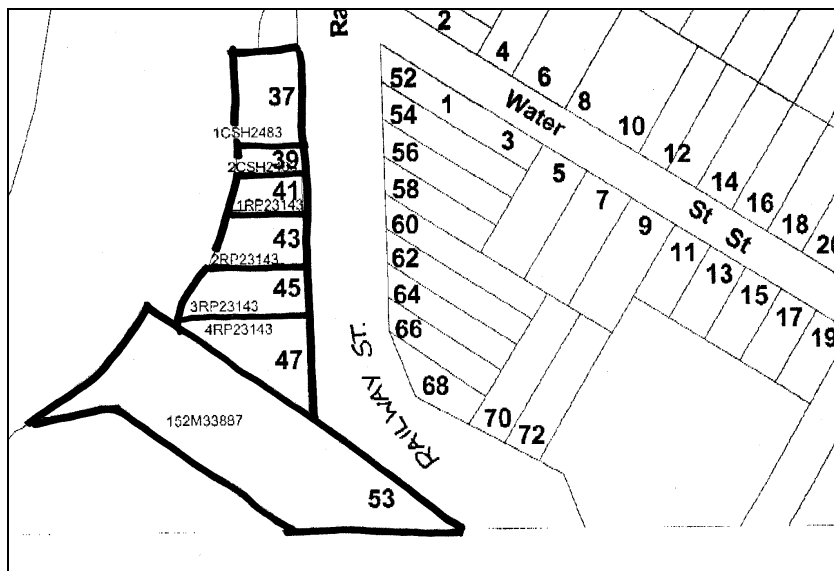
No 45

- Core appears to be c1880.
- Short ridge hip roof.
- Stepped front and rear verandahs, enclosed possibly 1930s with casement windows
- Weatherboard clad

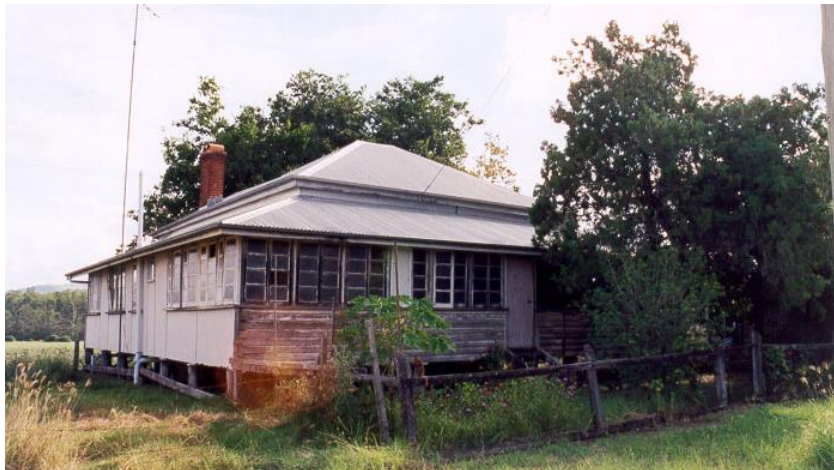
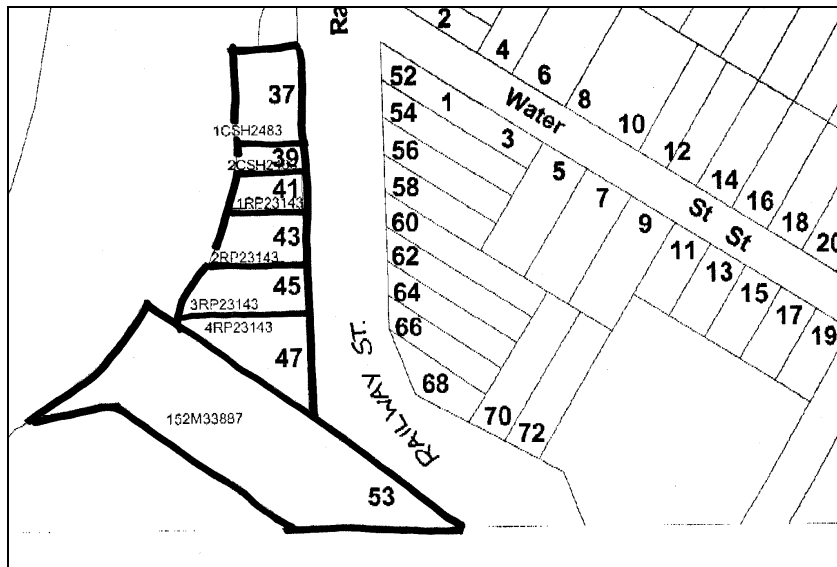
No 53

- Core appears to be c1880.
- Short ridge pyramid roof.
- Stepped verandahs to all sides, enclosed possibly 1930s with casement windows and weatherboard balustrade
- Chimney and fireplace
- Surrounded by old farm sheds and equipment

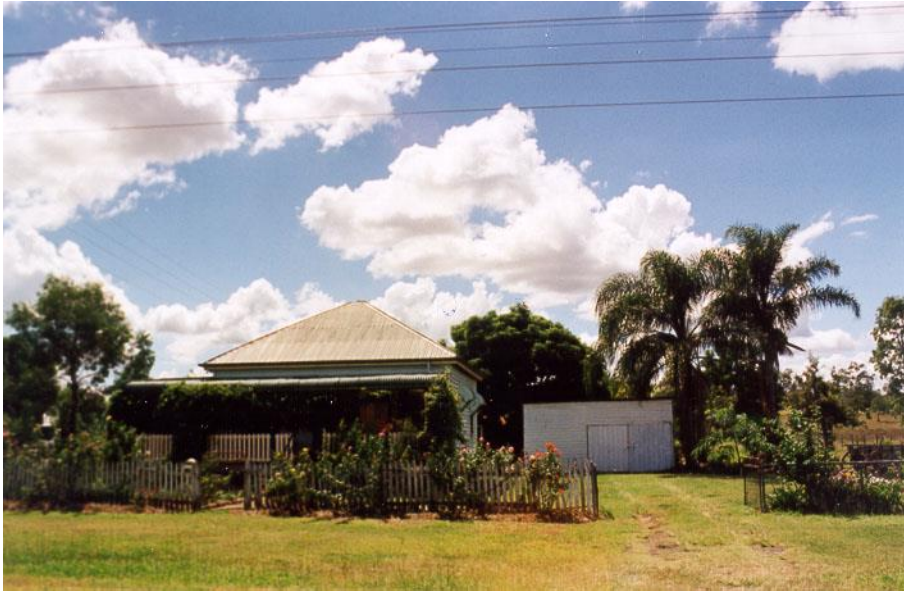
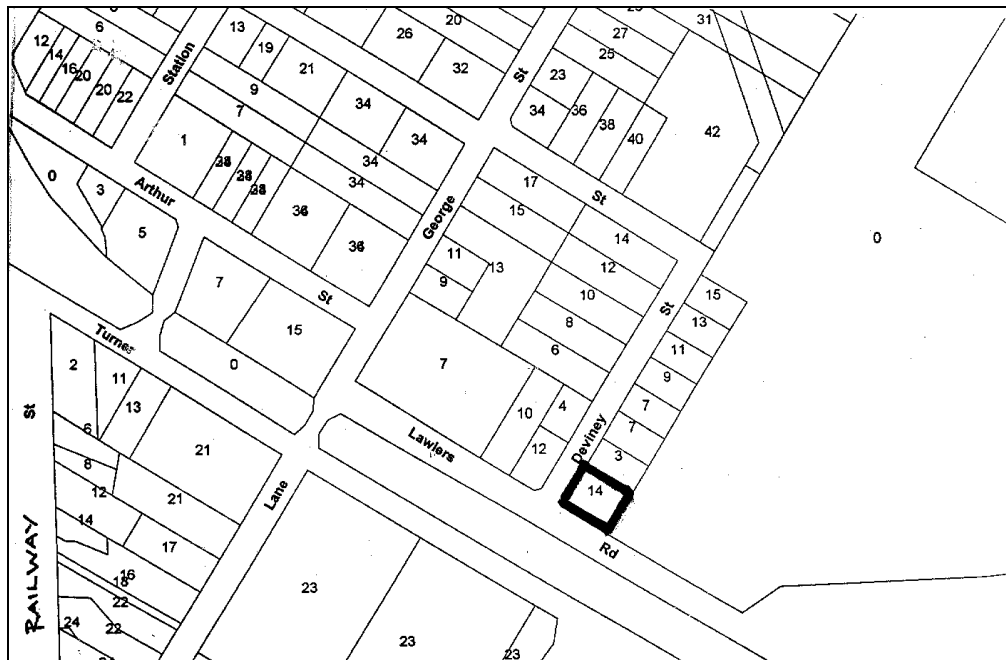
- C1890s style pyramid roofed with stepped bullnose verandah.
- Curved metal window hoods.
- Original doors and windows.
- Replaced slatted balustrade and restumped with steel posts.
- Old picket fence.
- Separate outdoor toilet.

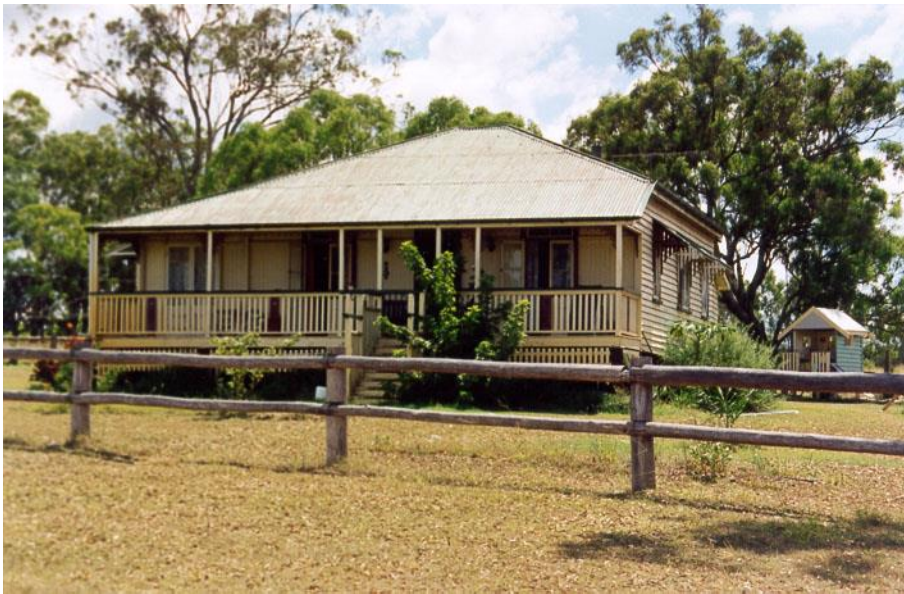
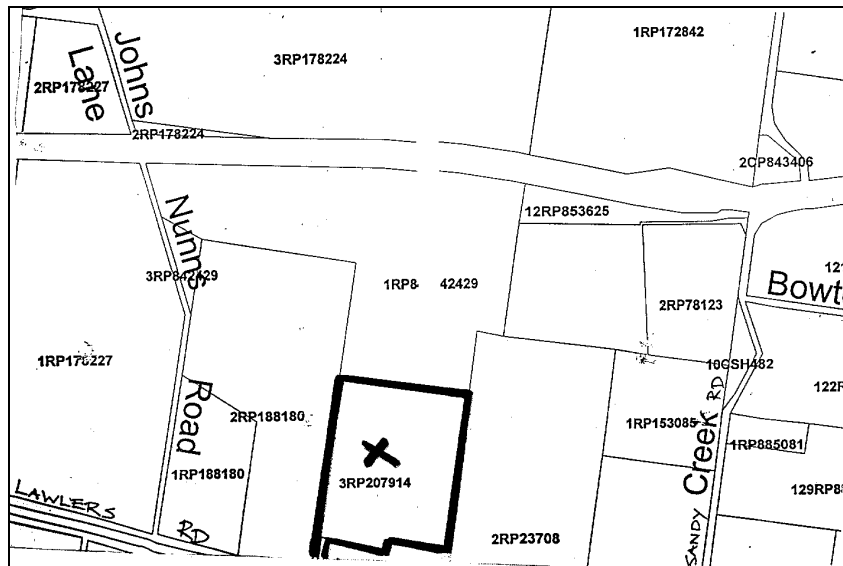
- Short ridge pyramid roofed bungalow with incorporated verandahs.
- Front verandah refurbished, side verandah enclosed.
- Original doors and windows.
- Intact window hoods.
- Low set on timber stumps
- Post and rail fence.

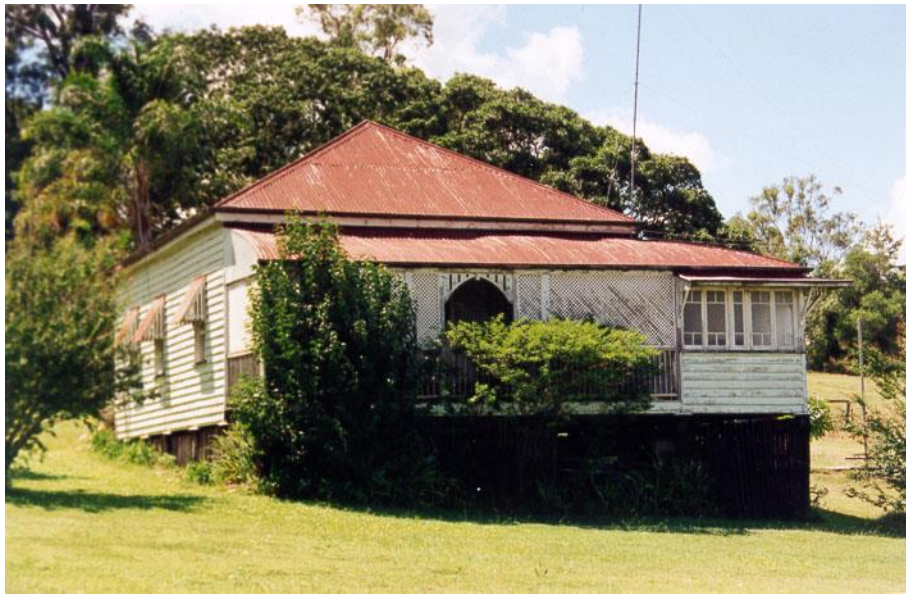
NAME	
CATEGORY	House
LOCATION	28 George St Helidon
RPD	309H1261
LISTING BOUNDARY	Whole site
OTHER LISTINGS	-
SIGNIFICANCE LEVEL	Local

- gable ended pitched roof cottage with front and rear skillion, enclosed verandahs.
- Separate kitchen wing clad with fibro, accessed via an enclosed breezeway.
- Weatherboard clad.
- Central stair entry.
- Front verandah enclosed with fibro and aluminium framed windows.
- Low set on timber stumps

Important for its demonstration of aesthetic characteristics and building techniques typical of the late 19<sup>th</sup>/early 20<sup>th</sup> century.

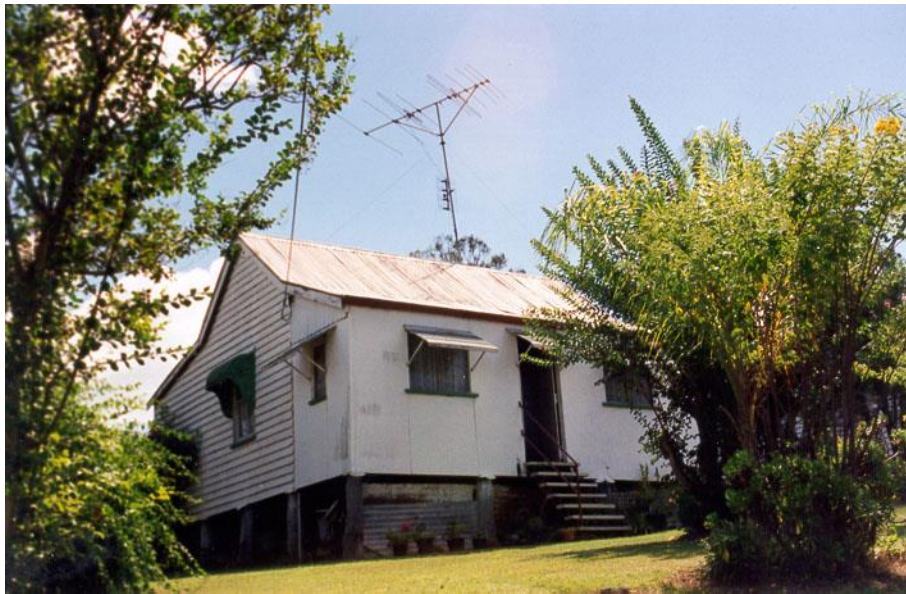
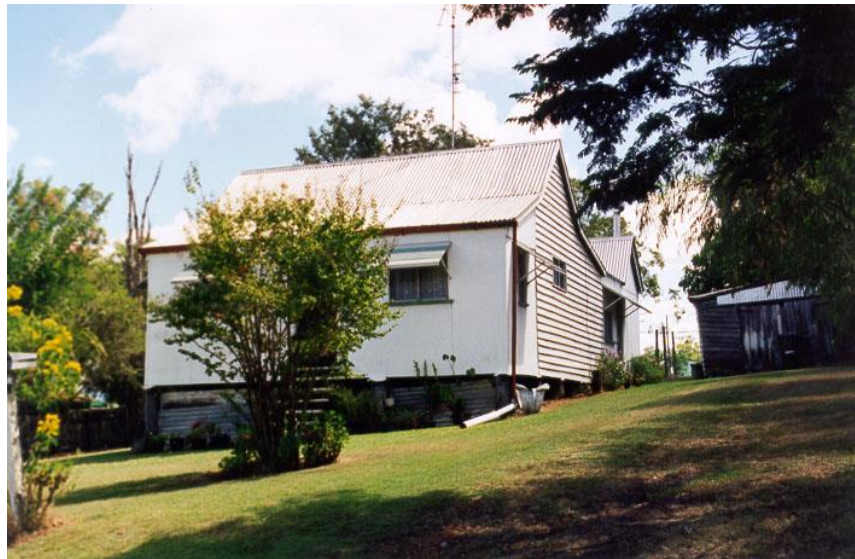
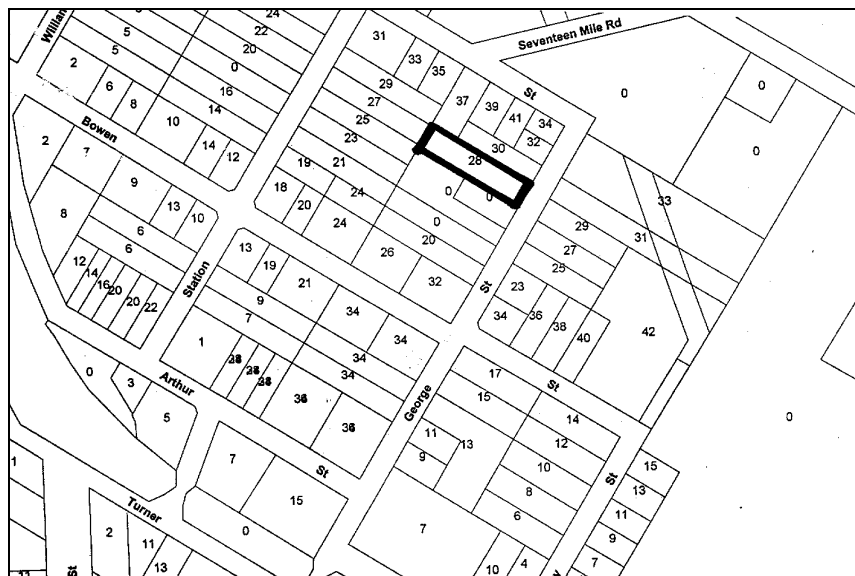
NAME	-
CATEGORY	House
LOCATION	26 Bowen St Helidon
RPD	303H1261
LISTING BOUNDARY	Whole site
OTHER LISTINGS	-
SIGNIFICANCE LEVEL	Recorded

- Short ridge pyramid roof with side facing gable and stepped verandahs.
- Front pyramid core has L-shaped bullnose verandah, enclosed on left.
- House thought to be refurbished and reclad with chamfer boards
- Unusual full length sash windows and central entry door with sidelights.
- Stop chamfered posts to front verandah, other details missing/under refurbishment.
- Set on block walls.
- Carefully tended rose garden in front yard and a large Camphor Laurel tree in the back.

Recorded for its demonstration of early form and materials and for its demonstration of early building techniques.

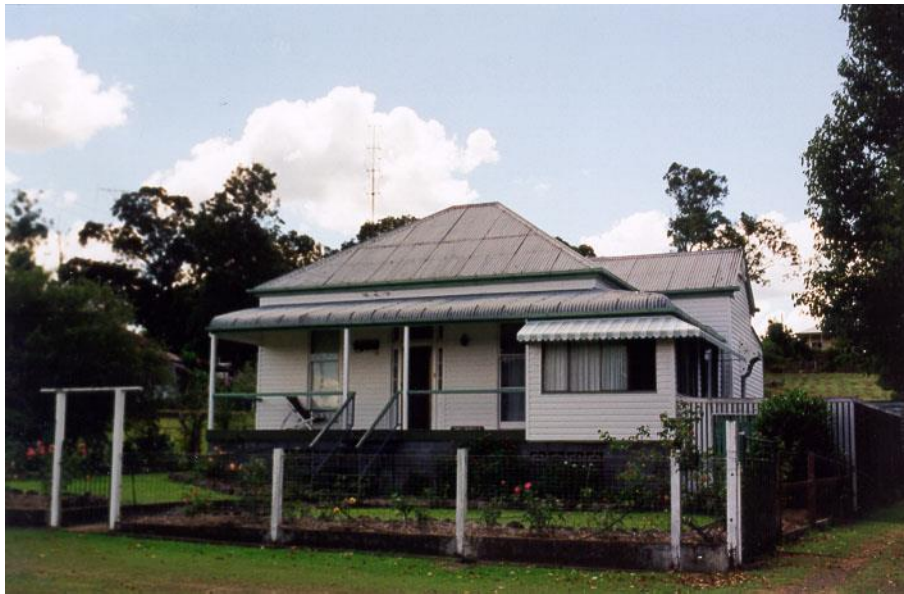
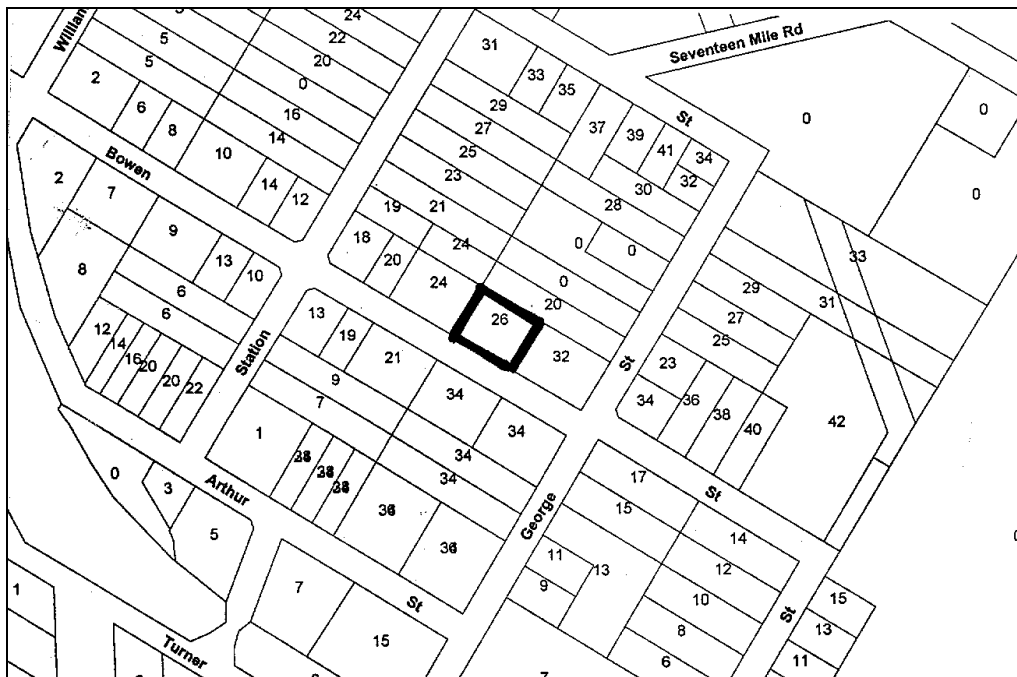
NAME	-
CATEGORY	House
LOCATION	8 Deviney St Helidon
RPD	5H1268
LISTING BOUNDARY	Whole site
OTHER LISTINGS	-
SIGNIFICANCE LEVEL	Local

- c1890s-1900s style short ridge (with iron ridge ornament) pyramid roof with rear hip and stepped curved verandah to 3 sides.
- Verandahs partly enclosed with weatherboards and aluminium framed windows to leave an L-shaped area open.
- Original verandah detailing not evident.
- Some evidence of original doors and windows.
- Recent exterior cladding has hidden the probable single skin construction.
- Low set on timber stumps

Important for its demonstration of aesthetic characteristics and building techniques typical of the late 19<sup>th</sup>/early 20<sup>th</sup> century.

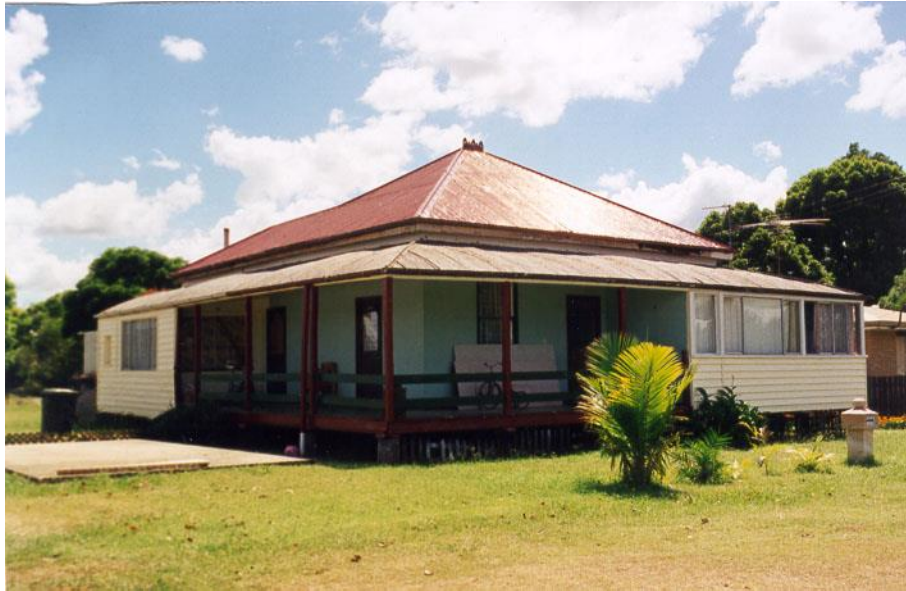
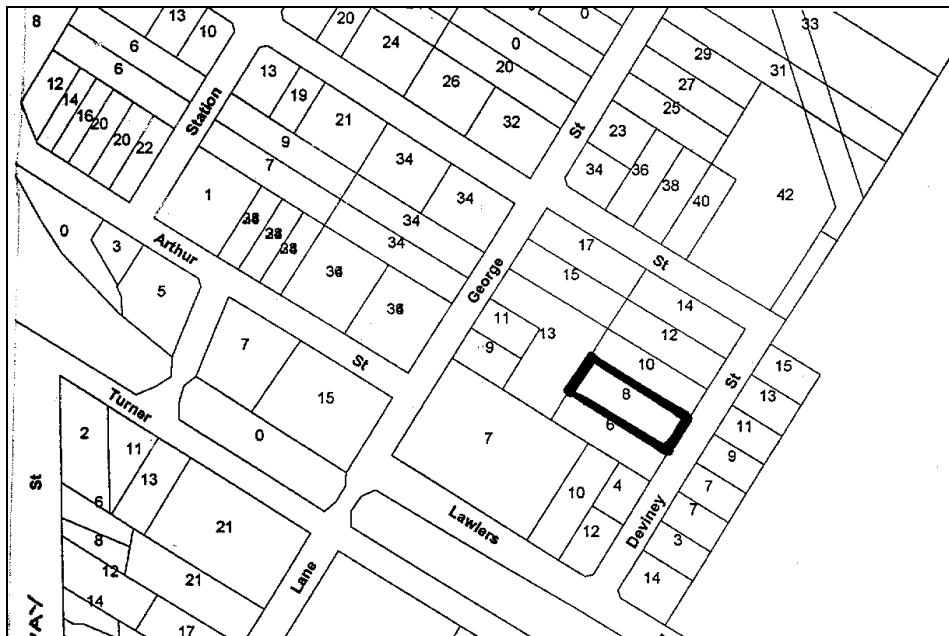
NAME	-
CATEGORY	House
LOCATION	15 Deviney St Helidon
RPD	1RP146973
LISTING BOUNDARY	whole site
OTHER LISTINGS	-
SIGNIFICANCE LEVEL	Local

- C1900s short ridge bungalow with incorporated front and side verandah.
- Refurbished front verandah with 2 rail slatted balustrade and corner brackets
- Decorative bullnose metal window hoods over sash windows.
- Tin stove alcove protruding at rear.
- Low set on timber stumps with central entry.
-

Important for its demonstration of aesthetic characteristics and building techniques typical of the late 19<sup>th</sup>/early 20<sup>th</sup> century.

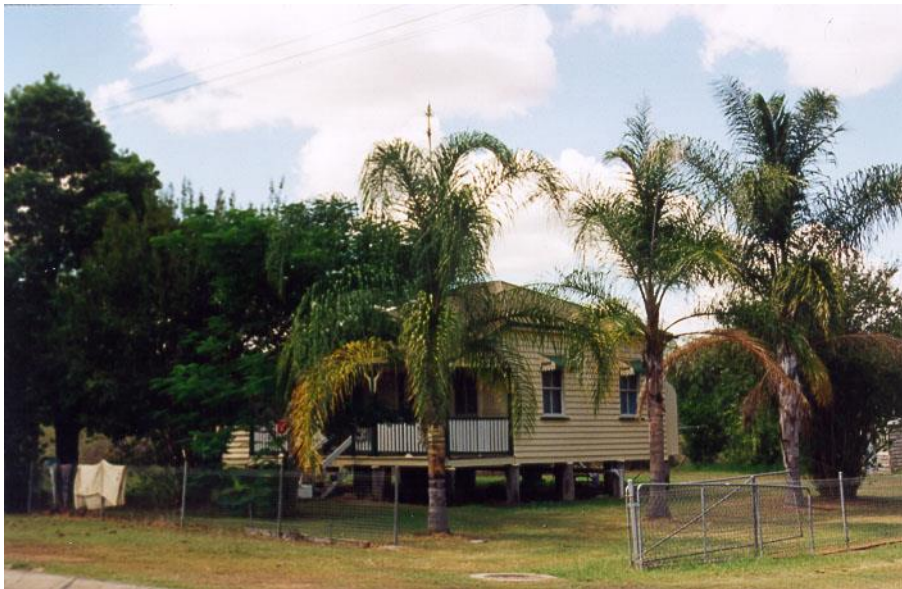
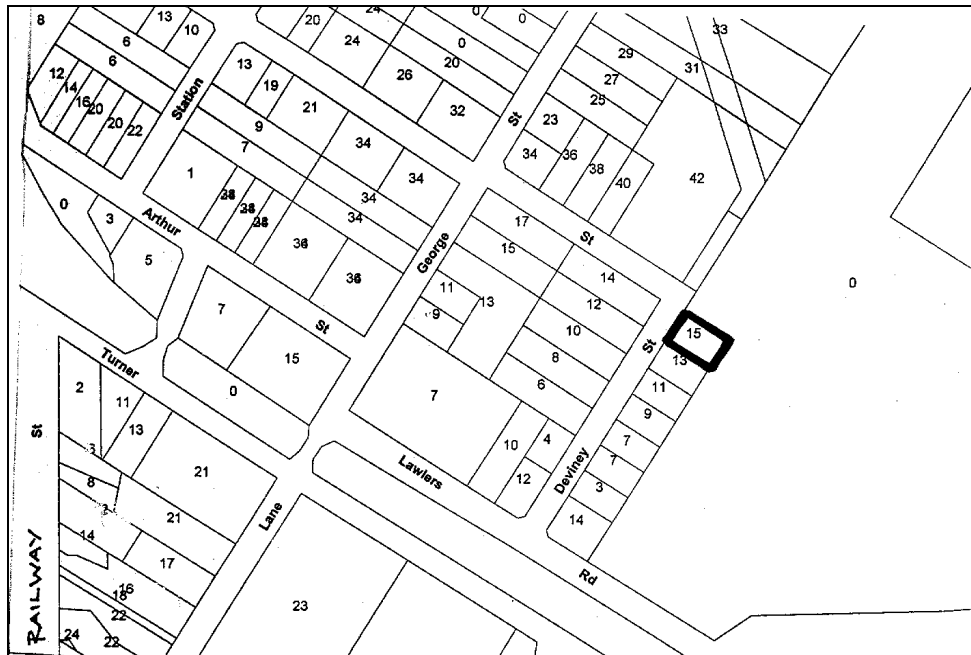
NAME	-
CATEGORY	House
LOCATION	15 George St Helidon
RPD	10H1268
LISTING BOUNDARY	whole site
OTHER LISTINGS	-
SIGNIFICANCE LEVEL	Local

- C1890s style, short ridge pyramid roof and right hand rear hip with stepped front enclosed bullnose verandah.
- Weatherboard clad with simple entry porch to enclosed verandah – stair and enclosure not original
- Decorative bullnose metal window hoods over sash windows.
- Low set on timber stumps
-

Important for its demonstration of aesthetic characteristics and building techniques typical of the late 19<sup>th</sup>/early 20<sup>th</sup> century.

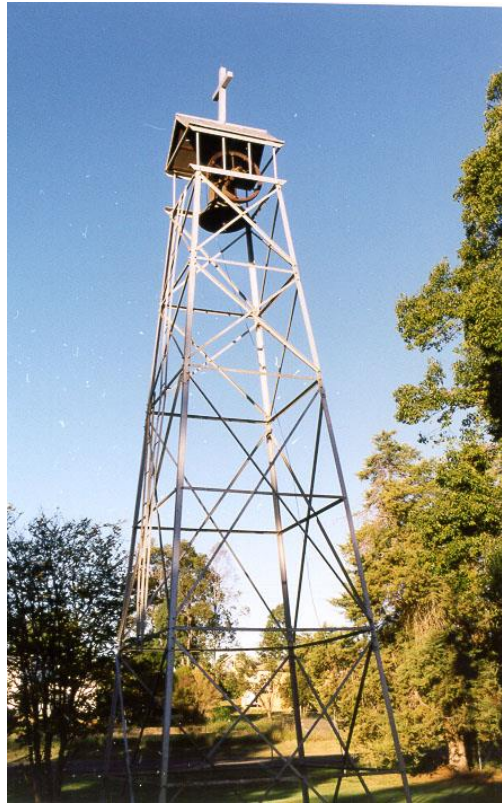
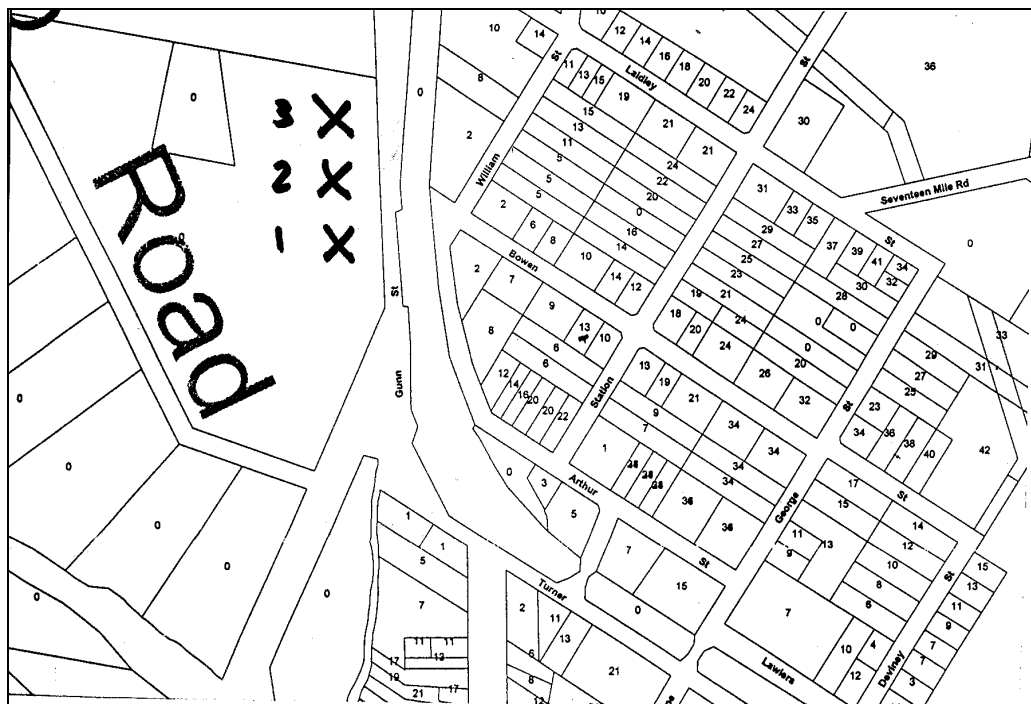
- 1 Church
- 2 Hall
- 3 Presbytery

The church, the hall (former School), bell tower and presbytery are in a line along the edge of a sharp fall to creek flats where there are the remains of an old sports ground. (Goal posts, Basketball Hoops)

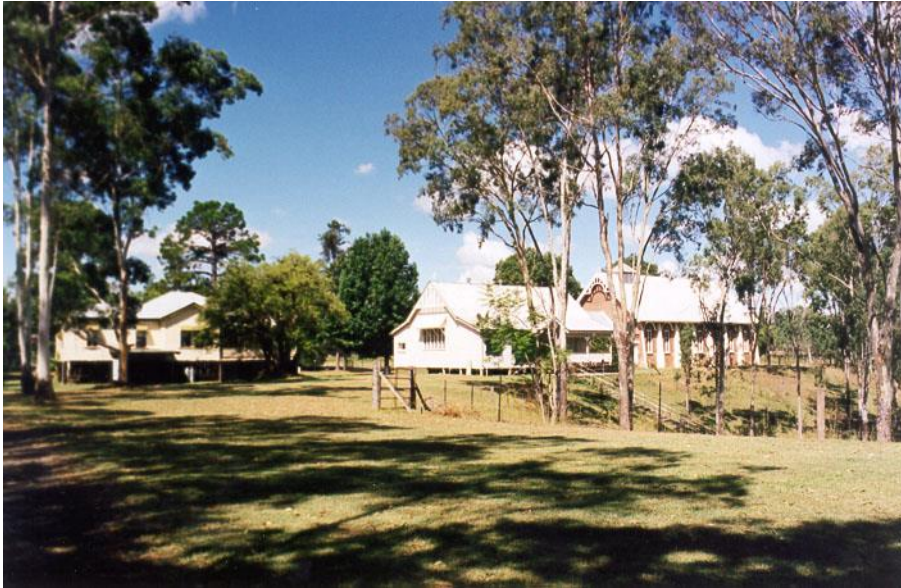
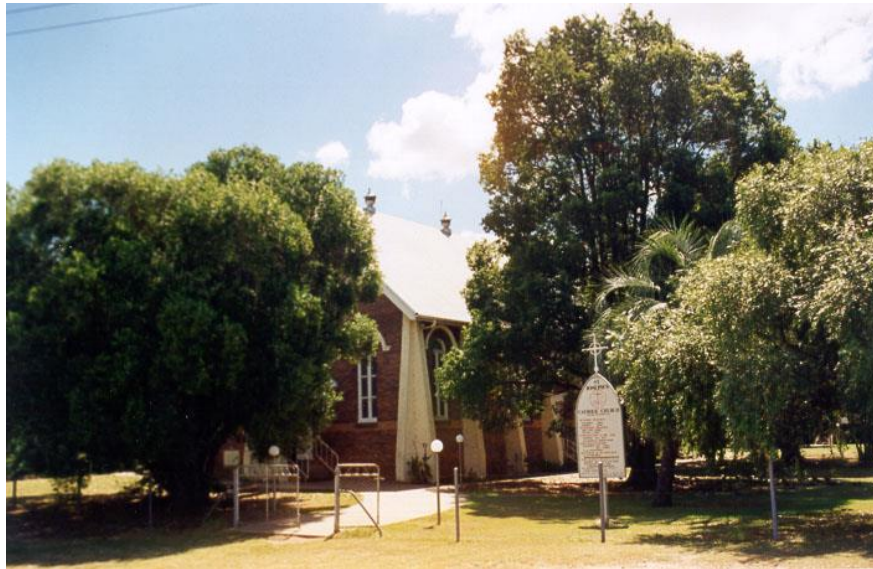
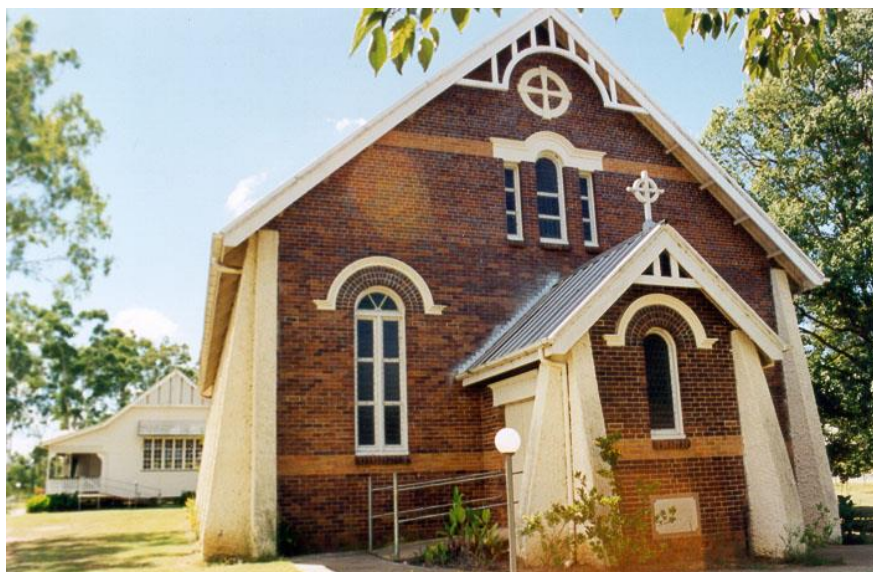
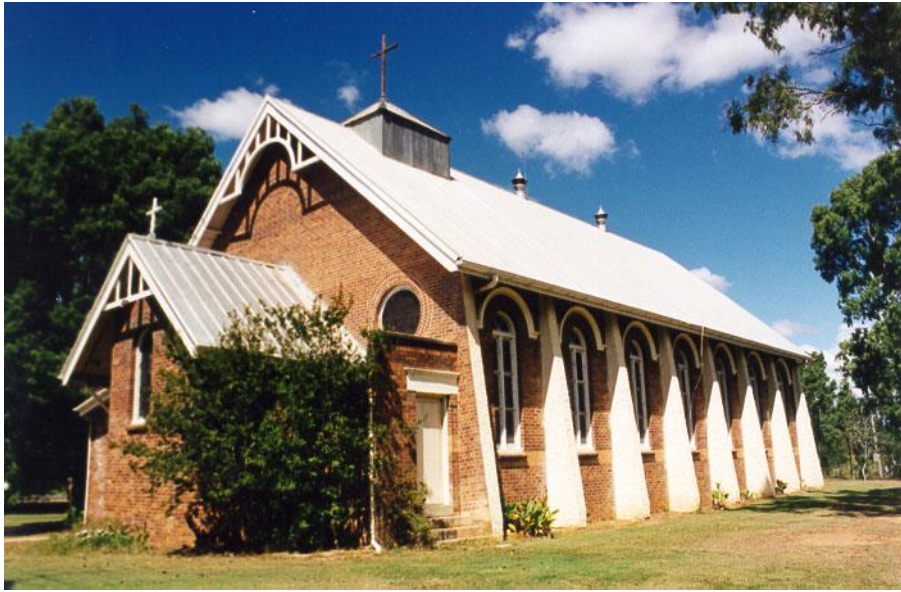
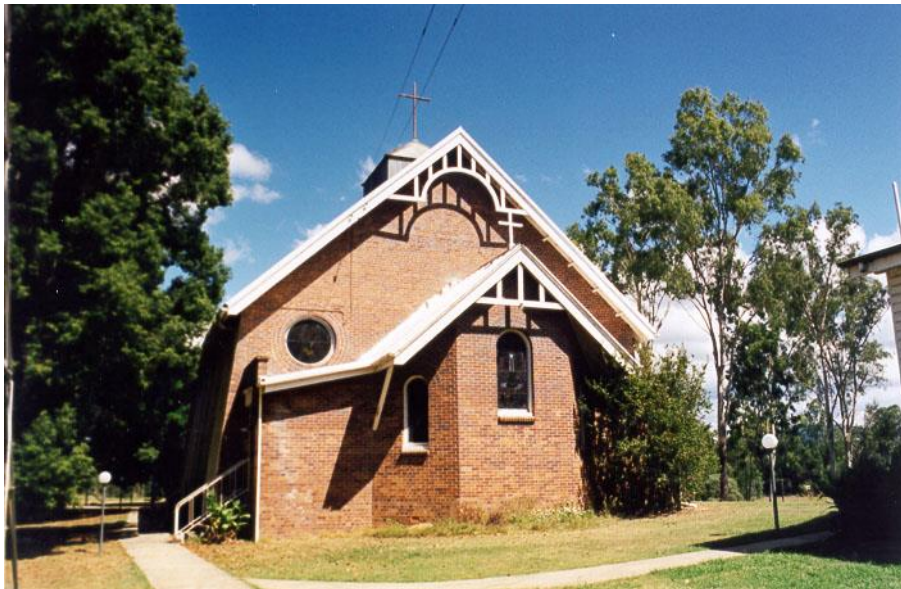
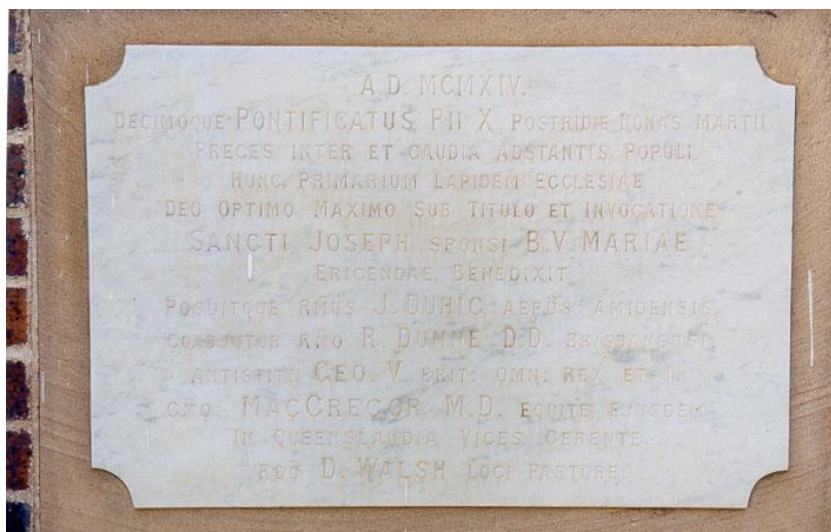
NAME	St Joseph's Catholic Church complex
CATEGORY	Ecclesiastical buildings
LOCATION	Gunn St Helidon
RPD	3RP892079
LISTING BOUNDARY	Whole site
OTHER LISTINGS	-
SIGNIFICANCE LEVEL	State

- Gable ended pitched corrugated roof
- Gabled flat pan and roll roofed, central front entry porch.
- Two roof top vents and a larger pyramid roofed lantern that protrudes to the interior, possibly for light or ventilation.
- Rear semi-octagonal sanctuary with the vestries on each side.

- Large bell in steel-framed tower surmounted by a small gable roof and Latin cross.
