Queensland
LIBRARY
Department of Mines

RECORD 1984/44

SLOPE STABILITY AND ITS CONSTRAINTS
ON CLOSER SETTLEMENT IN THE
FOOTHILLS OF THE TOOWOOMBA RANGE, GATTON SHIRE

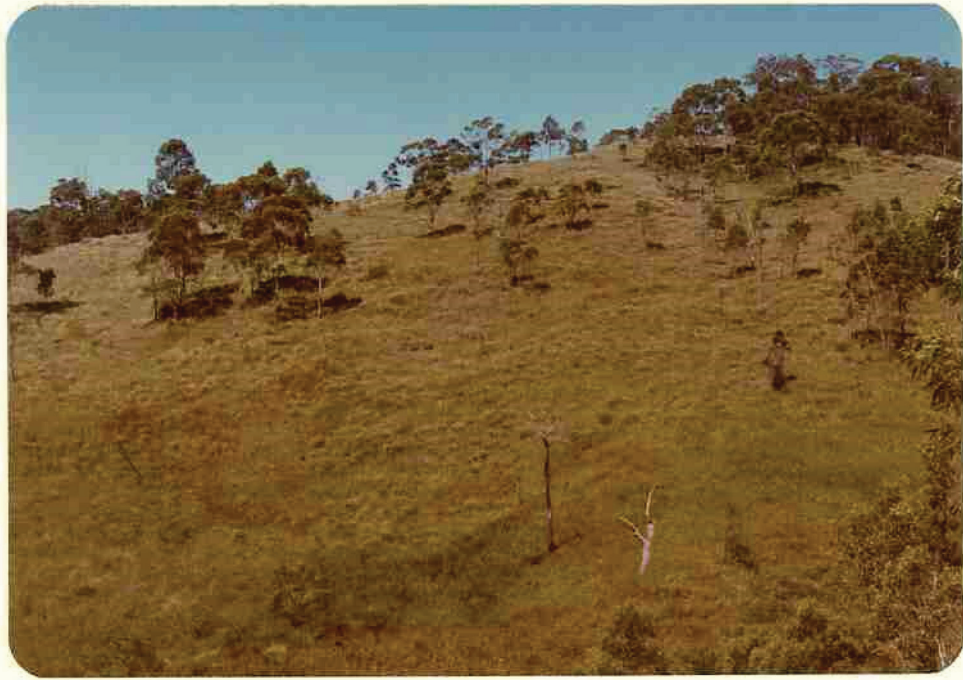
PHOTO 3. Soil creep and terracettes on steep basalt slopes of Zone Eb.

On the basalt terrain, some soil creep and terracetting seems normal under natural forest conditions, mainly in the steep heads of gullies and on the steepest scarps

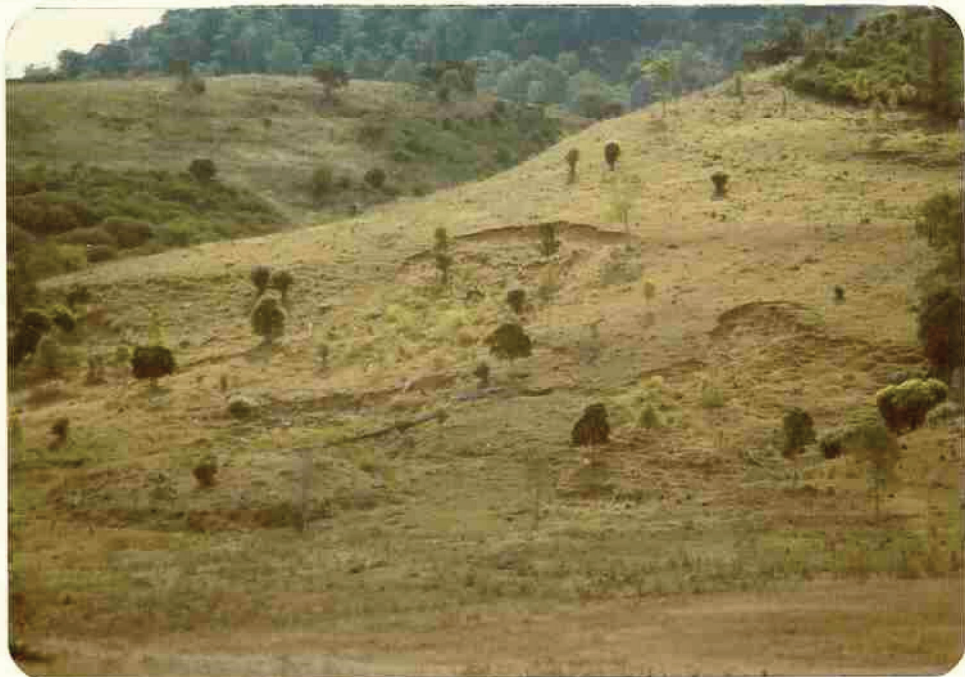
PHOTO 4. Small rotational slides at toe of Es Zone. Valley of Monkey Waterholes Creek.

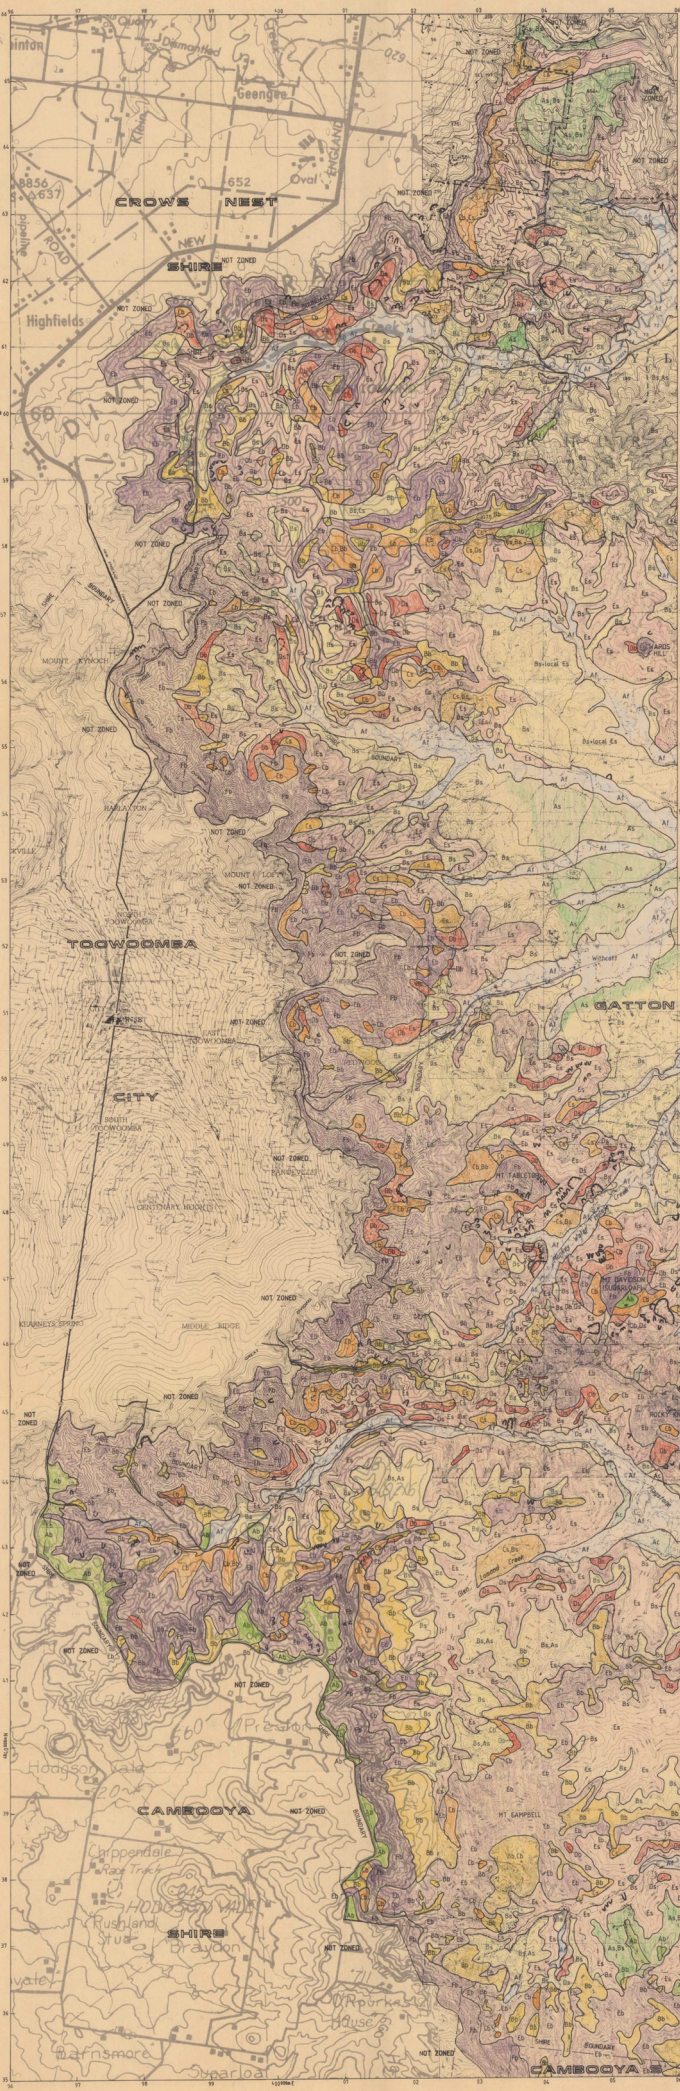
GEOLOGICAL SURVEY OF QUEENSLAND
SLOPE STABILITY
IN THE FOOTHILLS OF THE TOOWOOMBA RANGE
GATTON SHIRE
STABILITY AND SUITABILITY ZONING

A more appropriate procedure for ascertaining the likely stability of slopes in regional studies, such as the present one, is to empirically relate known landslide occurrences to particular conditions. If such relationships can be recognised, zones with similar combinations of conditions can then be outlined. Such an approach has been used to establish the zones of this study (shown on Map 2 and discussed below).
