Gatton Shire Cultural Heritage Study

Vol 4

Withcott Mt Sylvia Tent Hill Ropeley Special Sites

A report for Gatton Shire Council by Buchanan Architects December 2000

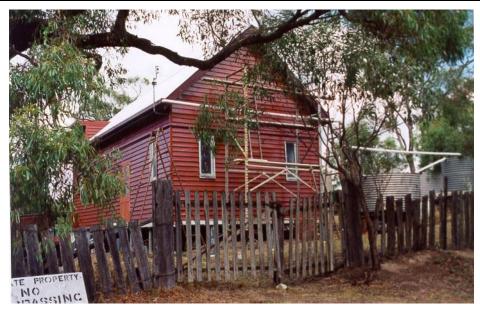
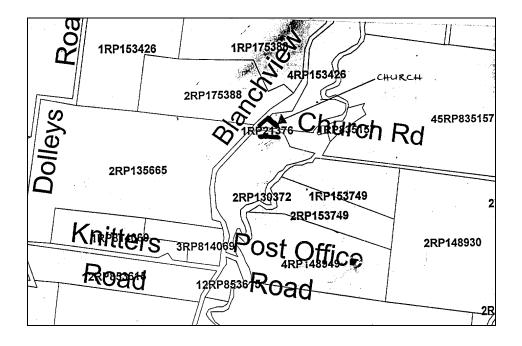
- Gable ended pitched roof and rectangular plan building
- Refurbished as a dwelling
- Weatherboard clad.
- Old slab and wire fence.

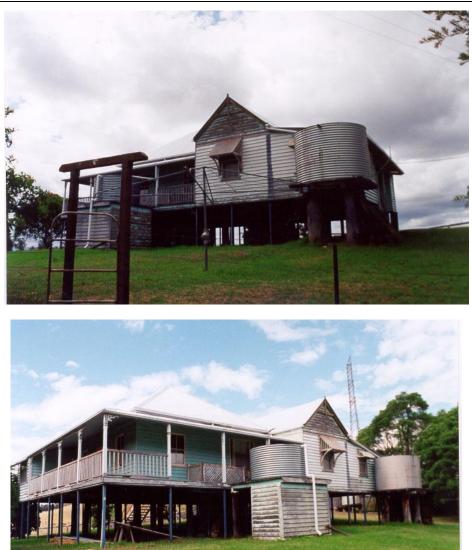
- Original section of the dwelling was the pyramid roof core with three sides stepped curved verandah. The gable ended pitched section with side skillion was added c1890s.
- Weatherboard clad with original windows and doors.
- Stop chamfered posts with capitals and ornate corner brackets.
- Slatted two-rail balustrade.
- Various window hoods.
- Water tanks and log stands
- Various farm sheds including creamery, stables and barns, machinery shed.

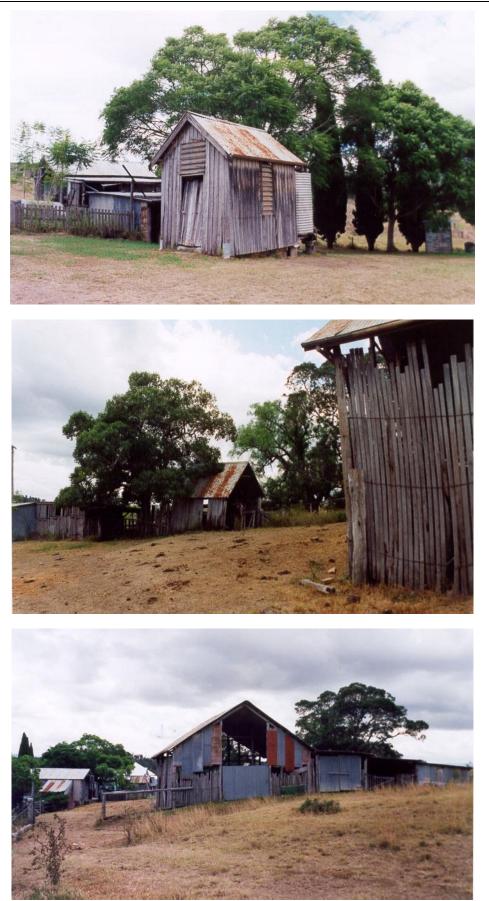
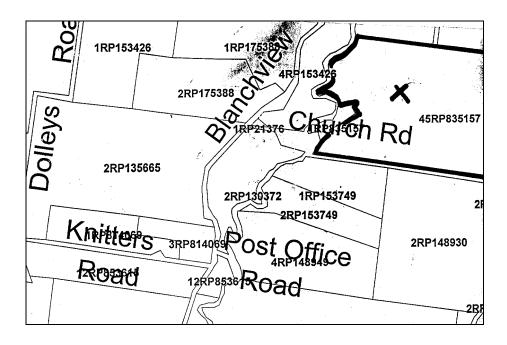
- C1880s style core, short ridge pyramid roof with stepped curved verandahs to three sides. Right hand rear half hipped section also c 1880s.
- Left hand L-shaped section is new construction linking to rooms that formed a part of the Harristown railway building that has been relocated to this site. The verandah continues to wrap around the new wing and are constructed to match the original detailing.
- Weatherboard clad with original sash windows.
- Curved tin window hoods to exposed areas.
- Central stair entry, cross-braced balustrade, stop chamfered posts with capitals and corner brackets.

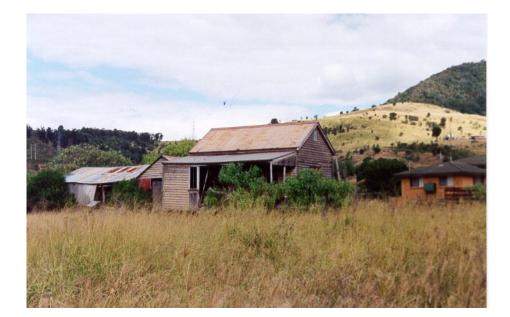
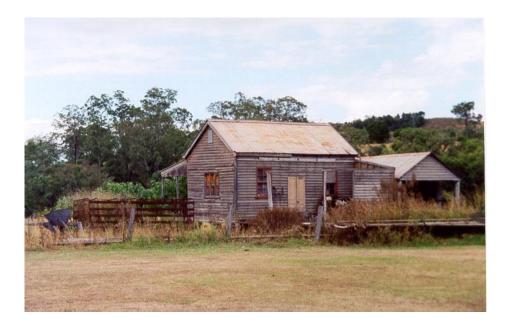
- Gable ended pitched roof with stepped front skillion verandah and enclosed side verandah.
- Weatherboard clad with symmetrically placed four light sash windows and a bank of three casement windows at the gable end.
- Entry porch is undecorated and the posts are square, the front entry door is not identified, the rear entry is a French door.

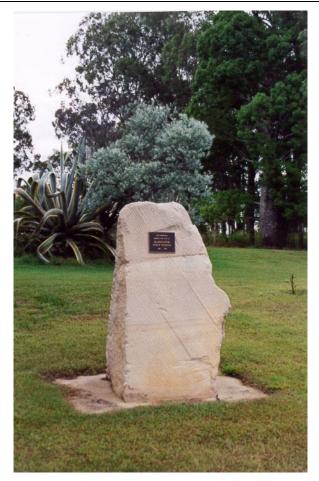
A monument marks the school's original site.

Monument marking the original location of the Blanchview School Building

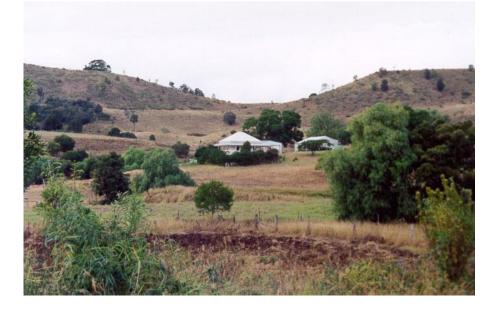
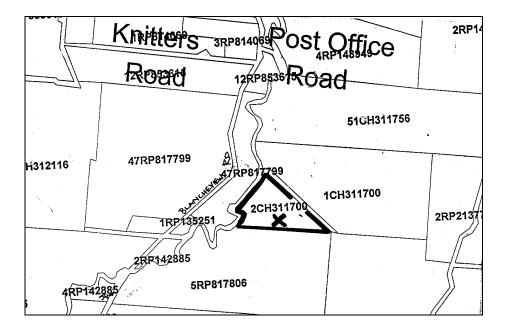
- Short ridge pyramid roof with stepped curved three sides verandah.
- Restored cross braced balustrade
- Original doors and windows

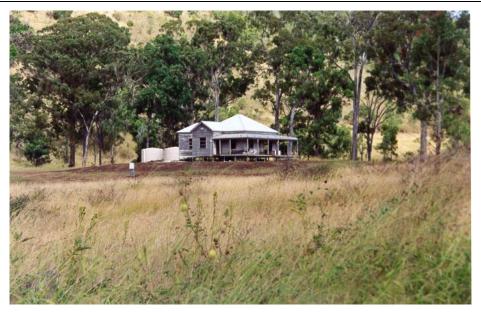
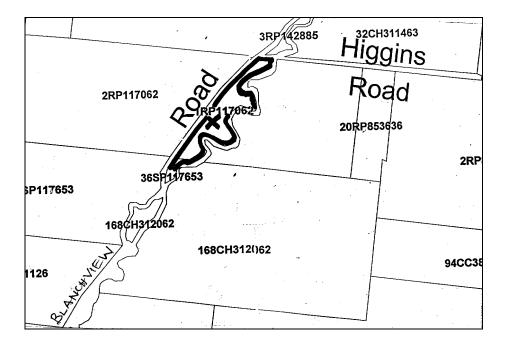
- Relocated and currently under going refurbishment.
- C1890s pyramid roof with asymmetrical gable and left-hand half-hipped extension, stepped curved L-shaped verandah.
- The building is very noticeable from Blanchview Road.

Comments: Might be worthy of a local listing when refurbished

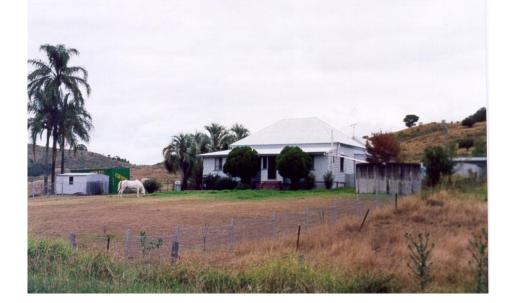
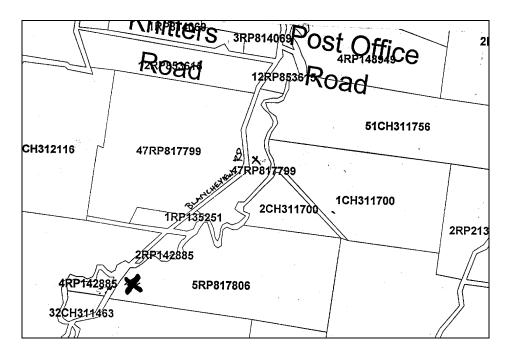
- C1890s style short ridge pyramid roof cottage with stepped skillion verandah to two sides.
- Verandahs enclosed
- Weatherboard clad with stove alcove evident.
- Low set with batten infill between stumps.

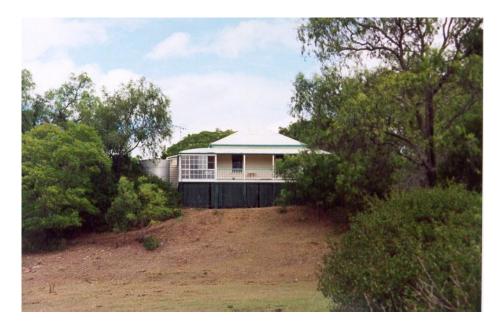
- C1890s style short ridge pyramid roof with stepped curved verandahs on four sides with the kitchen built to one corner.
- Two rail broomstick balustrade with plain posts.
- High set with timber posts and batten infill.
- Rear glazed enclosed sunroom.
- Several sheds and out buildings located on the right hand side of the house.

View to the left side elevation of the house. Blanchview Road runs past behind the trees on the right hand side of picture.

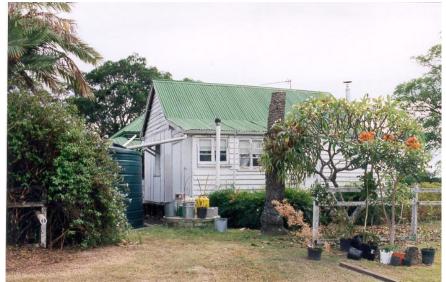
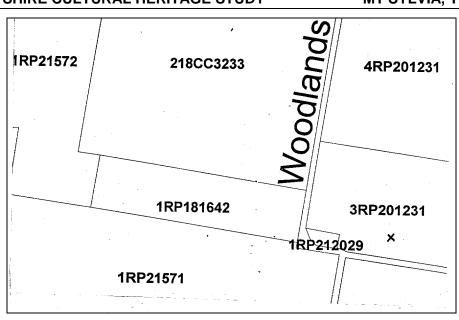
Stumps on the original houses extend up to become the frame

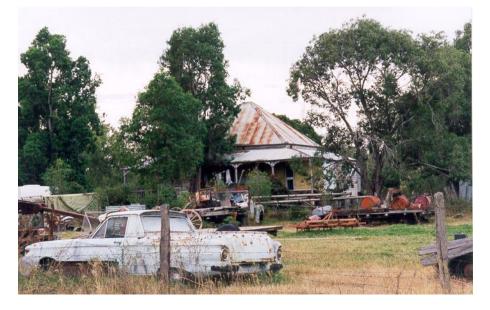
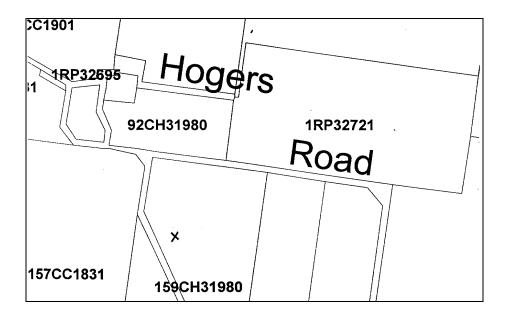
NAME	
CATEGORY	Farm
LOCATION	Ropely-Rockside Rd
RPD	159CH31980
LISTING BOUNDARY	House site
OTHER LISTINGS	-
SIGNIFICANCE LEVEL	recorded

House c1890 Old barns and outbuildings Huge fig tree

The house is important for its demonstration of aesthetic characteristics and building techniques typical of the late 19th century, now becoming rare.

The surrounding farm buildings demonstrate early building techniques and have the ability to yield information about early farming practices.

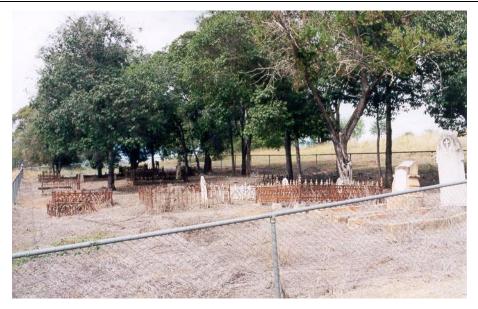
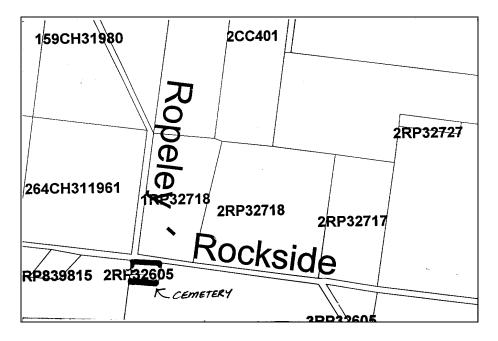
NAME	Lutheran Cemetery
CATEGORY	Cemetery
LOCATION	Ropely-Rockside Rd
RPD	2RP32605
LISTING BOUNDARY	House site
OTHER LISTINGS	
SIGNIFICANCE LEVEL	Local

Small cemetery Many graves fenced with iron lace panels on a brick or timber base, some timber bases recently replaced Some head markers are cast iron plaques Many German names, some inscriptions are in the German language Most graves c1900, oldest believed to be 1884 Surrounded by a pipe and chain wire fence

The large proportion of cast iron burial markers with raised inscriptions, some in the German language, is uncommon.

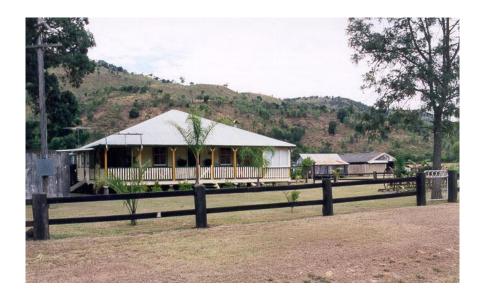
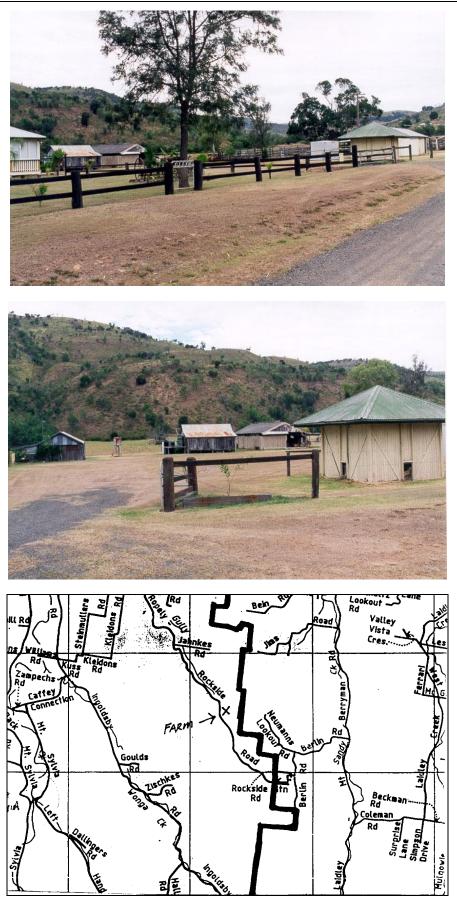
NAME	
CATEGORY	farmhouse
LOCATION	Lot 14, Ropely-Rockside Rd (200m after bitumen ends)
RPD	14RP802572
LISTING BOUNDARY	House site
OTHER LISTINGS	
SIGNIFICANCE LEVEL	House local; farm buildings recorded

Timber house Pyramid roof extends across verandahs which have a slatted balustrade Slab building and other farm buildings in quite good condition Large fig tree beside house

Important for its demonstration of early form and materials and for its demonstration of early building techniques.

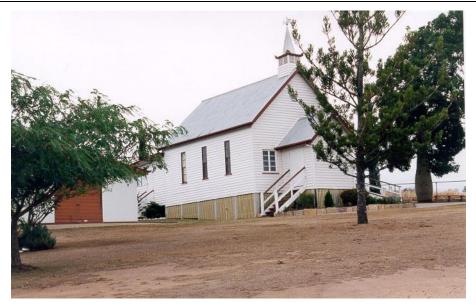
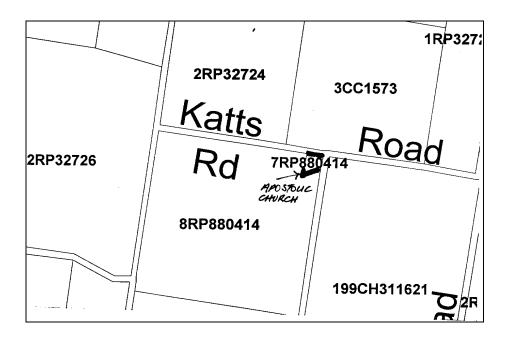
NAME	Ropeley Apostolic Church, Ropeley
CATEGORY	Church
LOCATION	Cnr Steinmuller and Katts Rd
RPD	7RP880414
LISTING BOUNDARY	House site
OTHER LISTINGS	
SIGNIFICANCE LEVEL	local

Weatherboard church on concrete stumps, battened underneath Casement windows small bell tower with acroterions, topped with a weathervane front porch corrugated galvanised iron roof Rear skillion extension Grounds contains a bottle tree, pencil pines and Norfolk pine

Significant as an example of a simple country church.

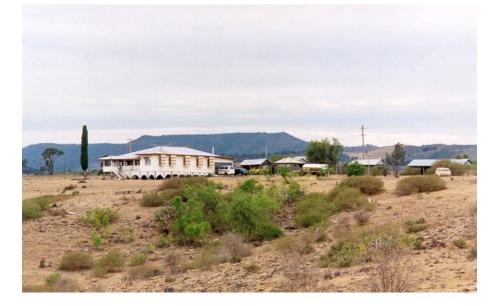
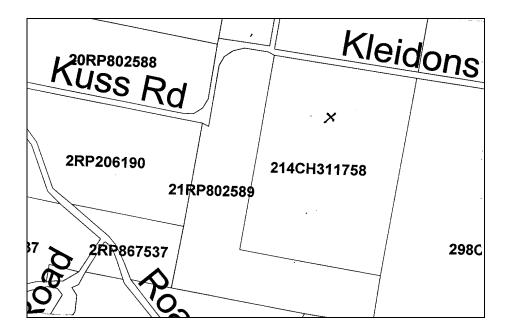
NAME	
CATEGORY	Farm
LOCATION	At intersection of Kleidons, Kuss and Steinmullers Rds
RPD	214CH311758
LISTING BOUNDARY	House site
OTHER LISTINGS	-
SIGNIFICANCE LEVEL	local

Substantial modified interwar house Open front verandah, Battened skirt

The house is significant as a good example of the use of materials, form and detailing typical of the interwar period.

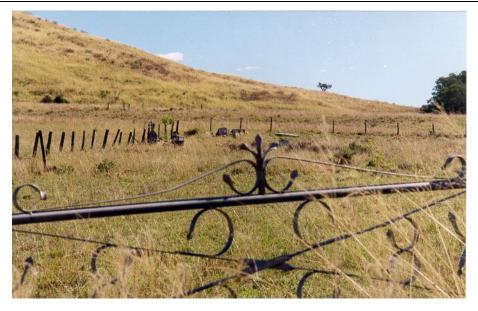
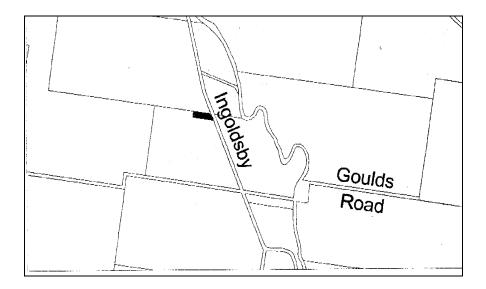
NAME	Ingoldsby Cemetery
CATEGORY	Cemetery
LOCATION	Ingoldsby Rd (near Goulds Rd)
RPD	RP36786
LISTING BOUNDARY	Whole site
OTHER LISTINGS	
SIGNIFICANCE LEVEL	Local

Small country graveyard, graves are at rear of the site. Remains of a wire and timber fence Early gate Dead trunks of two hoop pines on the front alignment

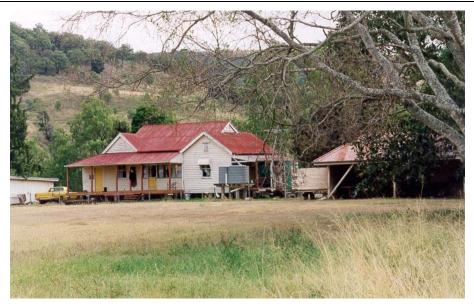
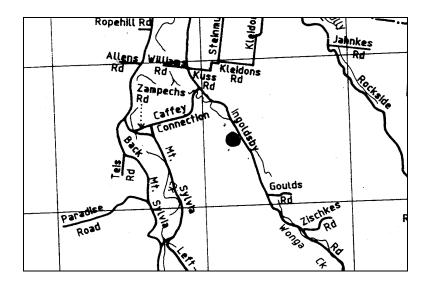
NAME	Old Ingoldsby School House
CATEGORY	House, former school residence
LOCATION	1128 Ingoldsby Rd
RPD	
LISTING BOUNDARY	House site
OTHER LISTINGS	-
SIGNIFICANCE LEVEL	Local

Gabled, lowset weatherboard school house Timber stumps Open front and side verandahs Corrugated galvanised iron roof Window hoods Open-sided hip-roof shelter shed and a small building, possibly former toilets, still remain on site

Important for its demonstration of aesthetic characteristics and building techniques typical of the late 19th century, now becoming rare.

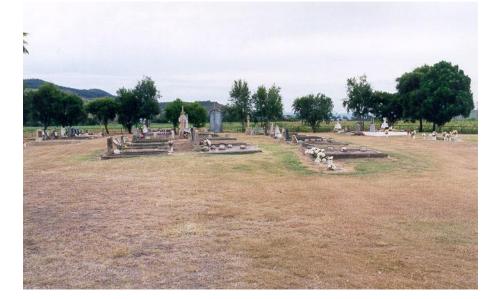
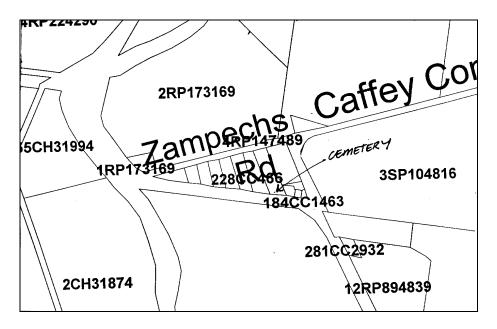
NAME	Caffey Cemetery
CATEGORY	Cemetery
LOCATION	Caffey Connection Road
RPD	227CC466
LISTING BOUNDARY	Whole of site
OTHER LISTINGS	
SIGNIFICANCE LEVEL	Local

Small cemetery, some substantial headstones including marble cherub and one large sandstone monument Unfenced at front Boundary lined with small trees

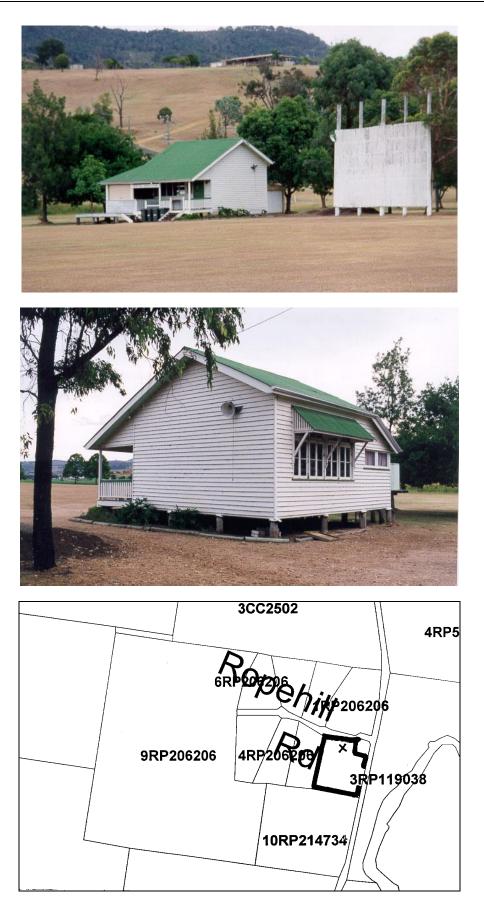
NAME	Upper Tent Hill School and residence
CATEGORY	School
LOCATION	Upper Tent Hill School Lane
RPD	285CC3073
LISTING BOUNDARY	Whole of site
OTHER LISTINGS	-
SIGNIFICANCE LEVEL	Local

School

Highset weatherboard school, corrugated galvanised iron roof, gable end has a window hood Side verandah concrete stumps Original wing has a lowset rear extension Original open sided play shed There are various other modern extensions and covered ways Modern steel storage shed Playground has large fig trees

Residence Typical interwar

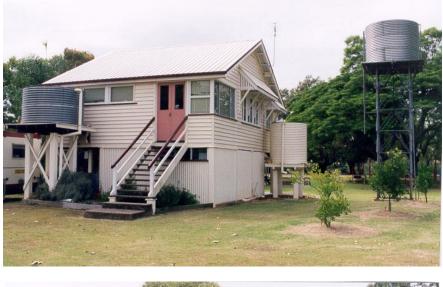
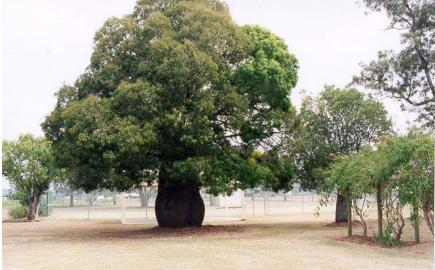
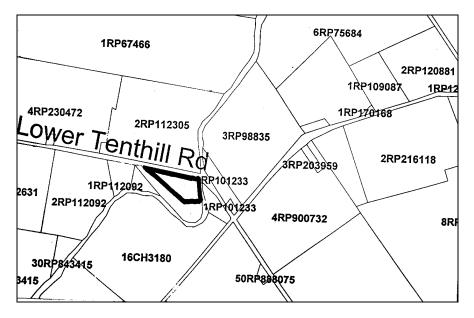
NAME	Lower Tenthill State School
CATEGORY	School
LOCATION	Lower Tent Hill Rd
RPD	2RP101233
LISTING BOUNDARY	Whole of site
OTHER LISTINGS	-
SIGNIFICANCE LEVEL	Local

Highset weatherboard timber school Gable ended, casement windows, window hoods, concrete stumps Front verandah enclosed, hopper windows Symmetrically-placed timber stairs

Original opens-sided playshed plus a new colorbond one New covered way linking to newer classroom wing at side Colorbond shed Two elevated rainwater tanks

Very large bottle trees in grounds

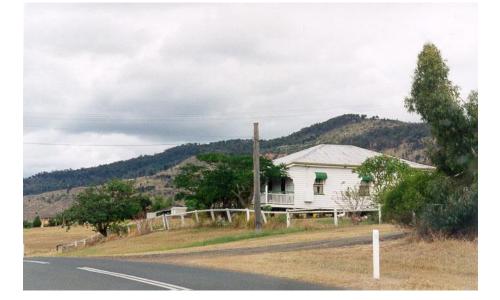
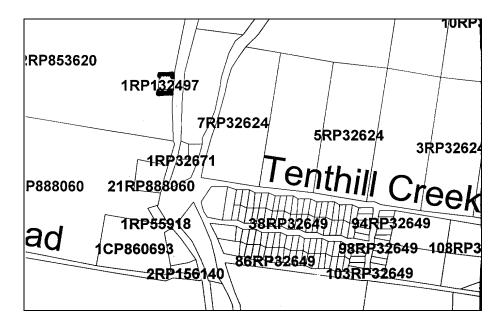
NAME	
CATEGORY	house
LOCATION	Mt Sylvia Rd (near Tenthill Ck Rd)
RPD	1RP132497
LISTING BOUNDARY	House site
OTHER LISTINGS	-
SIGNIFICANCE LEVEL	local

Highset weatherboard cottage , hip roof Open front verandah, left hand verandah enclosed Broomstick balustrade, decorative brackets Window hoods Colonial sash windows Separate gabled timber garage

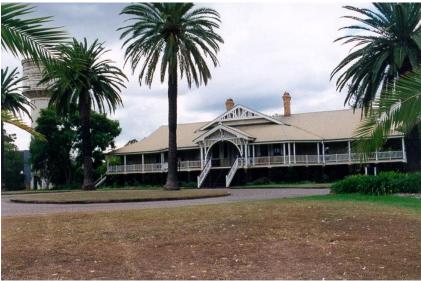
The Foundation Building was constructed in 1897 as the first college building.

The Foundation Building

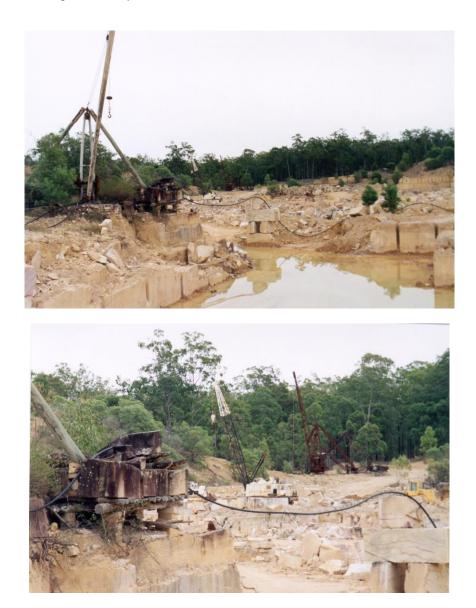
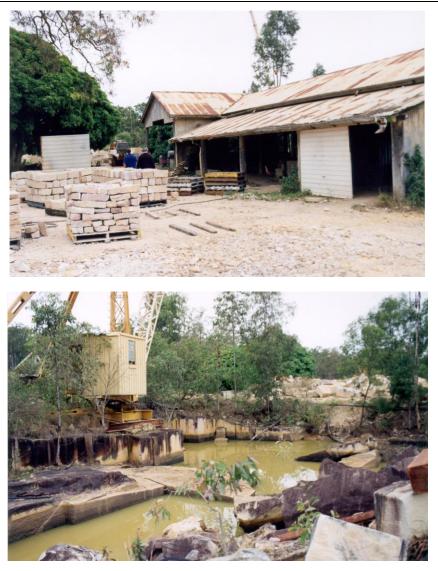
- Large operational quarry site. A rockface near the office/shed shows signs of a succession of quarrying methods, from handwork to modern trenching machinery.
- Two steam cranes are still situated in the adjacent State Forest 616.
- The buildings on site include a large mainly open-sided timber shed, now in rather deteriorated condition, containing the remains of former cutting machinery.

Site which provided stone for Jupiter's Casino 2000

Same site 1985

This is an operational industrial site. It is recommended that Gatton Shire Council hold discussions with this quarry and with other local quarries to see if they can mutually agree areas which can be conserved. A heritage boundary should be established within the overall site.
